CORROSION OF ELECTRONIC CONTROL SYSTEMS IN GAS TREATING ENVIRONMENTS

ABSTRACT

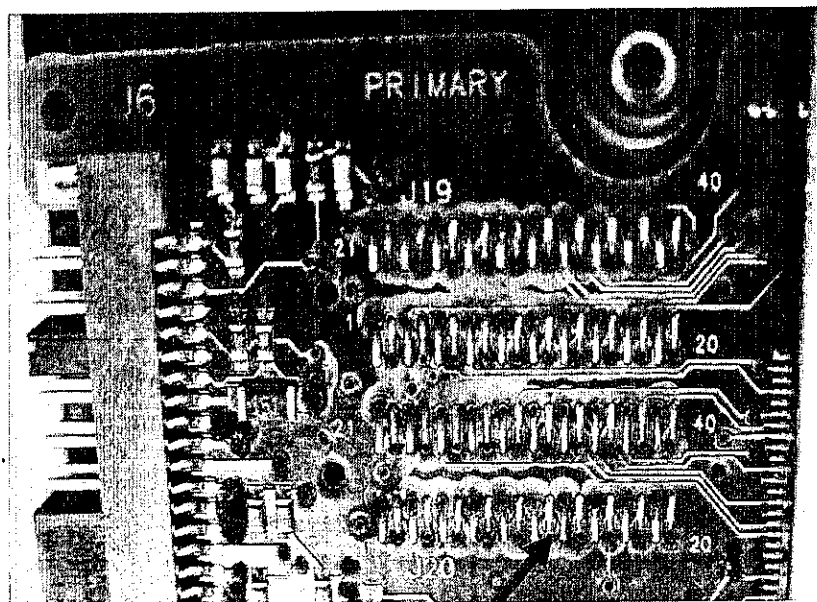
Visual and stereomicroscope examination showed that many circuit board pads and connectors were badly tarnished (Figures 2, 3). Though heavy copper sulfide (Cu_2S) corrosion products were present on many conductor tracks and pads, the circuit board's gold-plated external connector pins were not corroded (Figure 3). The hard drive's vacuum seal was still intact. Further laboratory investigation of the problem included microscopy and energy dispersive microanalysis (EDS) of extracted corrosion products, which were removed using a replication technique.

Figure 3: Detail view of circled area in Figure 1.
Note corroded pads (arrow) and uncorroded external contact pins (left)

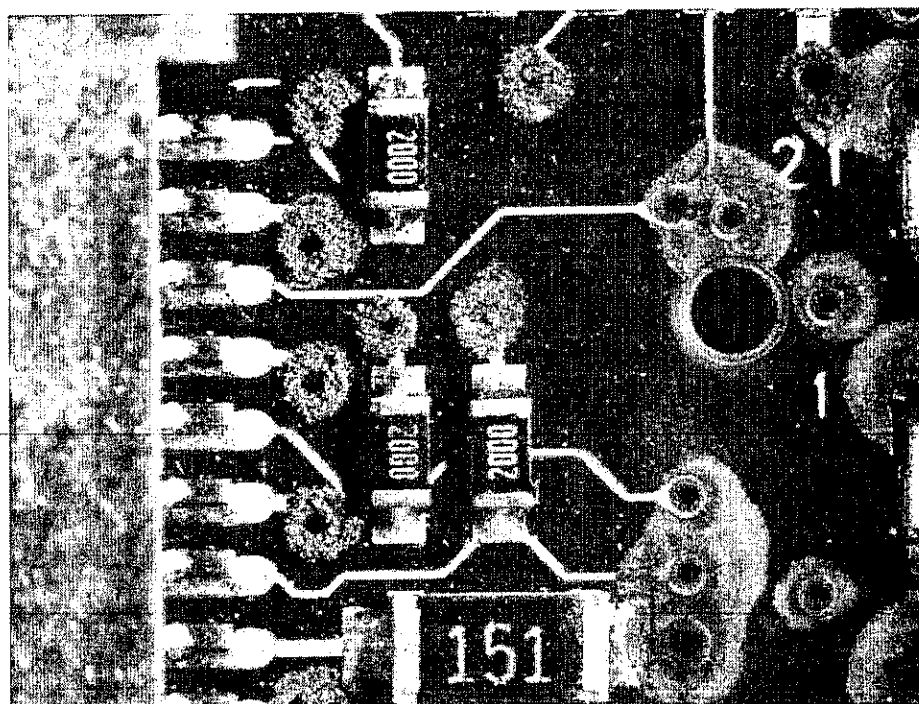
Optical microscopy of the electronic module revealed radial growth of iridescent brown-black deposits on open connector pads (Figure 4). The deposits formed from corrosion of copper in a sulfur-bearing environment. These deposits appeared to be growing out from beneath the connector holes and coalescing with time, perhaps leading to a short circuit of related electronic components. The corrosion products were extracted onto acetate replica tape. EDS microanalysis (Figure 5) revealed primarily copper (Cu) and sulfur (S) in the corrosion products, corresponding to copper sulfide (Cu_2S).

Figure 4: Optical image of corrosion product

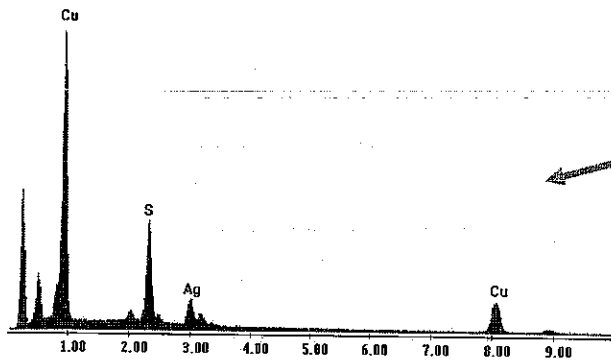
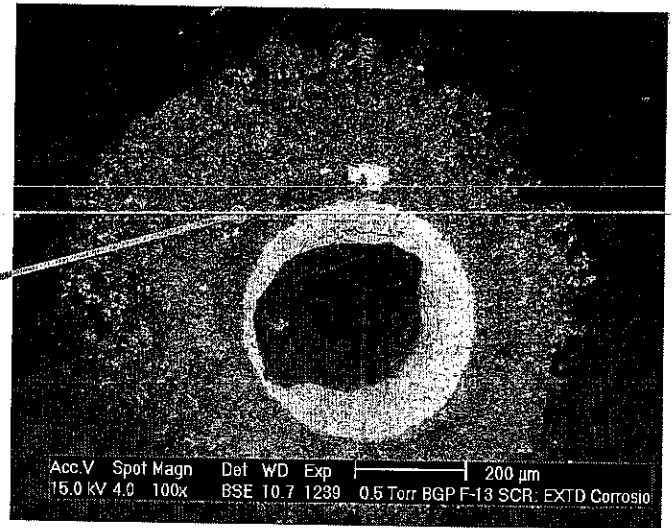
Figure 5: EDS X-ray microanalysis spectrum of corrosion product and corresponding BSE image in the scanning electron microscope

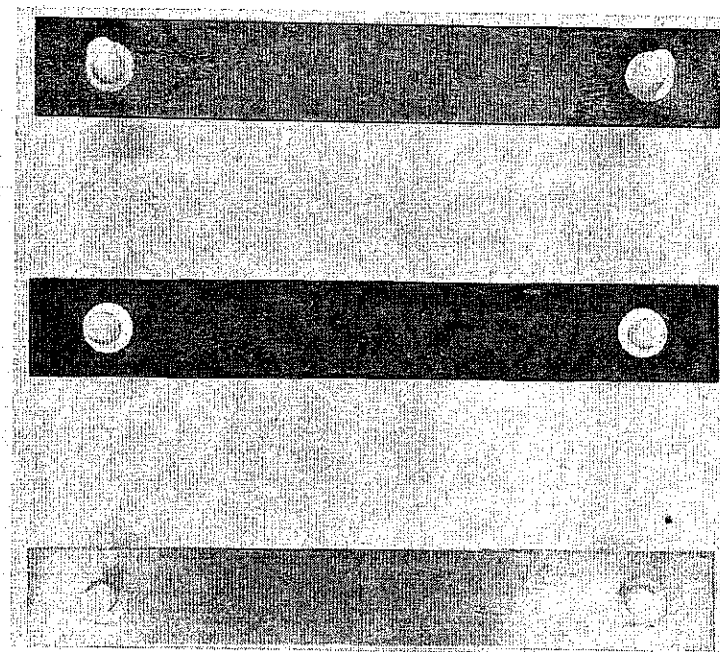
The control room and cabinet room was found to be extremely corrosive. The copper corrosion product film thickness was rated moderately corrosive, G2. The silver corrosion rate was equivalent to severe, GX. The cabinet room adjacent to the control room was rated as harsh, G3, with respect to copper corrosion and silver corrosion. Figure 6 shows the cabinet room coupons.

Figure 6: Cabinet room results

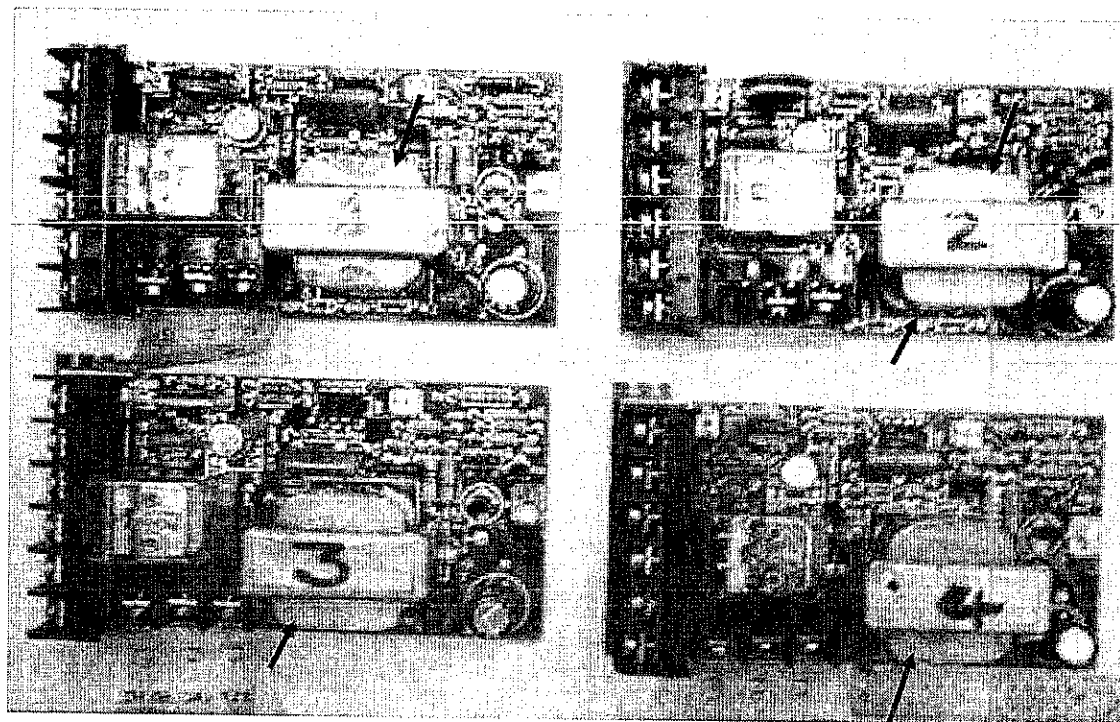
Several failed boards, showing transformer lead breaks, were examined (Figure 9). The fractures of these leads were studied on-site with a hand lens, which revealed that the leads showed a low ductility failure mode. Some leads and lead fractures were discolored, in some cases virtually blackened, and this was suspected to be a superficial corrosion product. Although the service life of these boards was not known precisely, an upper estimate was derived from the circuit board manufacturing date codes, found on the reverse side of the boards. More than ten failures have occurred, and failure after as little as about a year in service is strongly suspected.

Figure 9: Plan view of four circuit boards, as received; arrows show locations of transformer lead failures.

1. Mount the electronics remotely.
2. Consider a more rugged construction, where the manufacturer encapsulates the circuit board in a resin, to minimize mechanical and other forms of damage, such as corrosion. A field alternative is to use a polymer spray on the boards to minimize corrosion, such as the vapor phase corrosion inhibitor spray tested in the control rooms discussed in the previous section.
3. Minimize or dampen the vibrations. Although vibration is inherent in this process, stiffening the hopper tank with ribs, etc., may effectively reduce the mechanical vibrations and modify any resonance.
4. Improve sealing of the housing to eliminate ingress of the corrosive atmosphere.

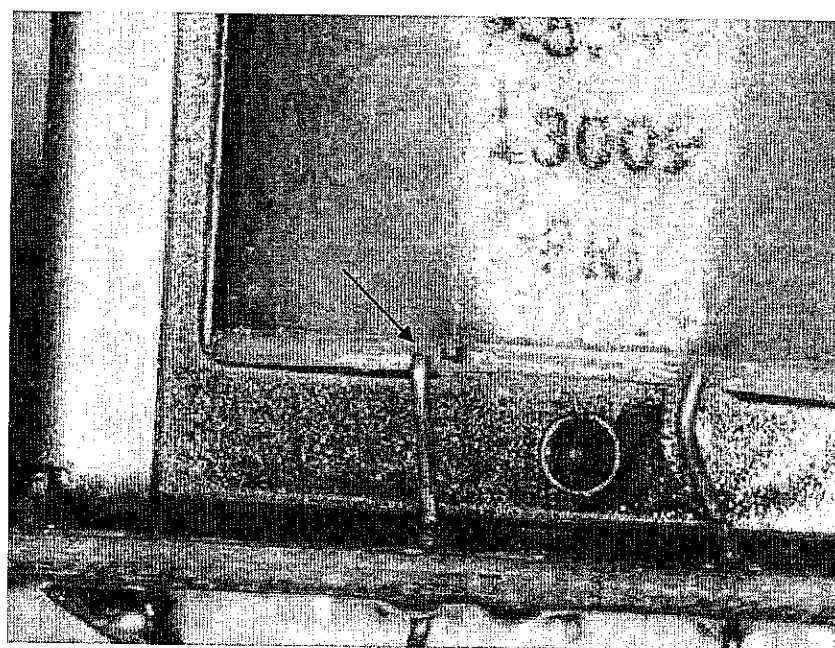
The transformer lead wires had broken at a position close to the transformer coil (Figure 10). The blue arrows on the plan view of the four boards indicate the locations of the five broken transformer leads. Figure 10 shows a side view of one of the two broken leads on board 2; its location is marked on Figure 9. Several lead fractures were examined in the scanning electron microscope (SEM). The fracture surfaces of the all leads showed low ductility, flat fractures which were tarnished or blackened (Figure 11). After ultrasonic cleaning, two lead fractures (from boards 2 and 4) were examined at increasing magnifications. At 2000x magnification, a very flat fracture surface was apparent, with a hint of fatigue striations.

Figure 11: Side view of a broken transformer lead on Board # 2 (arrow), magnification approximately 2X

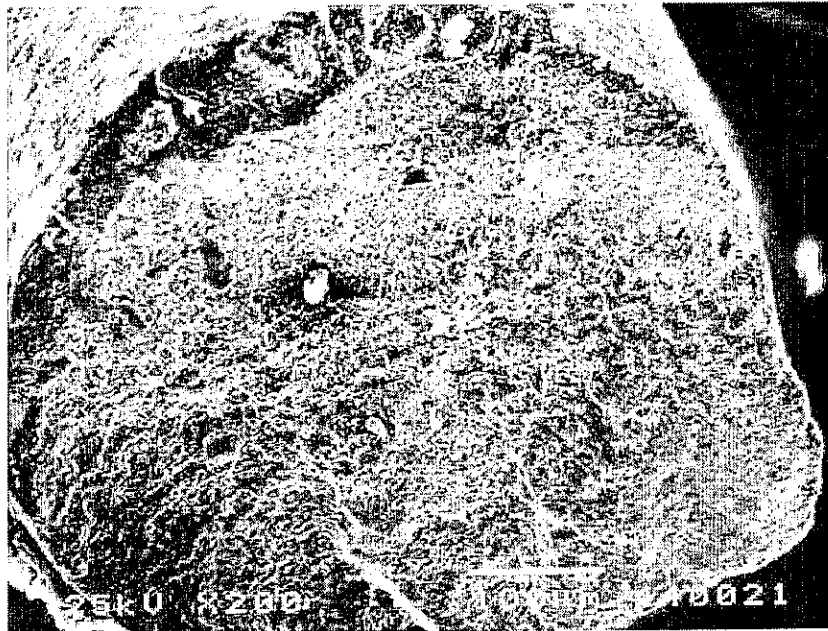
The lead failures were flat and non-ductile and showed characteristics of fatigue fracture at both a low and high magnification examination. Following fracture examination, longitudinal microsections were taken along the failed wires to include the fracture surfaces. Evidence of fine secondary microcracks was also found (Figure 12); these tiny cracks contained a dark-colored corrosion product. The microsection showed that the leads are made from tinned copper wire; the copper was fine grained and annealed. Finally, two blackened lead fracture surfaces were examined using a 15 kV electron gun potential in the SEM, to get an improved surface microanalysis. This clearly revealed that the corrosion product film comprised copper and sulfur, presumably as copper sulfide.

**Figure 11: Fracture surface of broken lead, Board # 2
SEM micrograph, 200X**

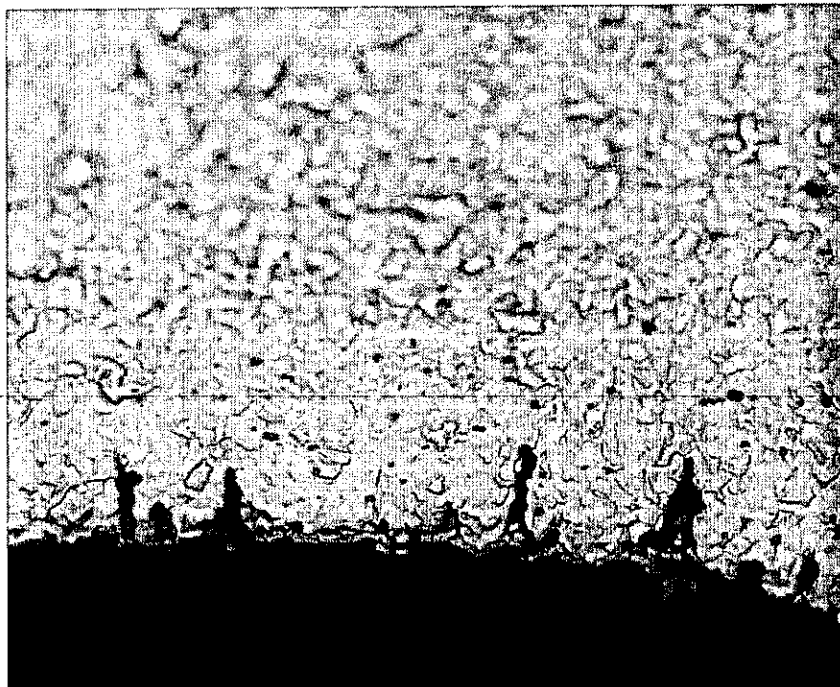
Following laboratory evaluation and a site visit, the failure mode of the transformer's copper conductor leads was indicated to be corrosion fatigue. Vibration plus corrosion by sulfur compounds had promoted the fatigue cracking and some fine, secondary corrosion fatigue cracks were also found.

**Figure 12: Microsection showing fine secondary cracks
on broken transformer lead from Board # 2, etched 750X**
