**Project of the Year:
PENTAGON RENOVATIONS—
EXTERIOR WALL REPAIR AND
INTERIOR STRUCTURAL REPAIR**

Pentagon Renovations— Exterior Wall Repair and Interior Structural Repair

Arlington, Virginia

Submitted by Concrete Protection & Restoration, Inc.

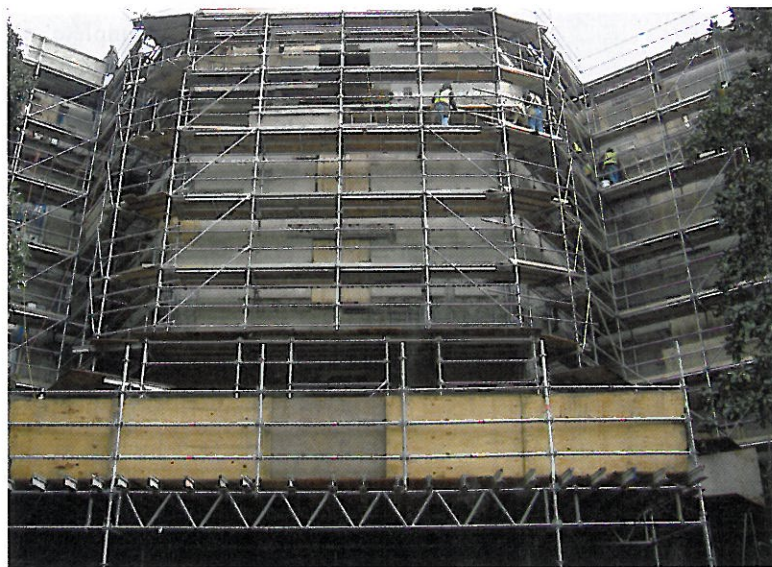
Repair crews working on Pentagon walls

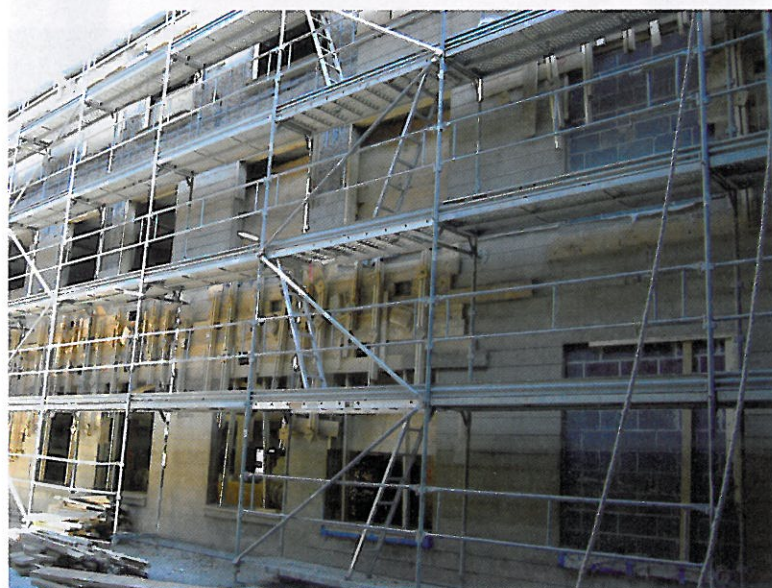
Work area showing extensive scaffolding

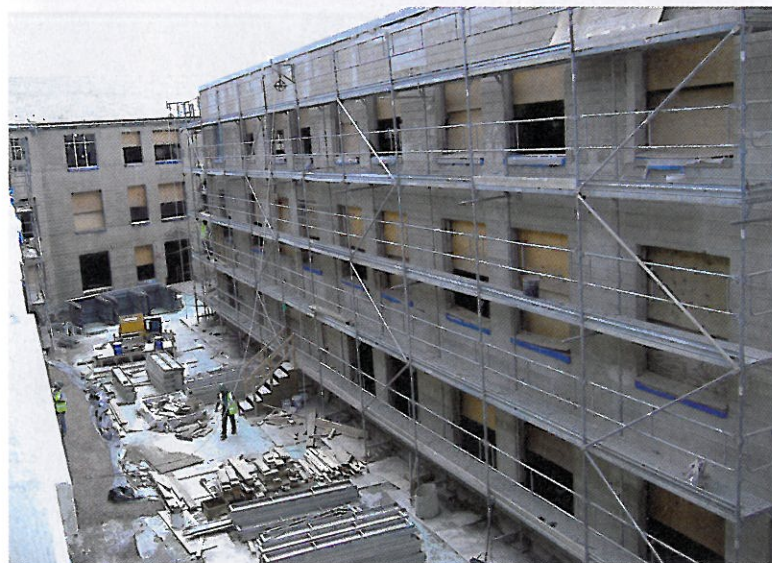
View of interior lightwell work area

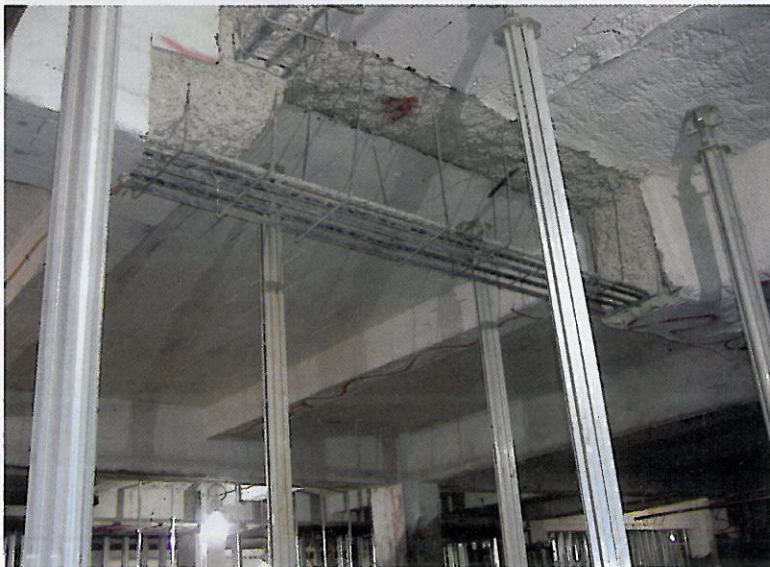
Interior beam repair work—notice the extensive shoring

In one particular area, the removal of the interior finishes uncovered a large section of the second-floor structure that had been damaged by an historical fire. This unexpected repair required full-depth removal of beams and girders, some more than 4 ft (1.2 m) deep. After the floor slab was extensively shored, the damaged concrete was removed, the beams were formed, and ready mixed concrete was placed from the above level.

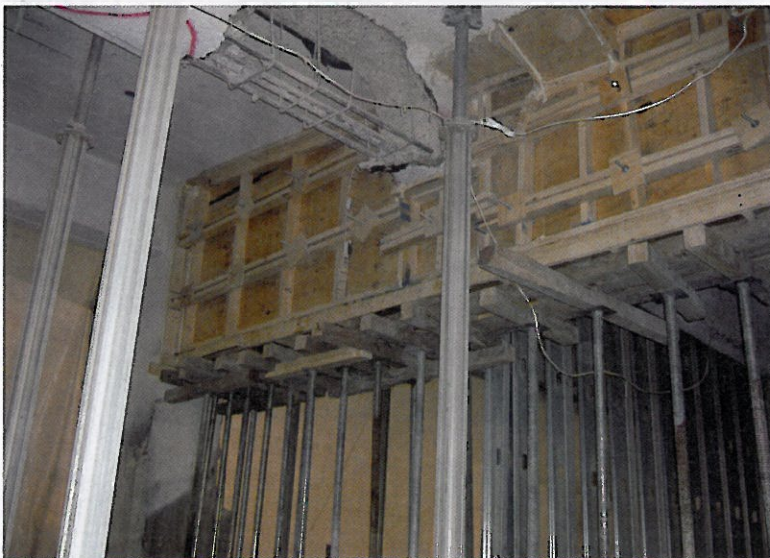
View of the full-depth beam repair

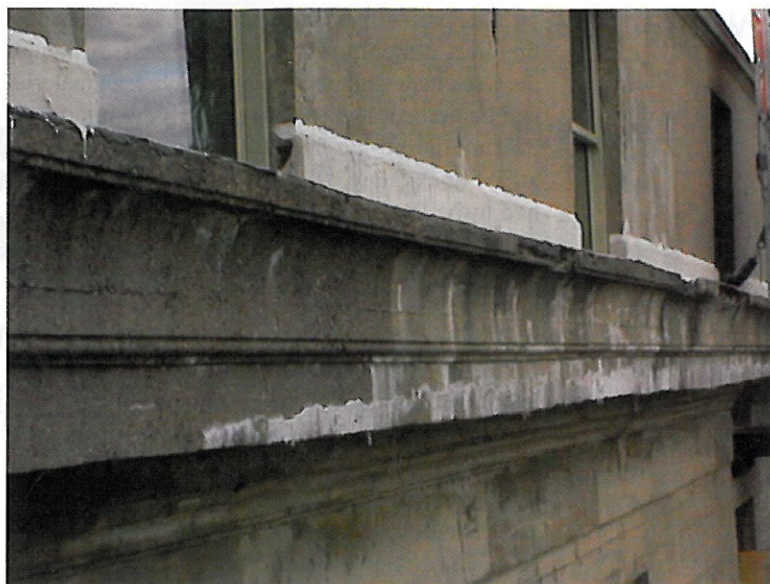
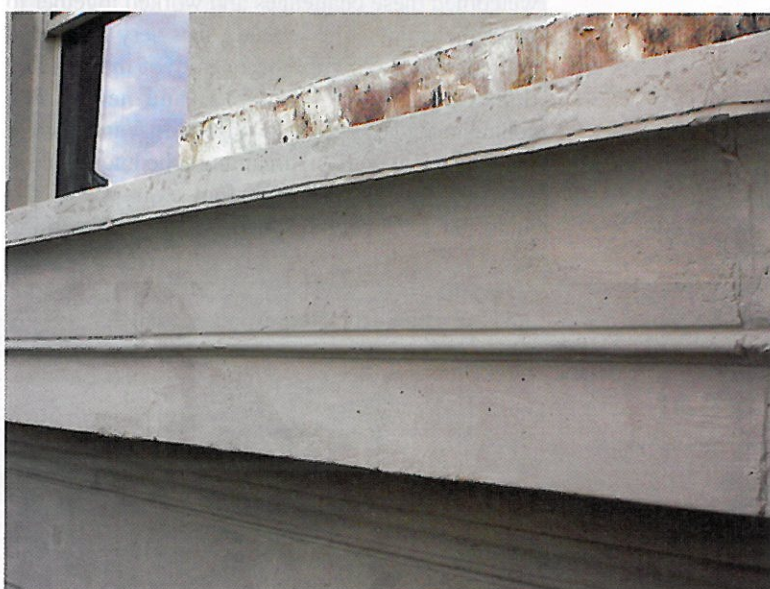
Close-up of repaired area on walls, before and after

To meet the specification requirements that the repairs are not detectable from a distance of 30 ft (9 m), the contractor used rough-cut lumber to match the texture of the original surface. Each board was cut specifically to match the varying widths of the existing wall, and the edges were beveled to create the “ribbed” finish.

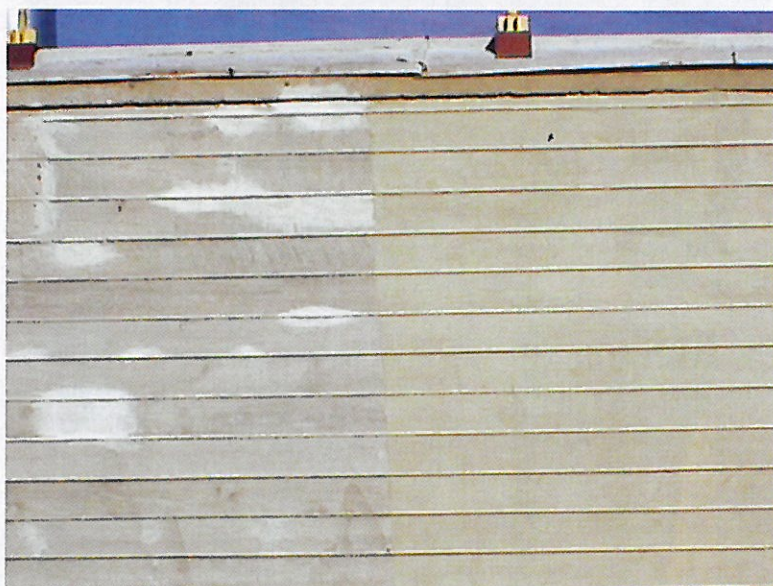
Before and after coating application

- A mineral-based coating was applied to provide a preventative waterproofing for the unrepaired concrete areas, protect the new repairs, act as further prevention against water absorption, and give the building a uniform appearance. This potassium silicate coating was chosen to form a chemical bond with the concrete, yet allow the cast-in-place structure to breathe and be permeable. The coating system chosen is high in pH to protect the reinforcing steel and concrete from carbonation.

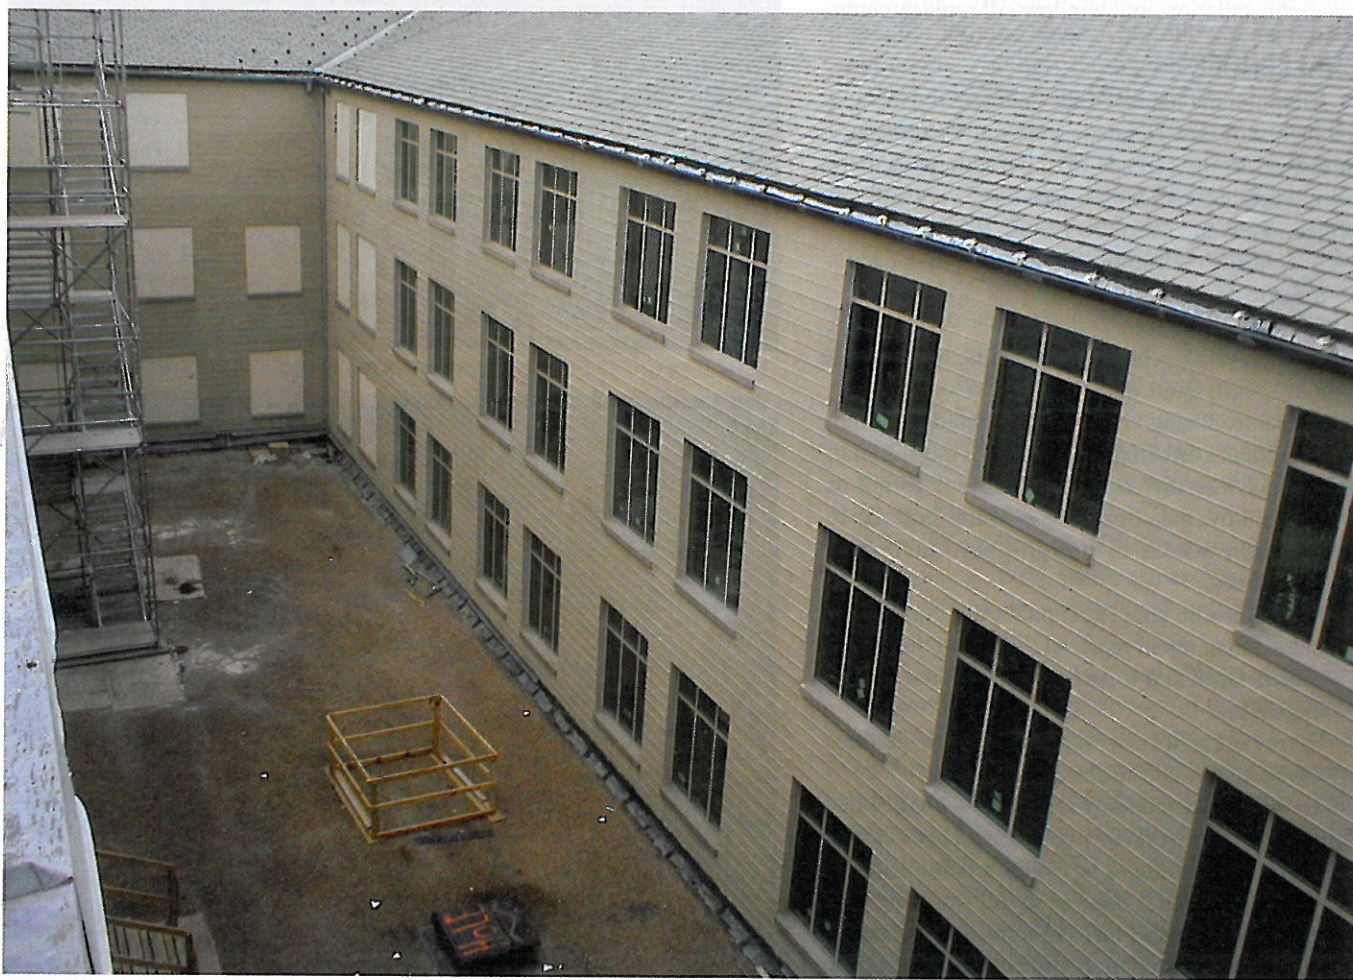
Completed repairs
