Cummins Turbo Engines: VpCI-126 bags vs. Competition

From: Cortec Corporation Laboratories

Project #: 15-050-1525

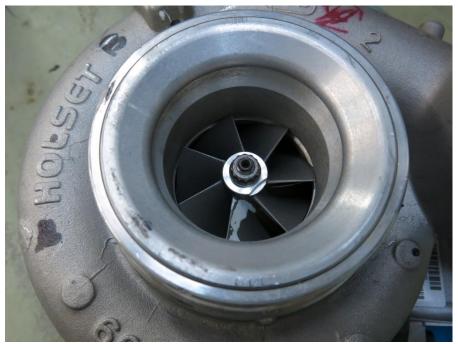
Picture 1: The turbo engine packaged and sealed in VpCI-126 and PE after 300 hours of testing. Little to no discoloration is observed on the intake.

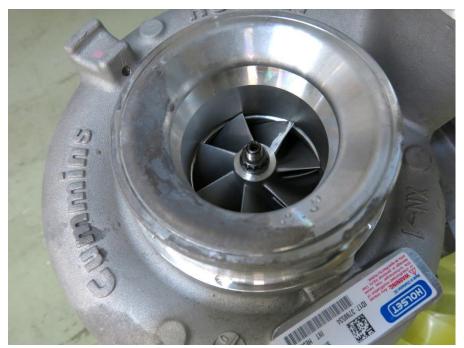
Picture 2: The turbo engine packaged and folded in two NT bags after 300 hours of testing. Significant discoloration can be observed on the rim on the intake.

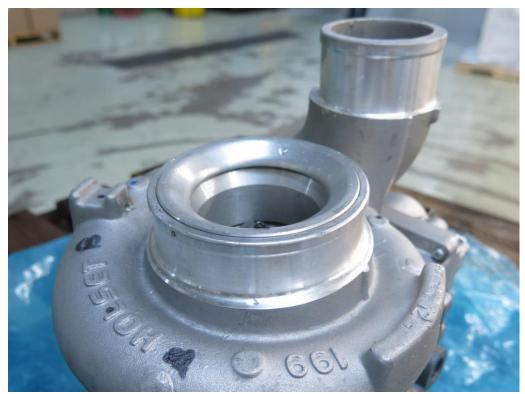
Picture 3: Intake portion of the turbo engine packaged in VpCI-126 and PE bags after 500 hours. Little to no discoloration can be seen on the intake or surrounding engine body.

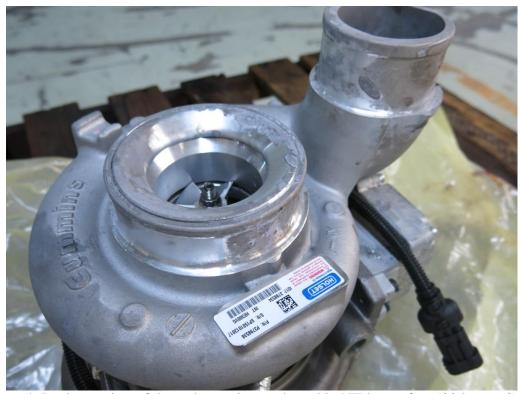
Picture 4: Intake portion of the turbo engine packaged in NT bags after 500 hours. Severe discoloration can be seen at the intake and on the surrounding body of the engine.

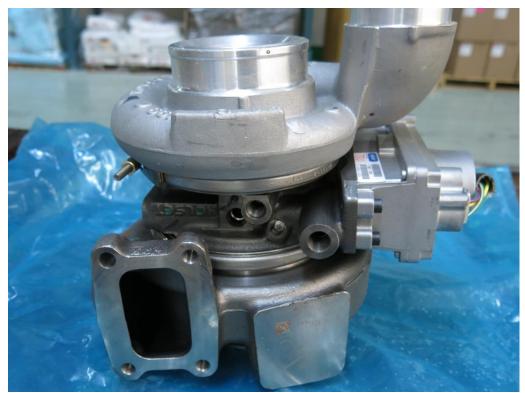
Picture 5: The base of the turbo engine packaged in VpCI-126 and PE bags after 500 hours. Small amounts of corrosion can be seen on the flat base.

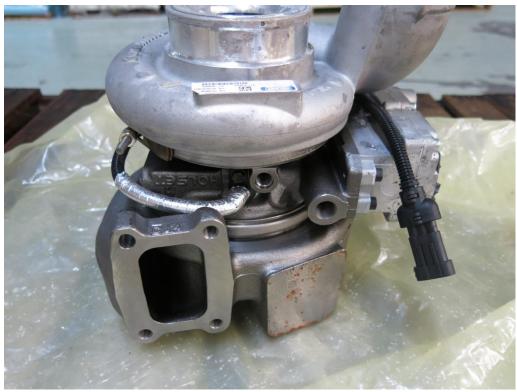
Picture 6: The base of the turbo engine packaged in NT bags after 500 hours. Moderate corrosion can be seen on the flat.

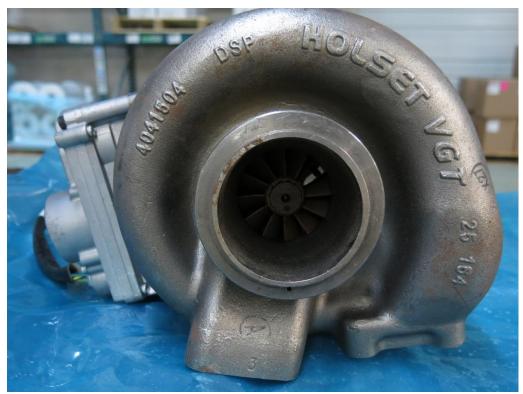
Picture 7: The bottom fan of the turbo engine packaged in VpCI-126 and PE bags after 500 hours. Only small amounts can be seen on the lip where the engine contacted the packaging

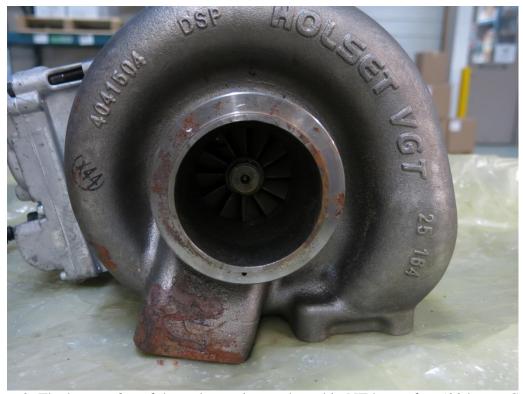
Picture 8: The bottom fan of the turbo engine packaged in NT bags after 500 hours. Severe corrosion can be seen on the lip and body of the engine that sat in contact with the packaging.

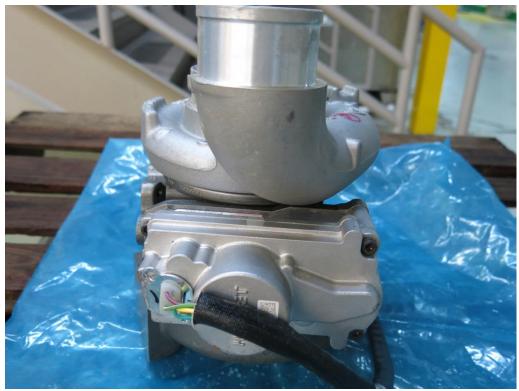
Picture 9: The wire housing of the turbo engine packaged in VpCI-126 and PE bags after 500 hours. No corrosion can be seen on the wire housing or the surrounding body.

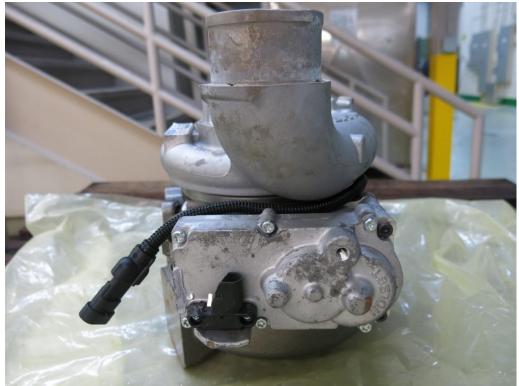
Picture 10: The wire housing of the turbo engine packaged in NT bags after 500 hours. Significant discoloration was observed on the wire housing and surrounding engine body.
