C2020-15065

Comparison of VCI and CP Performance Using Floor Scan Data from Several 10-Year Old AST Floors

Tim Whited
MESA
4445 S. 74th E. Ave.
Tulsa, Oklahoma 74145
Tim.Whited@mesaproducts.com

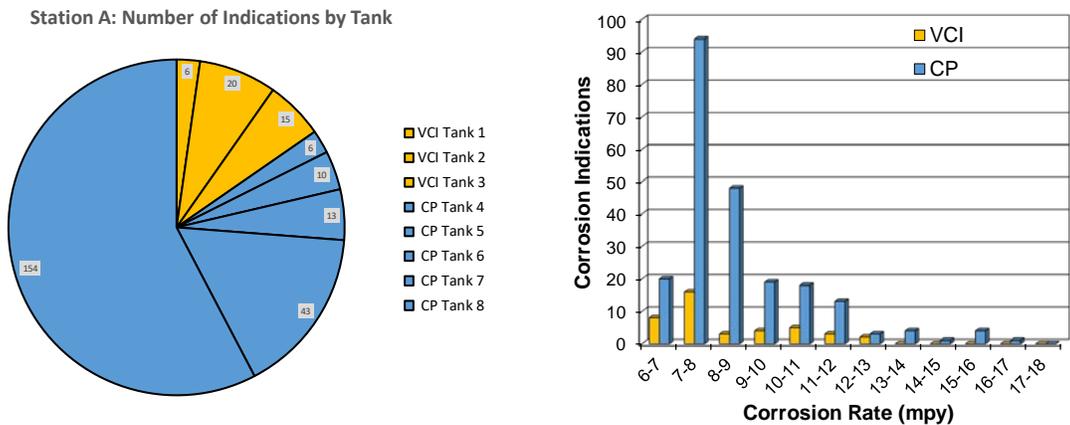
Figure 1. (a) Station A total number of corrosion indications per Tank. (b) Total number of corrosion indications per corrosion rate segments of Station A tank floors.

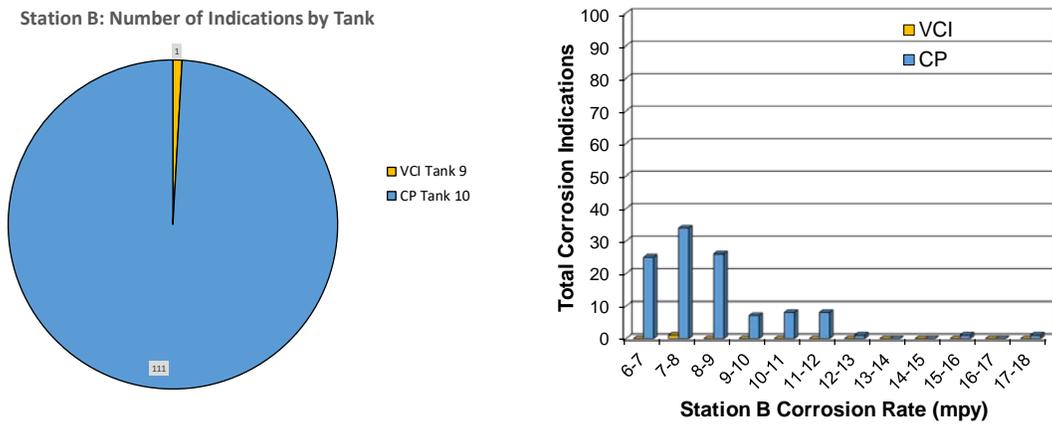
Figure 2. (a) Station B total number of corrosion indications per Tank. (b) Total number of corrosion indications per corrosion rate segments of Station B tank floors.

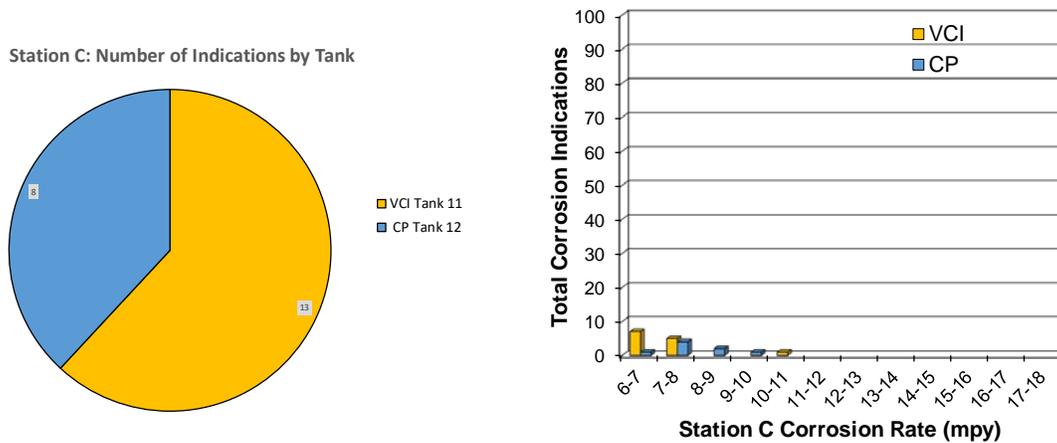
Figure 3. (a) Station C total number of corrosion indications per Tank. (b) Total number of corrosion indications per corrosion rate segments of Station C tank floors.

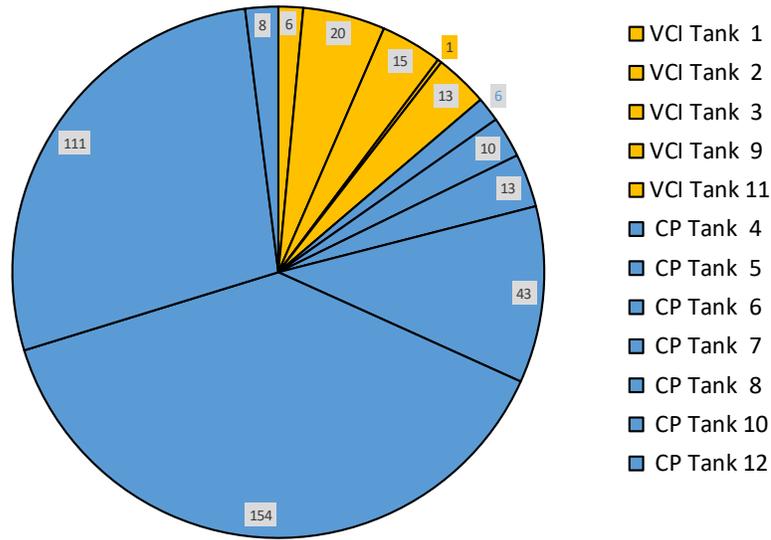
Figure 4. Total number of corrosion indications per all (12) tanks

- 1) VCI and CP corrosion indication data were statistically comparable for all (5) VCI tanks with (4) of the CP only tanks (numbers 4,5,6,12).
- 2) All (5) VCI only tanks performed significantly better when compared to the other (3) CP only tanks (numbers 7,8,10)
- 3) The reasons for the large disparity in the (3) CP only tanks (numbers 7,8,10) are not understood at this time. There were no operational issues with the CP systems. No information was recorded during the inspection of these (3) tanks to explain the significantly higher number of indications. Speculation on the reasons for these outliers is not included in the scope of this paper.

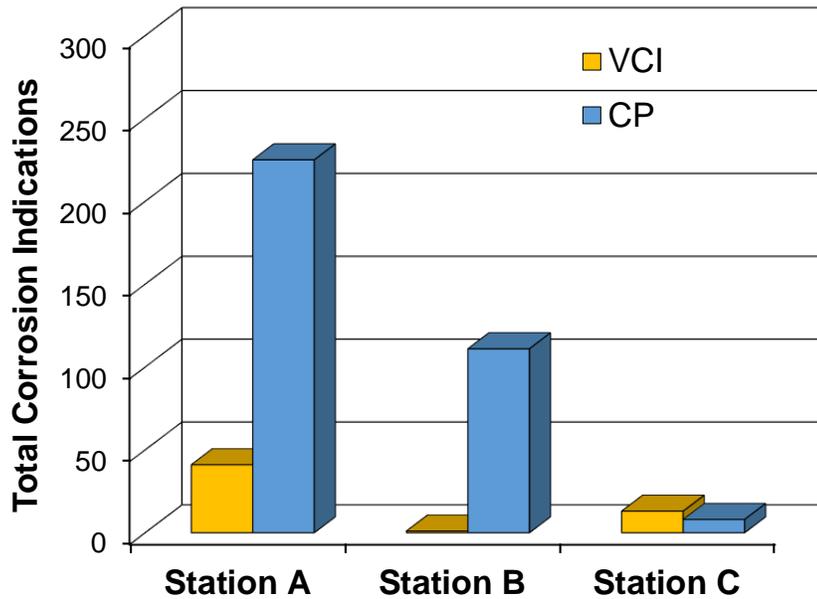
Figure 5. Total number of corrosion indications per each Station

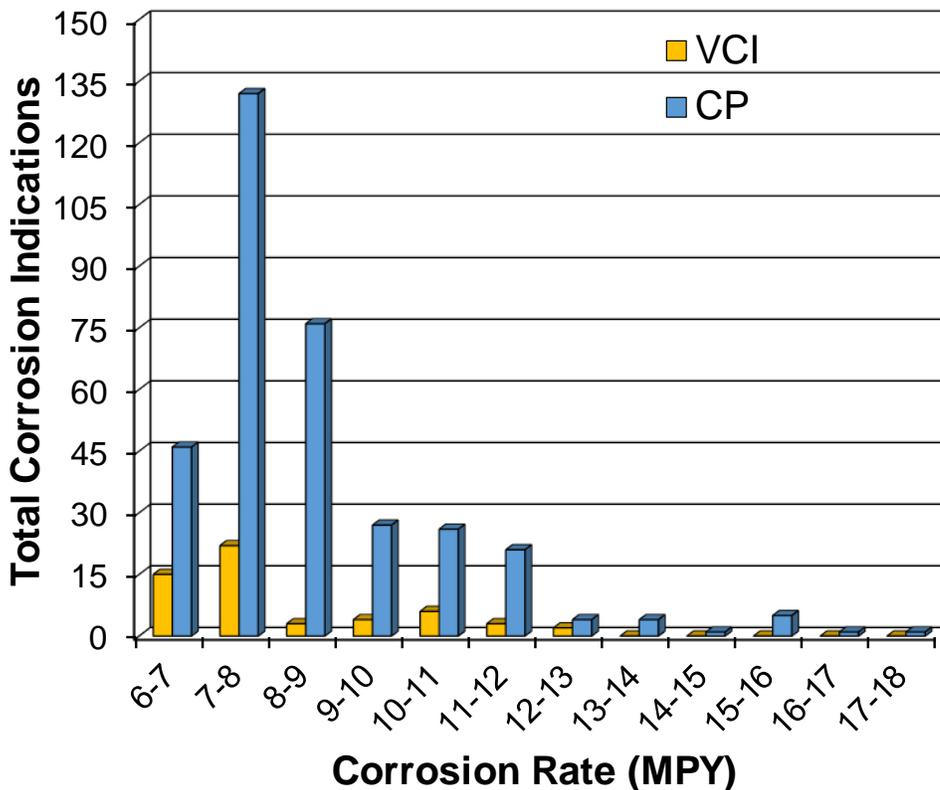
Figure 6. Total number of corrosion indications per corrosion rate segments of all (12) tank floors.

- 4) Within this sample group, it is important to note that the differences in the number of corrosion indications for the (5) VCI only tanks were not large.
 - a) The total number of indications for the VCI only tanks ranged from 1 to 20; and the average corrosion rates of the indications ranged from 6.5 MPY to 12.9 MPY (165.1 to 327.7 $\mu\text{m}/\text{yr}$).
 - b) Whereas the total number of indications for the (7) CP only tanks ranged from 6 to 154; and the corrosion rates of these indications ranged from 6.5 MPY to 19.7 MPY (165.1 to 500.4 $\mu\text{m}/\text{yr}$).
