Comparison of Corrosion Attack on Tank Bottoms With and Without Cathodic Protection

I.Y. BARNAWI, Saudi Aramco, Ras Tanura, Saudi Arabia

This study was conducted to compare the corrosion attack on the underside of storage tank bottoms protected with cathodic protection (CP) and tank bottoms without CP. The study is based on historical inspection records, CP potential measurements, and results of magnetic flux leakage testing.

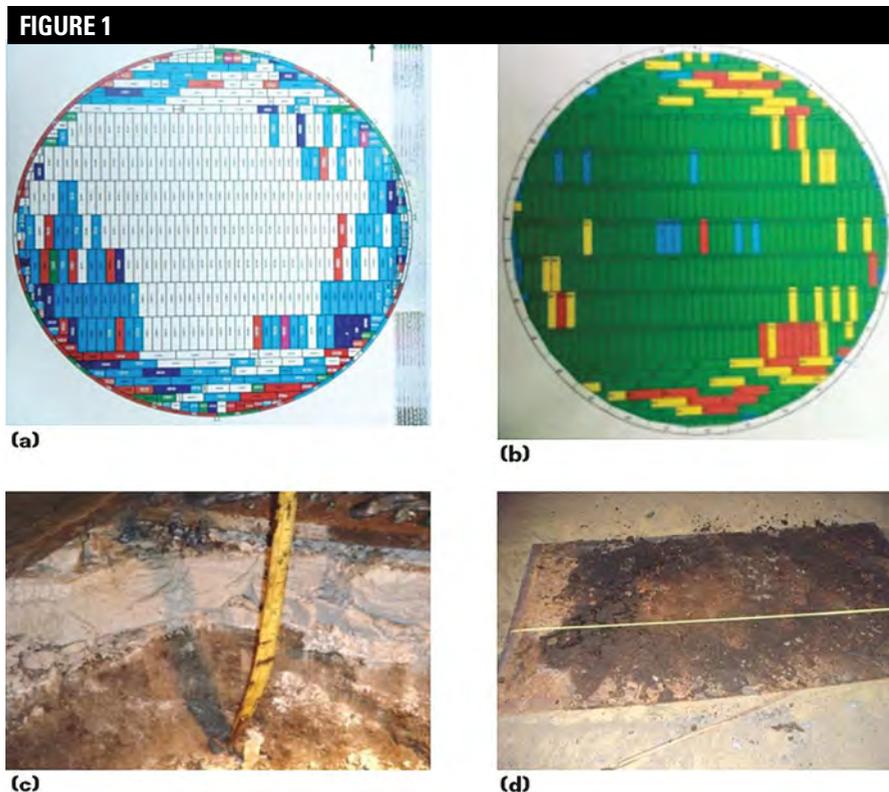
In January 1998, a leak was reported. Investigations revealed that the leak was caused by underside corrosion. After the tank was cleaned for a T&I, magnetic flux leakage (MFL) testing and visual inspection discovered 52 holes, and 101 plates had a metal loss of 60 to 100%, an increase of 130% in the number of holes and 90% in the number of corroded plates since the 1989 T&I. The corrosion was mostly concentrated in one half of the tank (Figure 1).

Figure 1 Bottom inspection of Tank J-1 at Ju'aymah Terminal. (a) 2008 MFL test result, (b) 1997 MFL test result, (c) injected grout, and (d) corrosion scale under bottom plates.

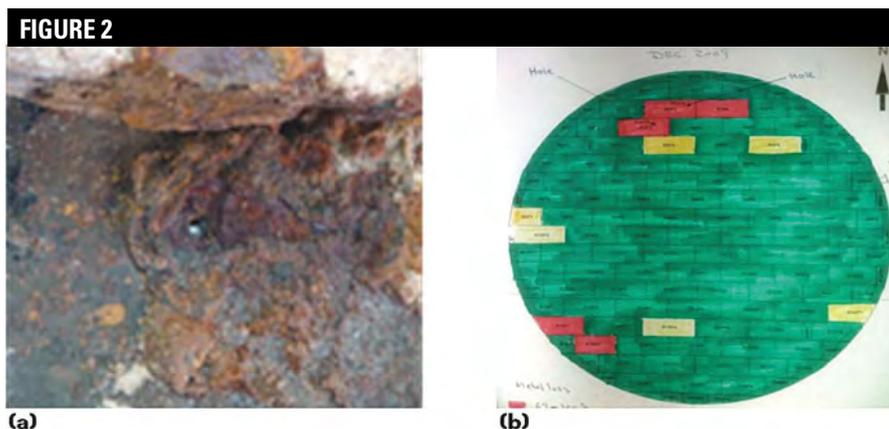
Figure 2 Bottom inspection Tank S-2 at South Terminal. (a) Penetration of bottom plate and (b) 2009 MFL test result.

After the first 10 years of service, the tanks were opened for T&I. Visual inspection and MFL testing were performed to check the integrity of the bottom plates. The report indicated that the bottom of Tank S-2, which was protected by zinc ribbon anodes, had devel-

oped two holes on two different plates due to underside corrosion (Figure 2 and Table 1).

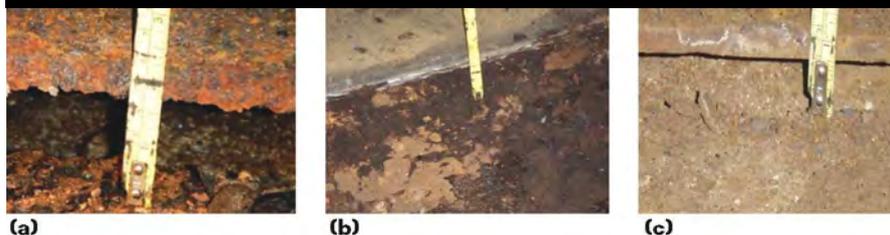
FIGURE 3

Underside corrosion of tank bottoms. (a) First T&I, MFL test of MMO anodes, (b) first T&I, MFL test of magnesium ribbon anodes, and (c) first T&I, MFL test of zinc ribbon anodes.

Gaps of 1 to 3 in between sand pads and tank bottoms were noticed in all tanks (Figure 3).

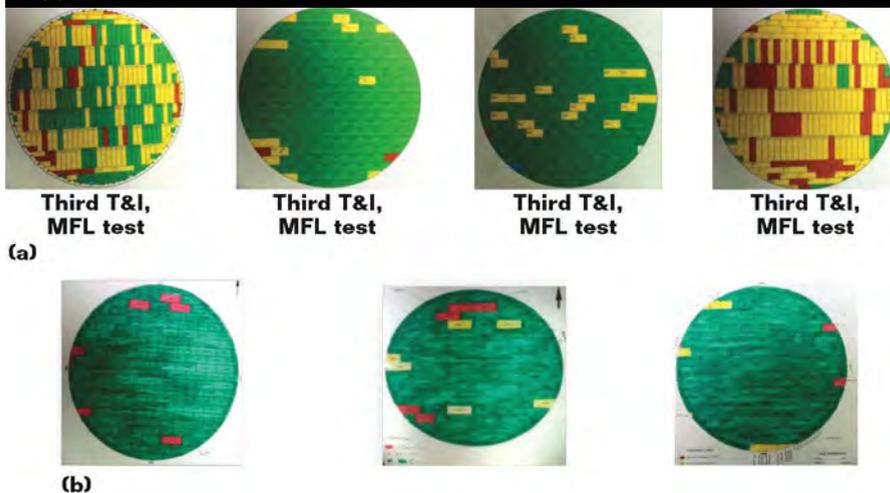
FIGURE 4

MFL test reports of various tank bottoms with and without CP. (a) Tank bottoms without CP and (b) double-bottom tanks protected by galvanic ribbon anodes/ICCP MMO anodes.

Some tank bottoms without CP are in better condition than tanks protected by CP (Figure 4).
