Re: Vehicle and equipment corrosion protection during storage and transit – Trial Report

Scope

To protect military vehicles in storage and transit, as well as various equipments and spares being transported in ISO containers, over a six month period at Defence Support Group (DSG) at Aschurch, on behalf of the Data, Recording, Analysis & Corrective Action System (DRACAS), using Vapour phased Corrosion Inhibitors (VpCI's), supplied and treated by HITEK-nology Solutions Ltd (HSL). This trial was started on 17th September 2012.

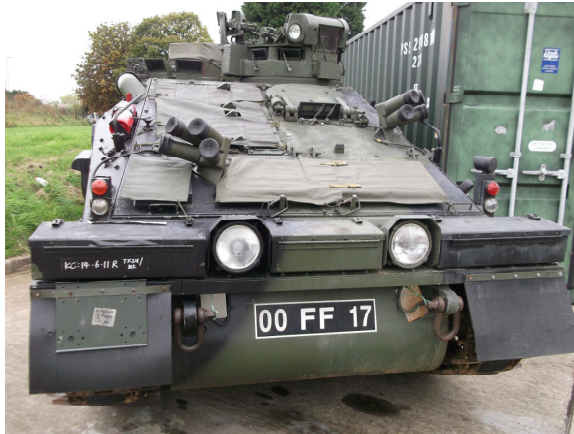
A difference could already be seen on CVR(T) one. The half that had been treated with VpCI 389D was in the same state as at the start of the trial, the half that had just been washed down with VpCI 415 was starting to degrade, this was particularly evident on the sacrificial plates and the tracks.

The frontal view, clearly showing the difference in the two halves as well as the carbon steel plates

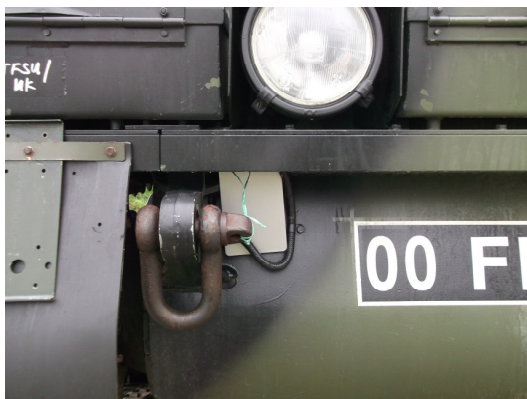
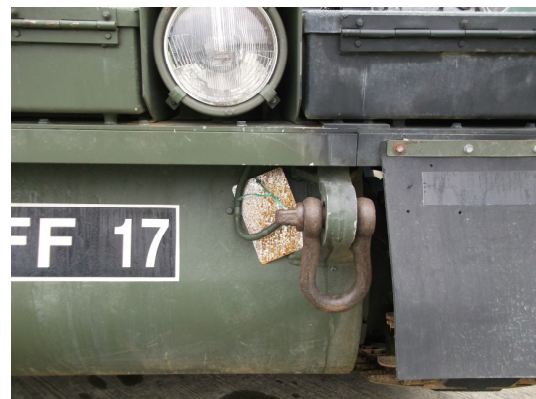
Close up photos of the front of the CVR(T), the left one is the half treated with VpCI 389D. The difference between the two halves can clearly be seen on both bodywork and the carbon steel plates

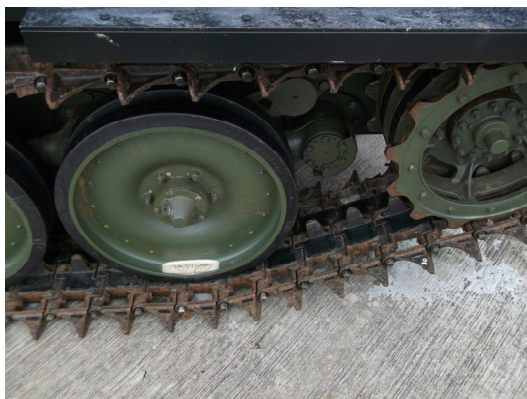
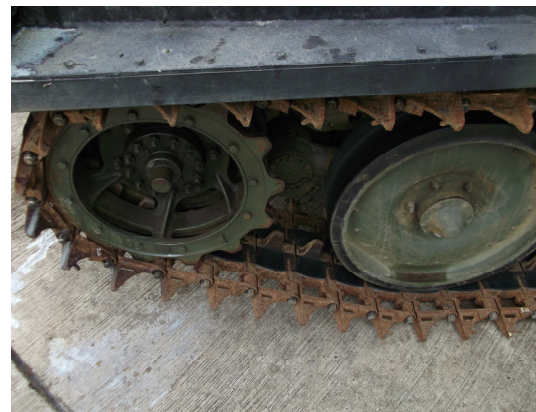
The difference can already be seen between the wheels and tracks. The left side is the side treated with VpCI 389D.

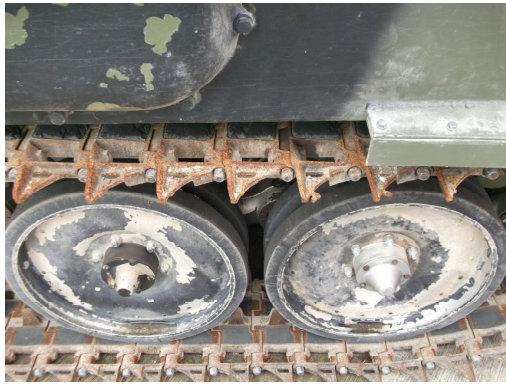
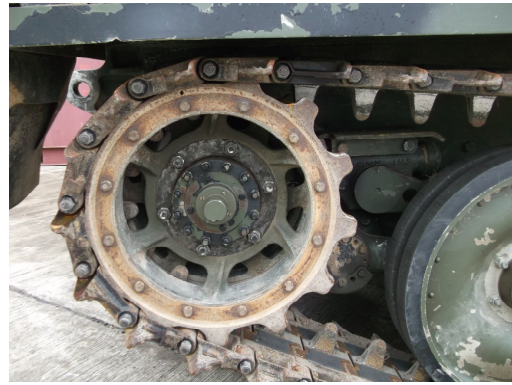
CVR(T) three which had received no treatment and was being used as the datum vehicle had degraded particularly badly on the wheels and tracks especially compared to CVR(T) one

As can be seen above, CVR(T) three, having had no VpCI protection of any kind, was already showing a lot of rust on the wheels and tracks

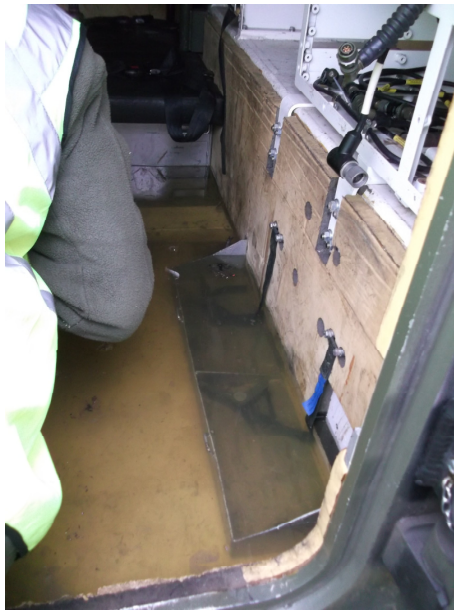
However when checking inside this CVR(T) it was apparent that the various hatch seals had failed and there was approximately 6" – 8" of water in the bottom of the vehicle. Signs of rust were seen on both the sacrificial plate fitted in the driver's compartment, and on the fitted equipment inside the vehicle. The plugs were removed from the vehicle to allow all water to drain, the plugs were left out to ensure that the vehicle would not refill with water again.

Rain water in the back of
CVR(T) one

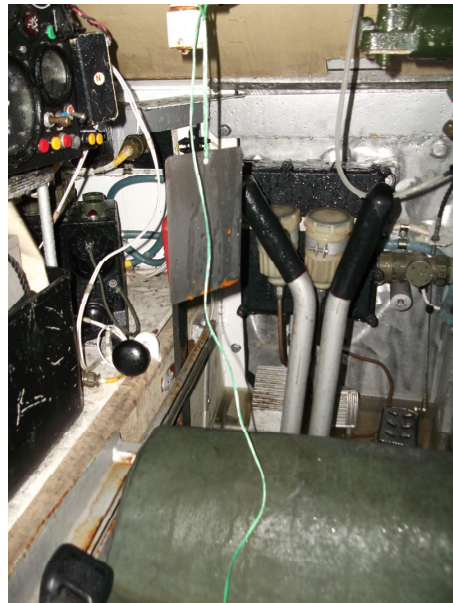
The plate showing signs of
corrosion in the back of CVR(T)
one due to rain water

It was also decided that in December 2012, VpCI 132 foam pads would be placed inside of CVR(T) one, as well as an extra (new) low grade carbon steel plate

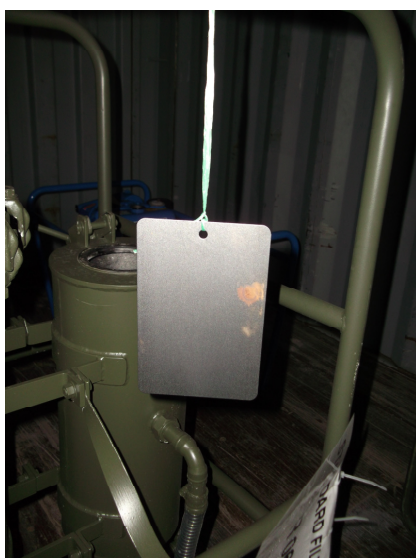
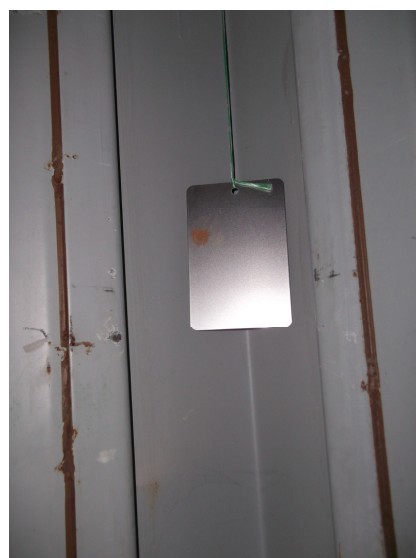
Once again no degradation could be seen on the carbon steel plates in any of the two treated ISO containers. The rust spot on the plate in the untreated container had got a little larger. Rust was also now appearing on the second plate in the untreated ISO container.

The two plates in the untreated ISO container,
showing signs of corrosion

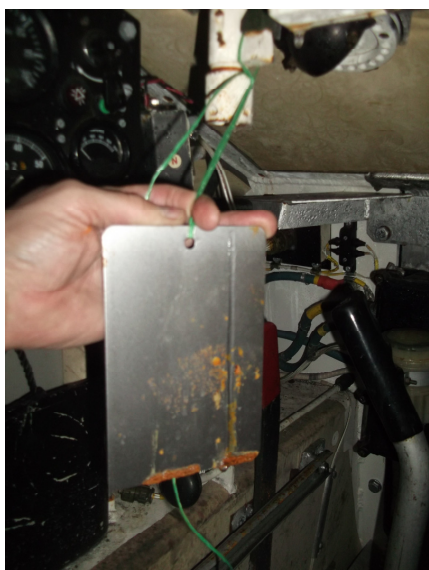
Although there was no standing water in the vehicle (the drain plugs had been left out once removed in November), it was evident that the environment inside the CVR(T) was damp and icy.

The plate in the back of CVR(T) one

As planned, VpCI 132 foam pads were placed in the back of the vehicle and a fresh low grade carbon steel plate was also fitted alongside the existing plate, the old plate was left in to show that the foam pads would stop the existing corrosion in its current state as well as protect the new plate from future corrosion.

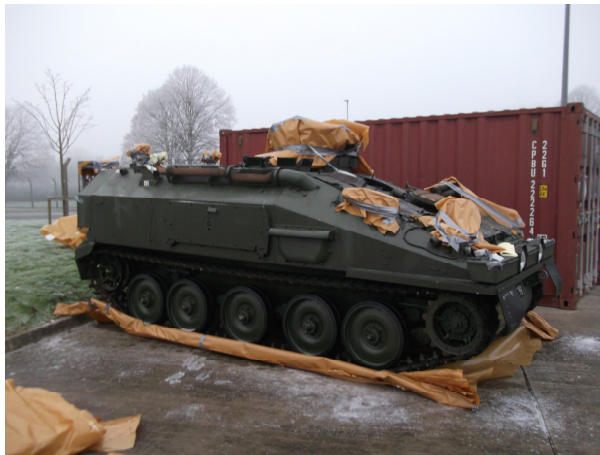
CVR(T) two, during the unwrap process, showing no signs of degradation

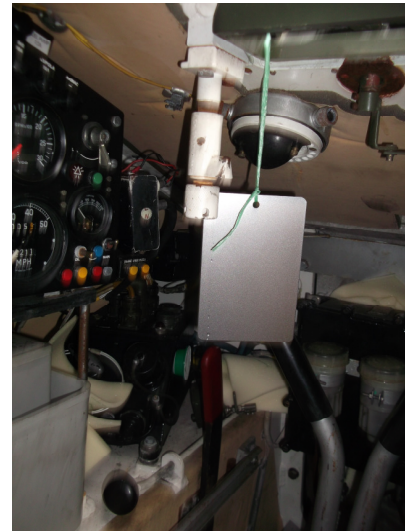
The plate in the back of CVR(T) two was as new when checked in December 2012

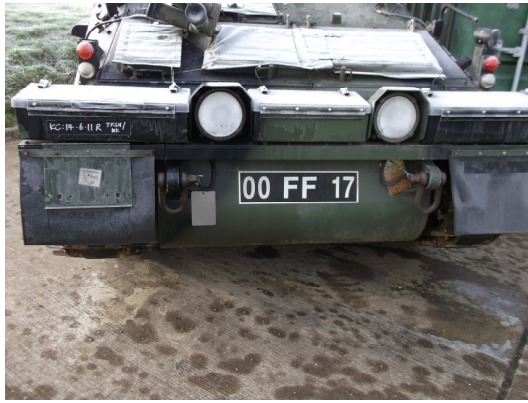
CVR(T) one continued to show the difference in the two halves of the vehicle. The plate on the half treated with VpCI 389D had slipped down slightly, although this has no impact on the trial

The plate fitted to the half treated with VpCI 389D had slipped

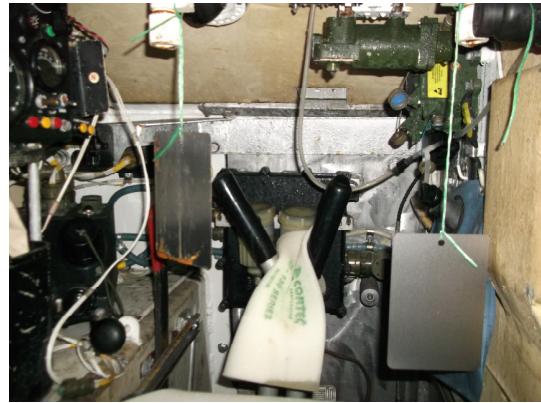
The VpCI foam pads that had been fitted internally were clearly working, and stopping any further corrosion, despite obvious signs of water and ice on all the internal surfaces.

This was evident on the two plates inside the CVR(T) . The one that had been originally fitted and had corroded, was in the same state as when the foam pads had been installed in December 2012. The new plate that had been fitted in December 2012 was looking as new.

The foam pads clearly working inside of CVR(T) one. The plate on the left has had the corrosion stopped in its tracks, whilst the plate on the right (fitted the previous month) shows no sign of corrosion

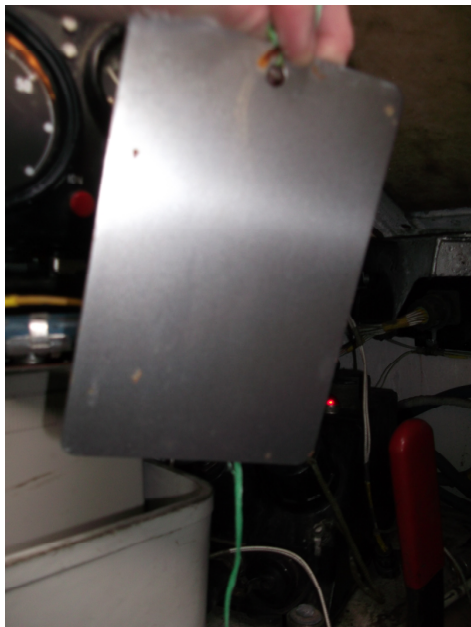
CVR(T) three which had received no treatment and was being used as the datum vehicle was still showing the degradation as previously mentioned. In addition the plate inside the vehicle was also showing signs of corrosion

The plate fitted to CVR(T) three, showing signs of corrosion

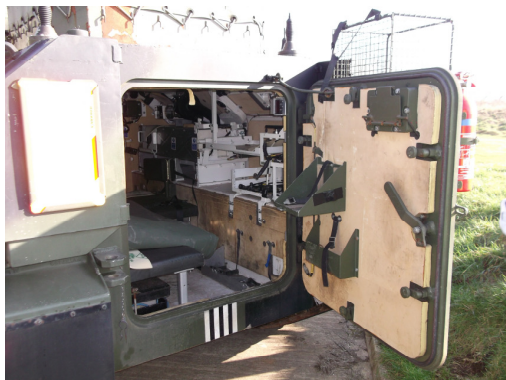
Upon going around the back of the vehicle it could be seen that the rear door was open. Although it's not known exactly how long this door had been left open for, the SSgt responsible locally for the CVR(T) stated he knew of no reason for anybody to open it, so it is likely it could have been left open for the whole month.

The door found open in February 2013

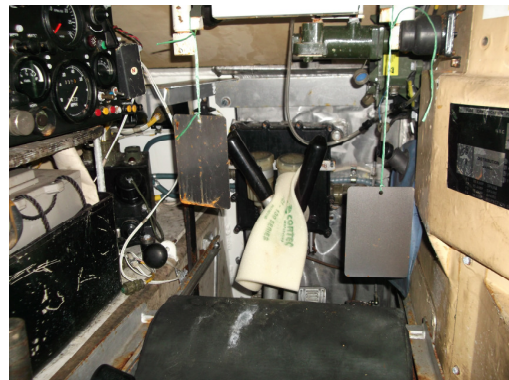
This had allowed the inside of the vehicle to dry out, but also proved that the VpCI foam pads were working, although a few small spots could be seen from the new plate fitted internally, had there been no pads fitted and the door left open we would have expected the plates to show a lot more signs of corrosion

The plates fitted inside CVR(T) one, after the door had been left open

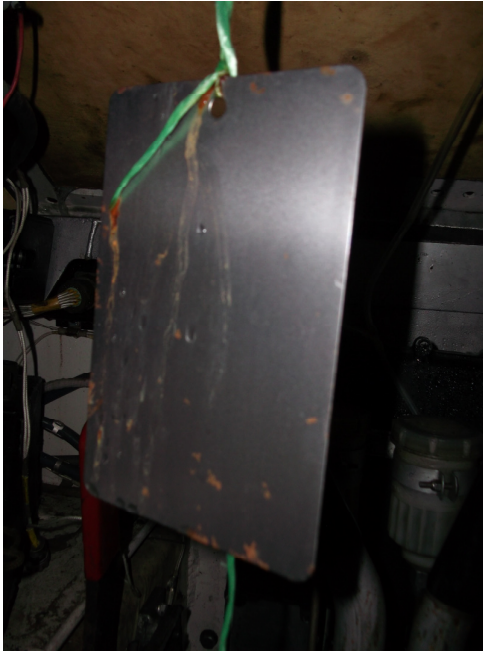
CVR(T) three which had received no treatment and was being used as the datum vehicle continued to degrade. In addition the plate inside the vehicle had continued showing more corrosion

The plate fitted inside CVR(T) three, showing a greater amount of corrosion compared to the previous month

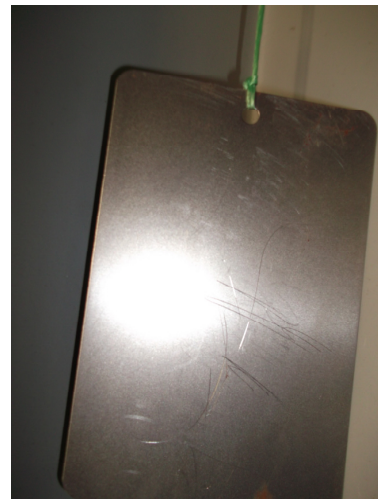
The plate fitted on the ISO container wall that had no treatment, showing a small covering of corrosion

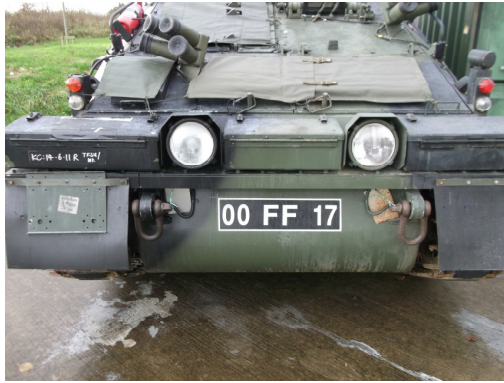
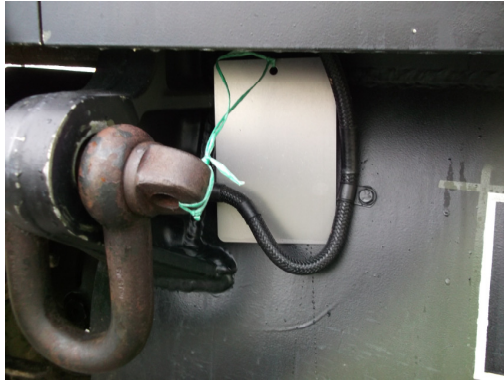
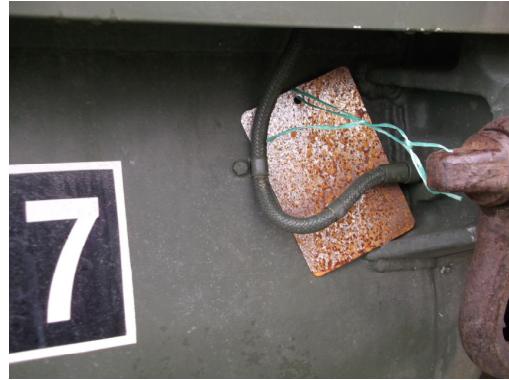
November 2012

Front view and close ups of the plates fitted to CVR(T) one, taken in November 2012, the untreated plate continues to degrade. It can also be seen that there is now a difference in the standard of the bow shackles fitted to the vehicle

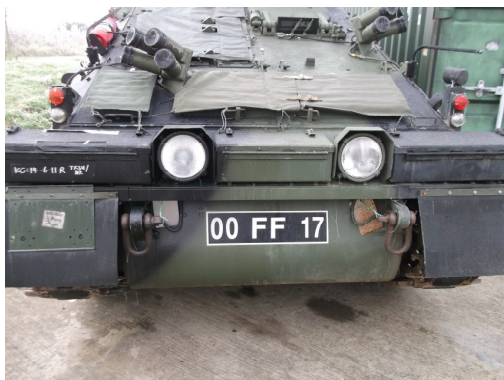
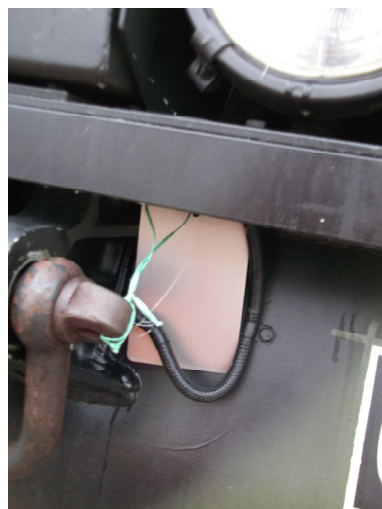
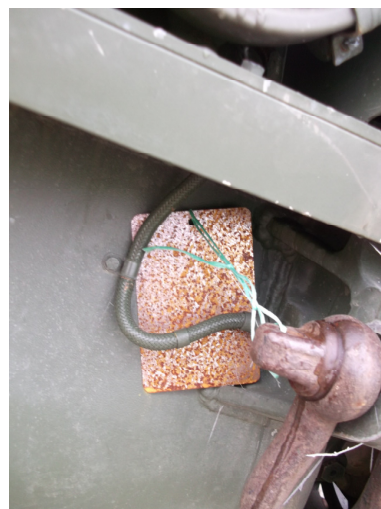
December 2012

Front view and close ups of the plates fitted to CVR(T) one, taken in December 2012, the untreated plate continues to degrade, whilst the treated plate shows no signs of degradation at all

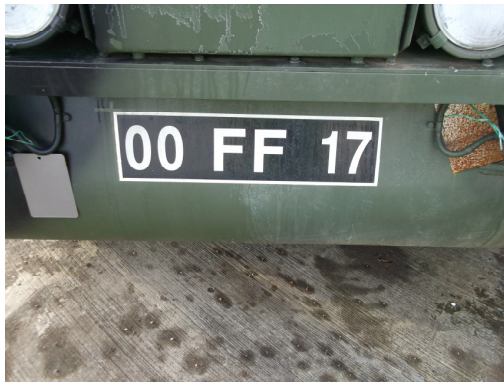
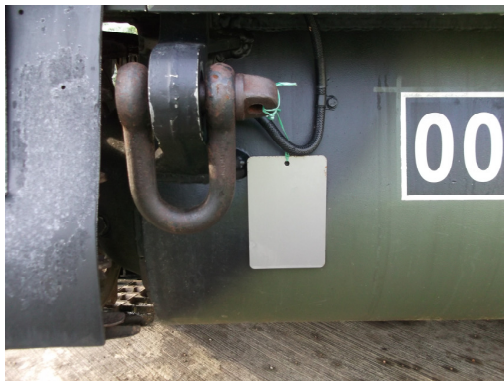
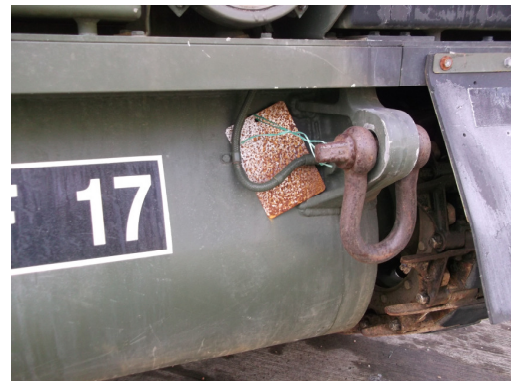
January 2013

Front view and close ups of the plates fitted to CVR(T) one, taken in January 2013, the untreated plate continues to degrade. The plate on the half treated with VpCI 389D has slipped. Also the difference of cleanliness and protection can be seen between the two halves

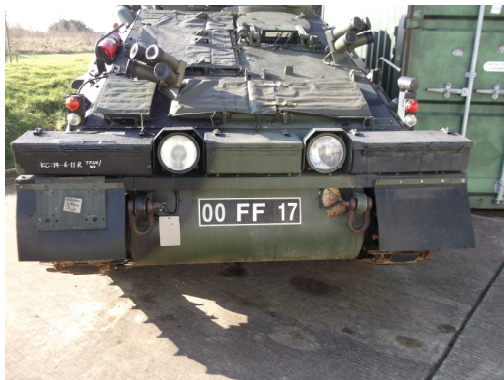
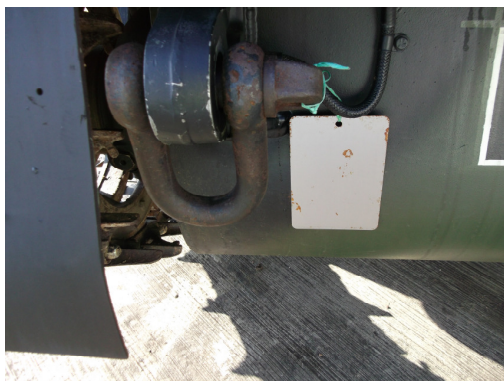
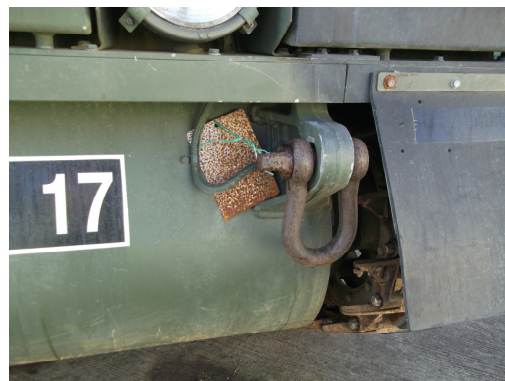
February 2013

Front view and close ups of the plates fitted to CVR(T) one, taken in February 2013. The treated plate is now showing a couple of small rust spots, although that side of the vehicle is still in good order. The untreated side is now heavily corroded, as is the bow shackle on that side

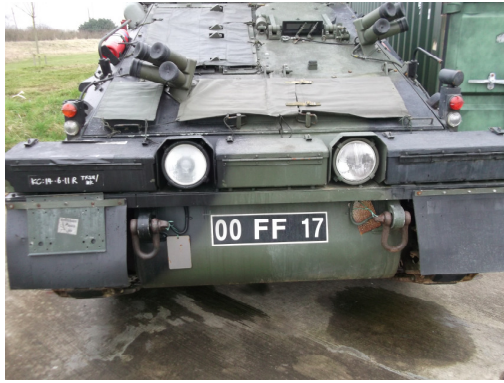
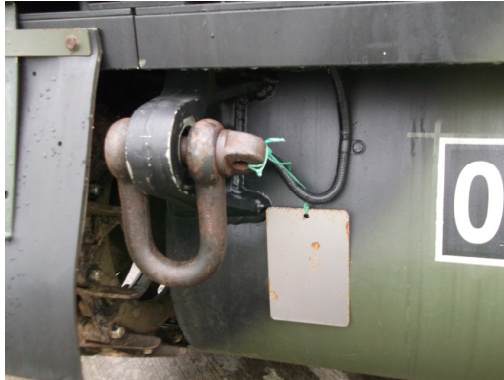
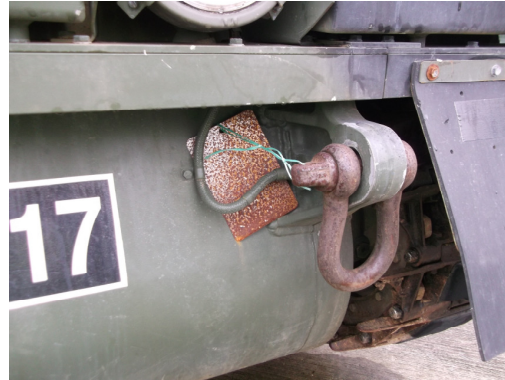
March 2013 (end of trial)

Front view and close ups of the plates fitted to CVR(T) one, taken in March 2013. Although the treated plate is now showing a small amount of rust around the edges, the vehicle still shows no visible signs of degrading. The untreated side has degraded even more

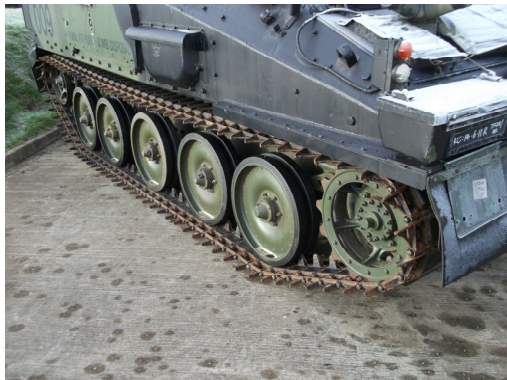
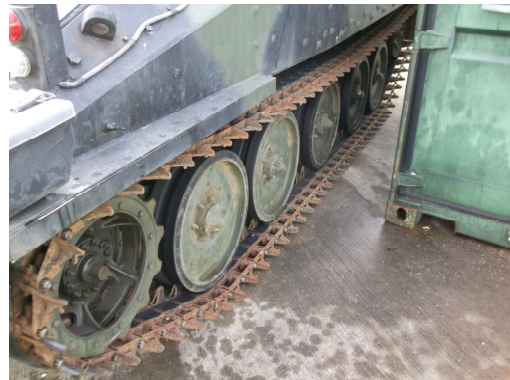
Pictures taken of the wheels / tracks of CVR(T) one in January 2013. The left side is the side treated with VpCI 389D. The untreated side continues to degrade

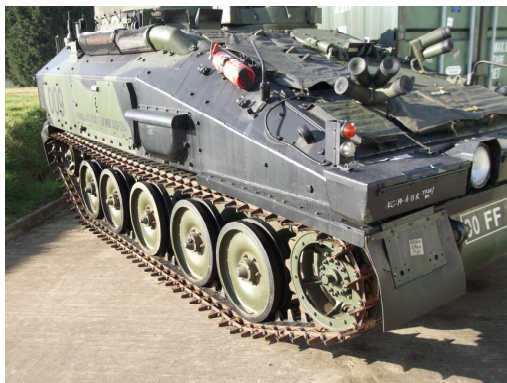
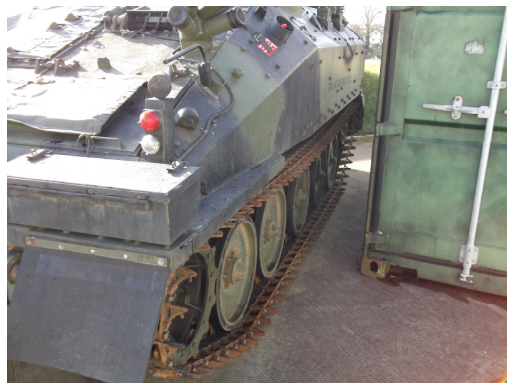
Pictures taken of the wheels / tracks of CVR(T) one in February 2013. The left side is the side treated with VpCI 389D. The treated side still looks fresh

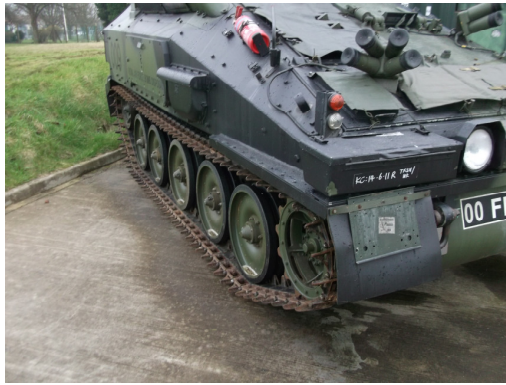
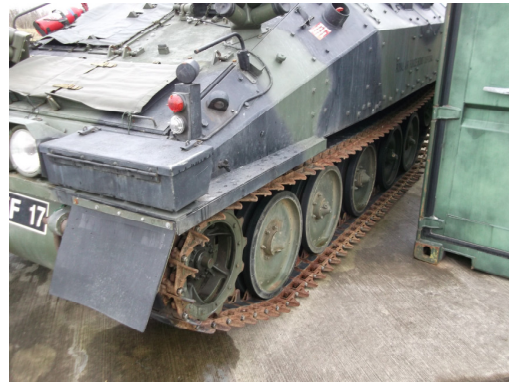
Pictures taken of the wheels / tracks of CVR(T) one in March 2013 (completion of trial). The left side is the side treated with VpCI 389D. The difference in the two side is clear, not just on the wheels and tracks but the whole vehicle

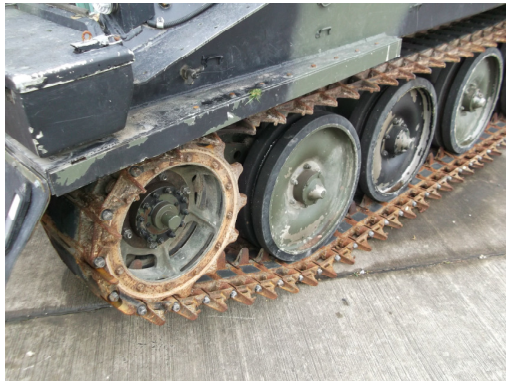
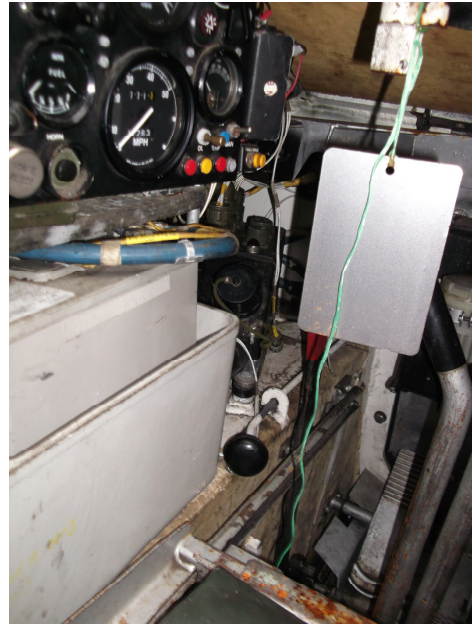
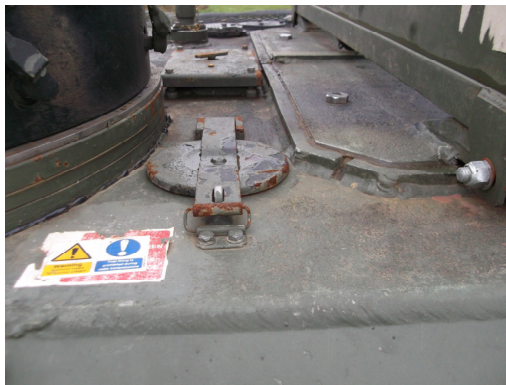
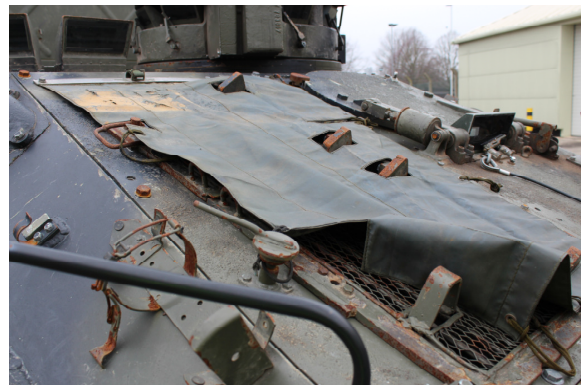
CVR(T) three which had received no treatment and was being used as the datum vehicle continued to degrade. In addition the plate inside the vehicle had continued showing more corrosion.

Below are some picture of CVR(T) three at the completion of the trial, including the plate that was fitted in the driver's compartment for the six month trial period

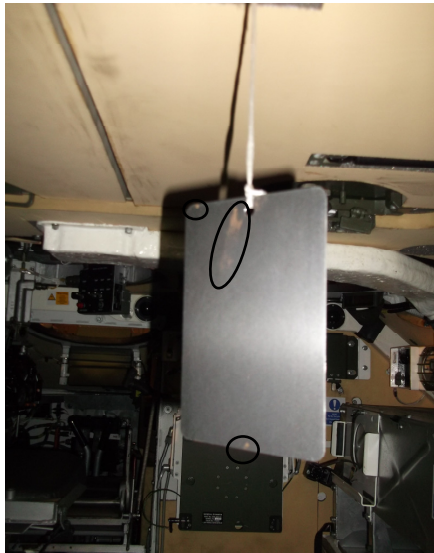
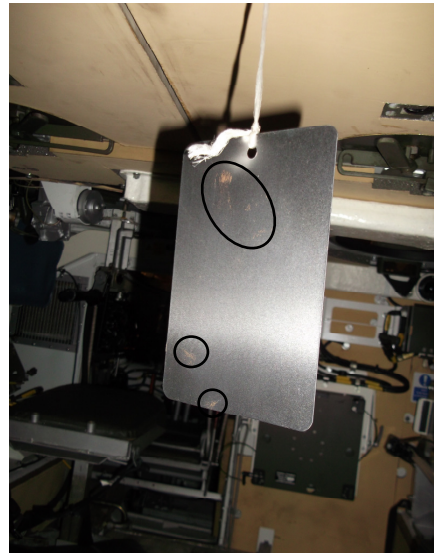
As mentioned earlier in this report, a low grade carbon steel plate had been hung in the CVR(T) that was in CHE. The plate was checked at the end of the trial and was showing signs of corrosion.

This was unexpected and would suggest that for whatever reason, the environment within Shed One is not constant

Pictures taken of both sides of the plate that was hung in the CVR(T) that was stored in the CHE, some of the rust spots are circled

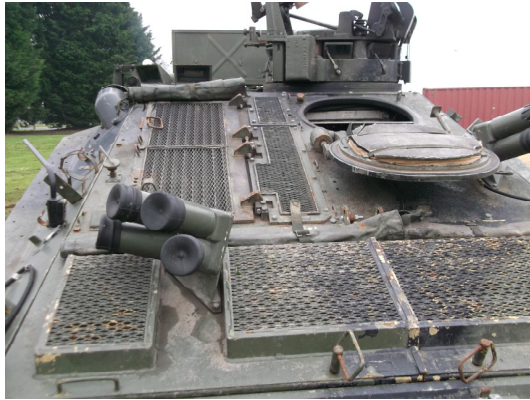
CVR(T) three which had received no treatment and was being used as the datum vehicle was as expected, on the tracks etc, however the corrosion on the vehicle decks was now showing quite clearly, even from a distance.

The decks of CVR(T) three (untreated)

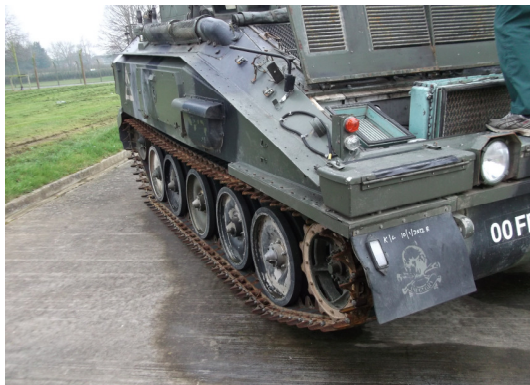
The side of CVR(T) three (untreated)
