## ***Evaluation of Armor Film***

**Project #:** 19-156-1125.bis

**Background:** Our customer is a stamping company who is currently having corrosion issues with the Armor film they are using to protect parts during shipping. This report will evaluate the chemistry of the film as well as corrosion protection.

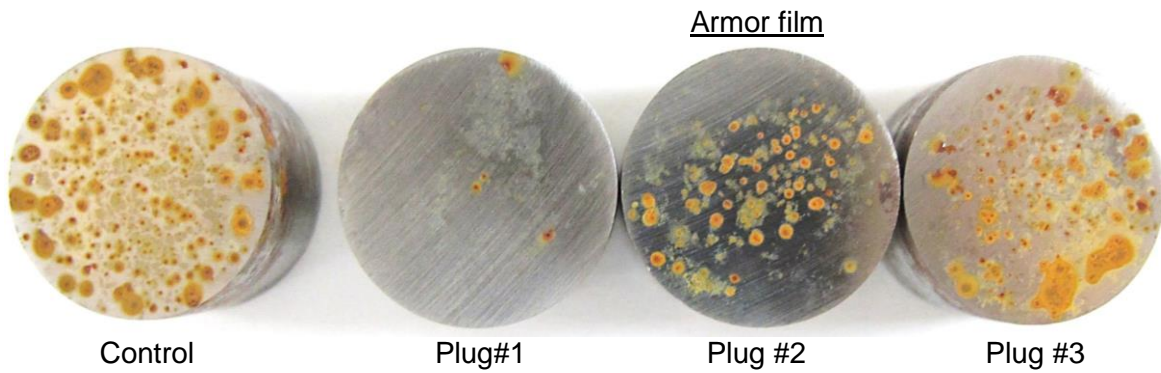
Photo from the NACE VIA test:

Sample	Plug #1	Plug #2	Plug #3
Armor Film	Grade 1	Grade 0	Grade 0
Control	Grade 0	-	-

The results of the NACE VIA test show that the Armor film does not provide good vapor phase corrosion protection. Furthermore, the results of the razor blade test shows that the Armor film only provides contact corrosion protection for steel, but not for copper.

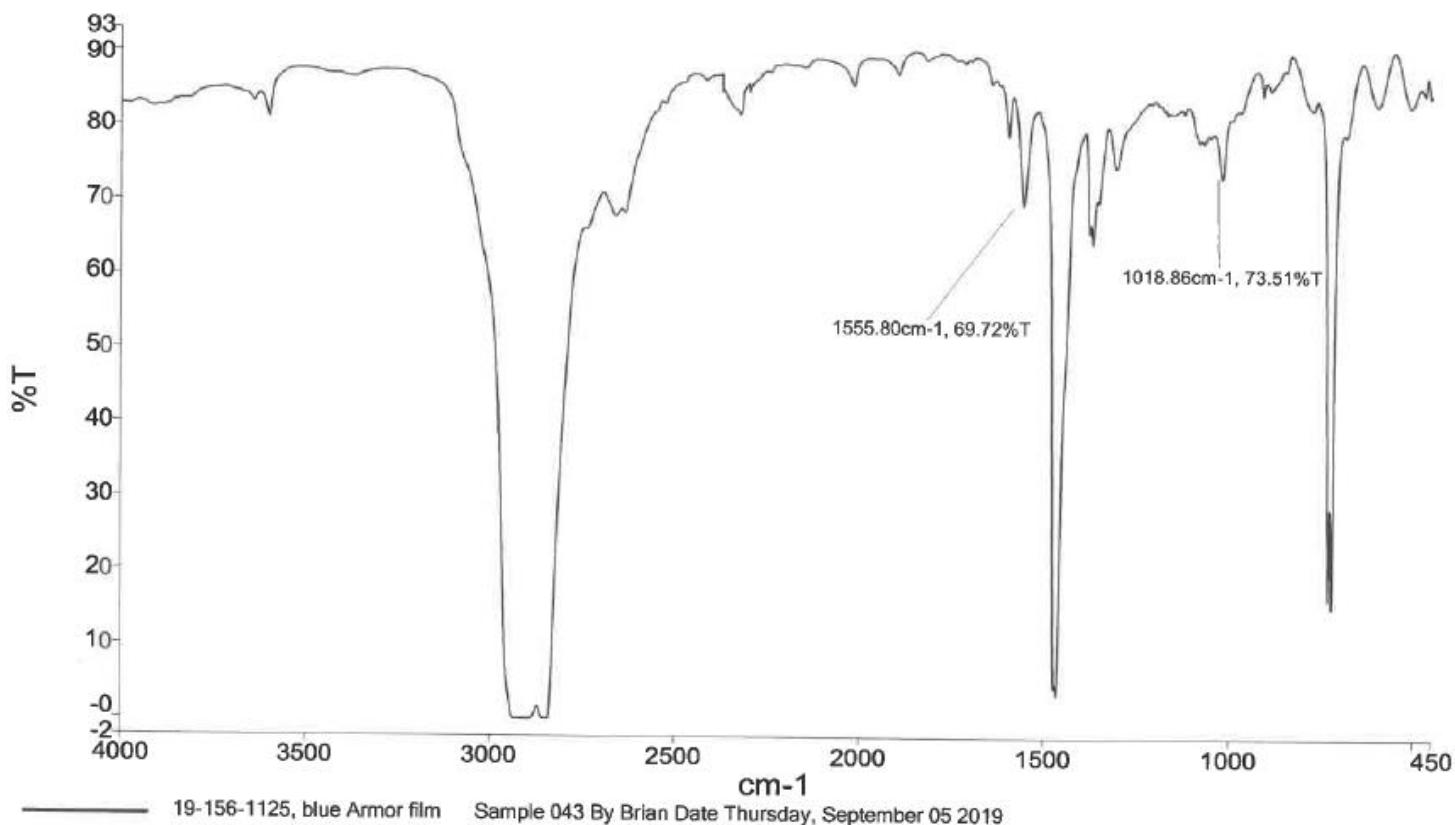
### Blue Armor Film

According to the FTIR analysis, the Armor film appears to contain carboxylate type corrosion inhibitors based on the peak observed around 1555 cm<sup>-1</sup>. This film also appears to contain desiccant based on the peak at ~1018 cm<sup>-1</sup>. Both of these peaks are small, however, which would indicate low concentrations.
