MARCH 2021  
VOL. 60, NO. 3

# **MMP** ***MATERIALS PERFORMANCE***

## Comparison of VCI-CP Effectiveness Using Aboveground Storage Tank Inspection Data

TIM WHITED, MESA, Tulsa, Oklahoma, USA

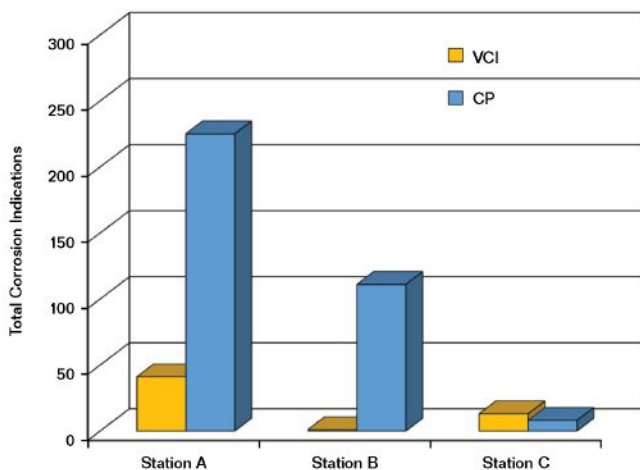
Figures 1 and 2 provide graphic depictions of the data sets for all 12 tanks located within the three pipeline stations.

**FIGURE 1** Total number of corrosion indications per each station.

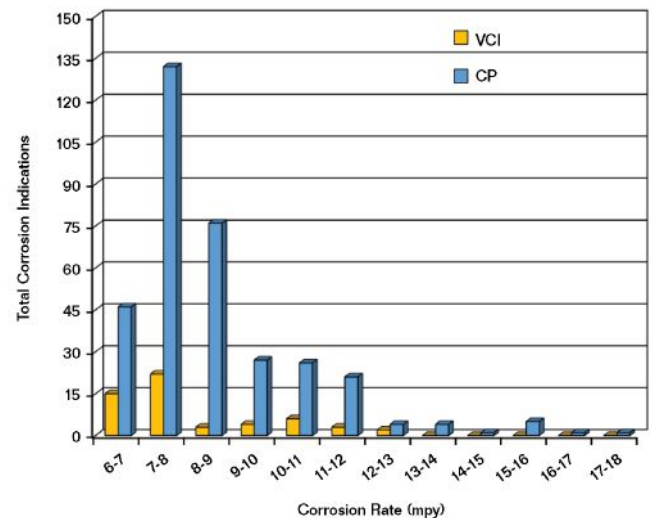
**FIGURE 2** Total number of corrosion indications per corrosion rate segments of all 12 tank floors.
