Bob Boyle Cortec Corporation Laboratories 4119 White Bear Parkway St. Paul, MN 55110 **Boris Miksic** Anna Vignetti **Cliff Cracauer Project** #:11-176-1325(bis) Josha Hicke

Analysis of Hydrotest Methods Used in Valve Preservation

Date: January 10, 2012

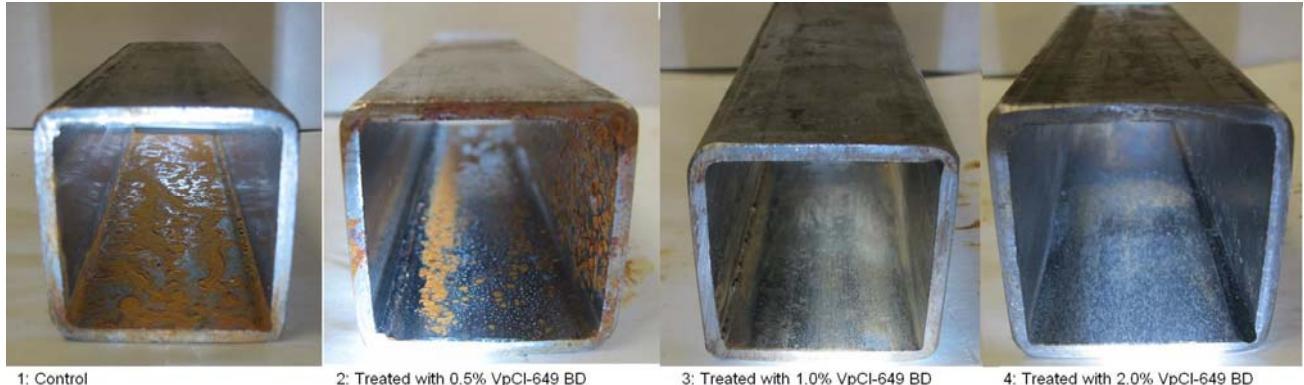
The salt spray chamber is a very harsh environment so this test provides an accelerated view of the corrosion patterns. After hydrotesting, the steel tubing shows a clear division between using VpCI-649 BD concentrations of 0.5% and 1% or greater. Although sample 2 does show some rust it is clear from Figure 1 that hydrotesting with 0.5% VpCI-649 BD provides some protection as the control exhibits a much greater level of corrosion. Samples 3 and 4 substantially outperformed the control. Sample 4 performed slightly better than sample 3 but both developed light surface corrosion.

2: Treated with 0.5% VpCI-649 BD 3: Treated with 1.0% VpCI-649 BD 4: Treated with 2.0 Figure 1: Tubing used to test 0, 0.5, 1, and 2 percent VpCI-649BD solutions for hydrotest

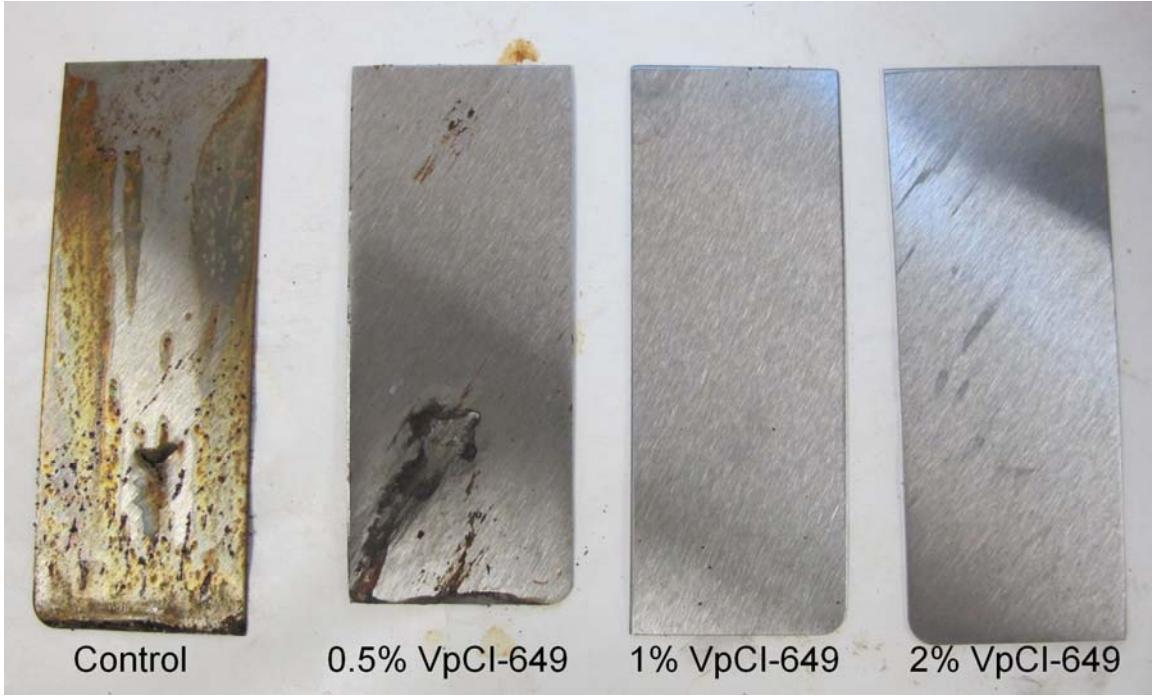
The hydrotest with steel panels confirms the results of the steel tubing test. See the comparison picture in Figure 2 below. VpCI-649 BD effectively reduces corrosion when it is applied on the panels at a concentration of one and two percent, the corrosion rates respectively are 0.03 and 0 mpy.

Figure 2: Panels treated with VpCI-649 BD and placed in the oven with 2% salt water at 40 °C for 5 days

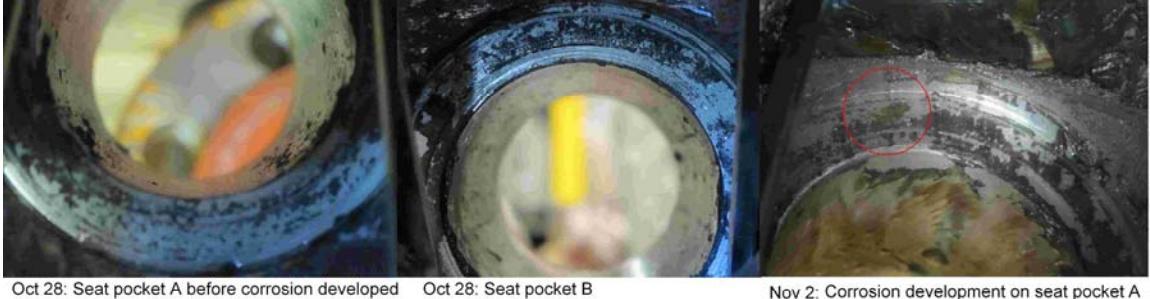
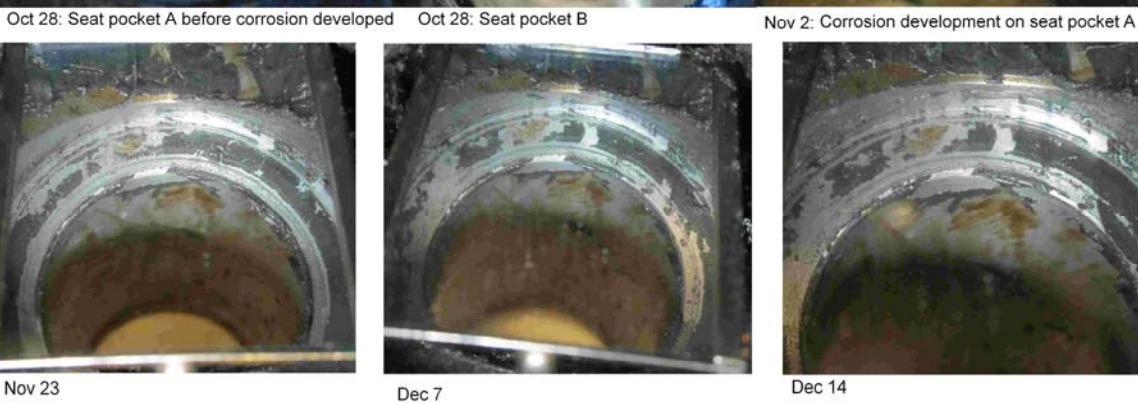
Figure 3: Pictures of the Valve 1 seat pocket over the course of the test. Seat pocket B didn't develop corrosion during the test.

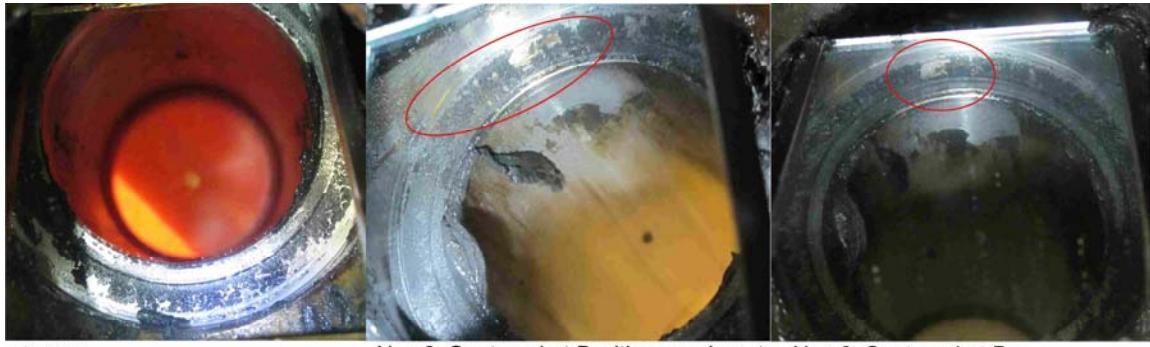
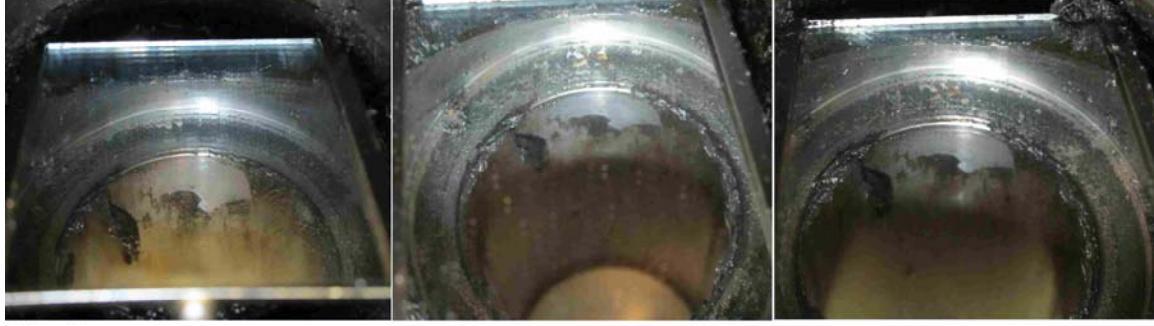
Nov 2: Seat pocket B with corrosion at the base of the seat pocket

Figure 4: Pictures of Valve 2 seat pocket B. Corrosion did not develop on seat pocket A during the test.

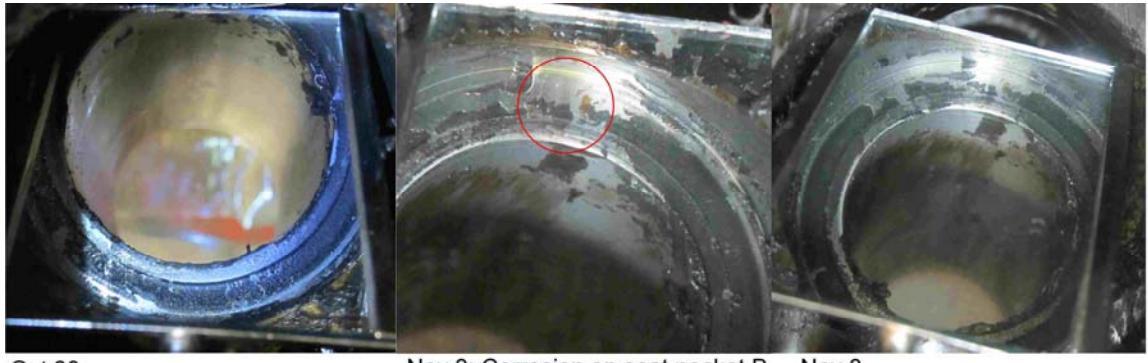
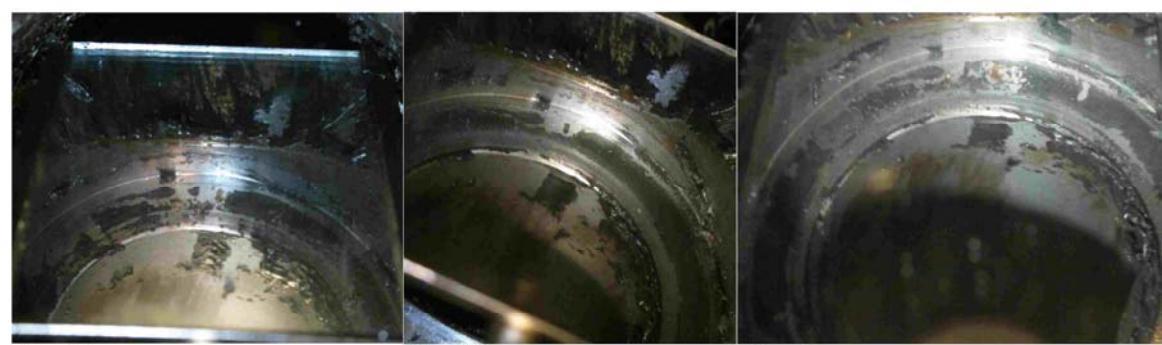
Nov 2: Corrosion on seat pocket B Nov 8

Nov 30Dec 14Figure 5: Pictures of Valve 3 seat pocket B, side A did not develop corrosion.

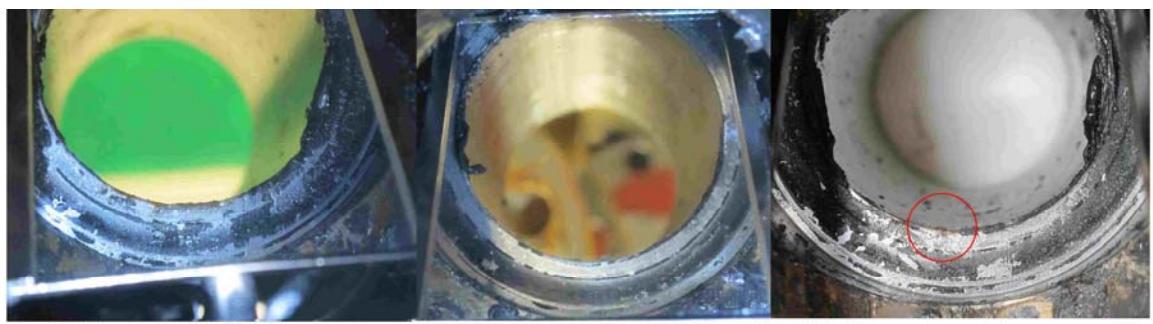
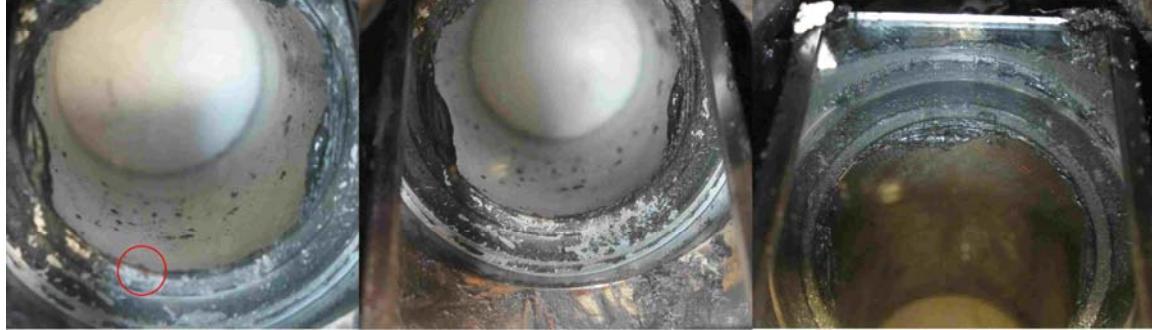
Nov 23: A corrosion spot developed on the top of pocket A

Dec 7 Dec 14: Seat pocket A Dec 14: Seat pocket B Figure 6: Valve 4 with only a small spot of corrosion developing on seat pocket A.

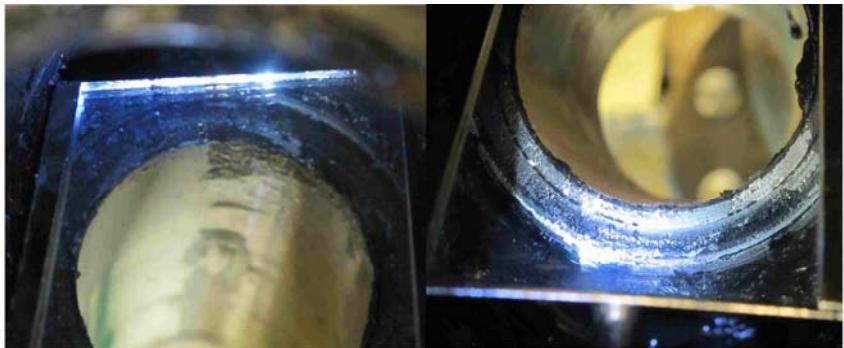
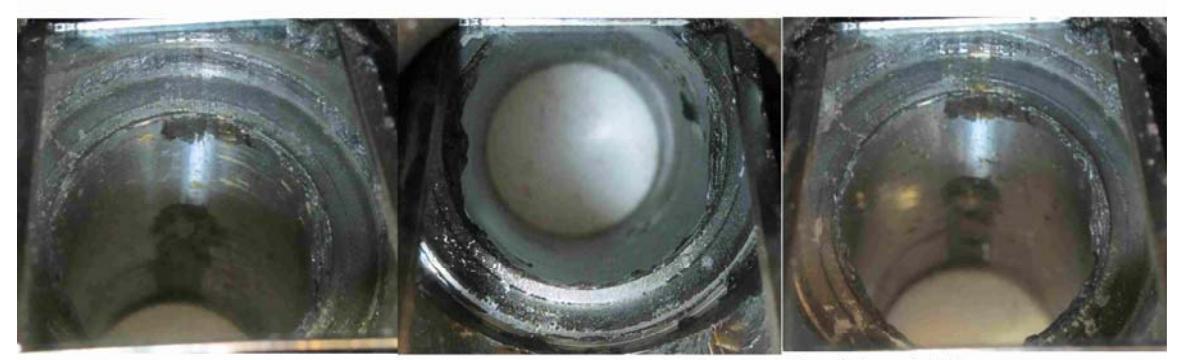
Valve 2, 3, 4, and 8 were tested with VpCI-649, VpCI-337, or a combination of both inhibitors and were compared to the control, Valve 1. Valve 1, 2, and 3 all developed some small corrosion spots on the seat pocket within 14 days of the beginning of the test. The seat pocket of Valve 4 and 8 both remained clean for the duration of the two month test.

Figure 7: Pictures of the Valve 8 seat pockets. The mark on the seat pocket in the December 14 picture is from VpCI-337 buildup and not corrosion.
 Figure 14: pocket A

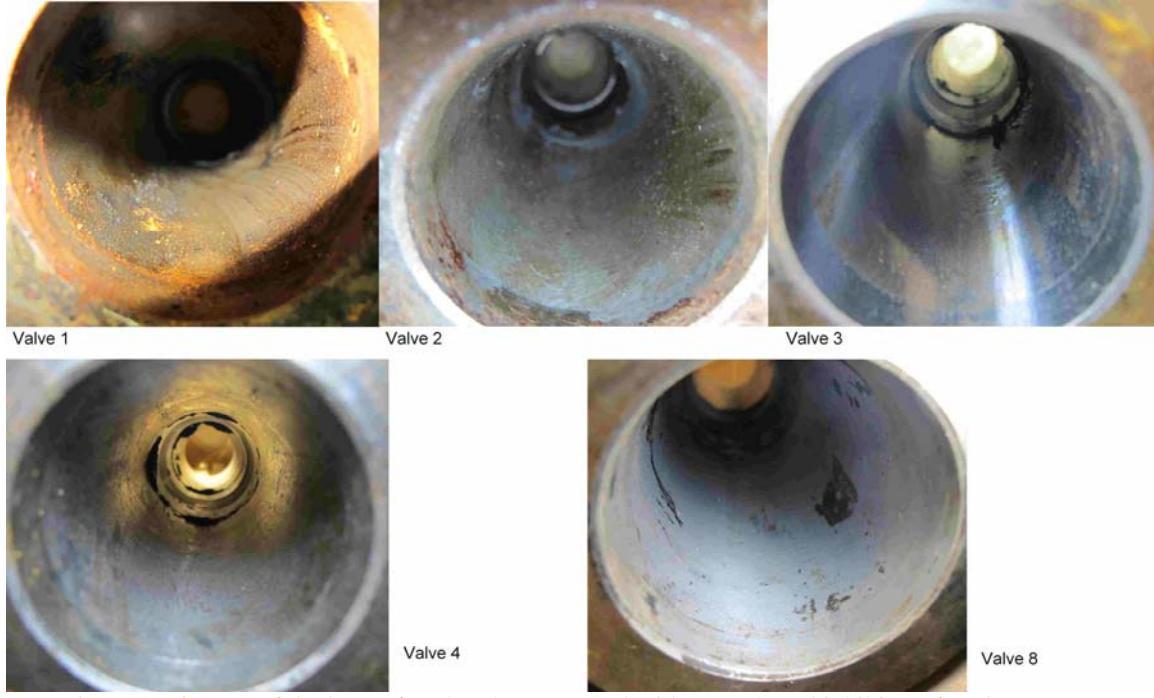
The corrosion on the bores of the valves provides more distinction than the corrosion seen on the seat pockets. The bore of the control valve over the course of two months shows substantial corrosion. As the comparison picture (Figure 4) shows the bore displays a lot of red rust across the surface. Valves 1, 2, and 3 all present some corrosion however it is much less severe than that seen on the control valve. Valve 8, which was periodically fogged with VpCI-337, shows almost no signs of corrosion on the bore. The seat pocket and bore pictures can be seen in below.

Figure 8: Pictures of the bore of each valve protected with water based inhibitor after the test was completed December 14th.

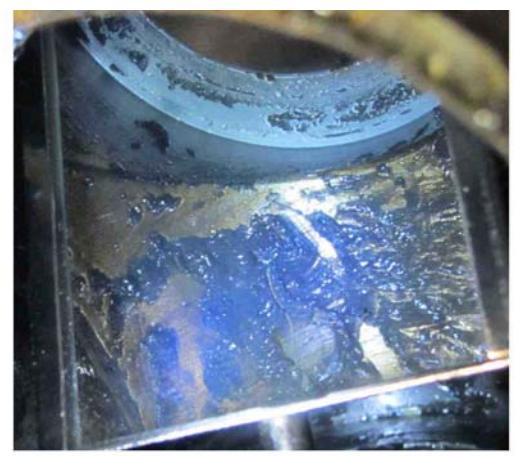
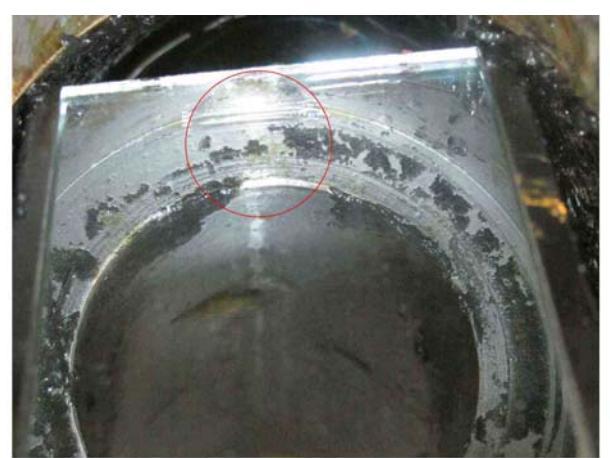
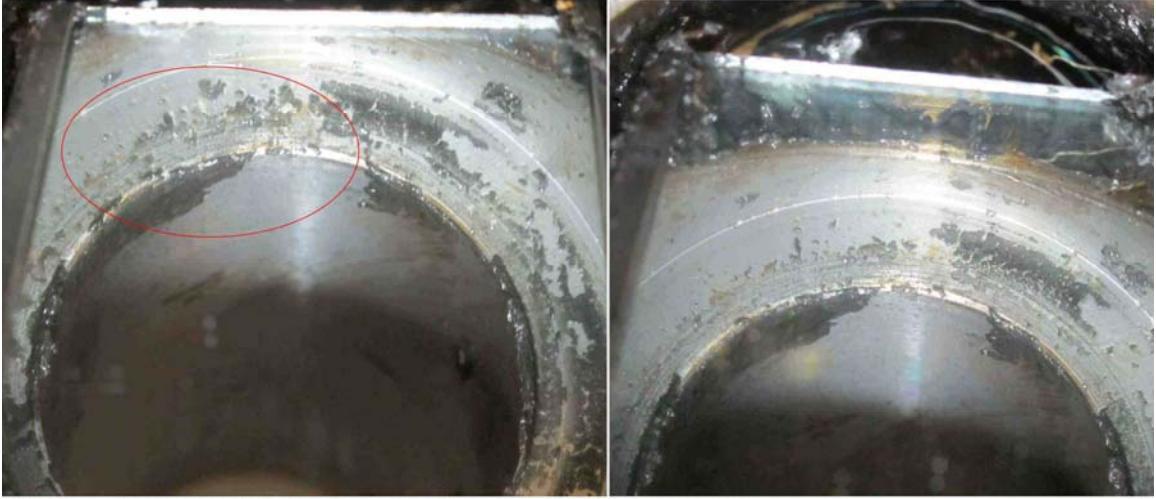
Valves 5 and 6 were used to evaluate the process of preserving the valves with oil pressure test. Valve 6 was the control as it was flushed with Shell Tellus S2 V46 and valve 5 was flushed with Shell Tellus S2 V46 containing VpCI-322 at 5 percent. The first spots of rust were seen on seat pocket B of valve 5 after 14 days in the chamber. Valve 6 exhibited rust during the following inspection period or after 20 days in the chamber.

Nov 2: When the rust mark developed

Nov 16: Corrosion on the seat pocket

Nov 30: The corrosion can be seen developing at Dec 14 the top of the picture. (the bottom of the seat pocket)

Figure 9: Pictures of the seat pocket of Valve 5.

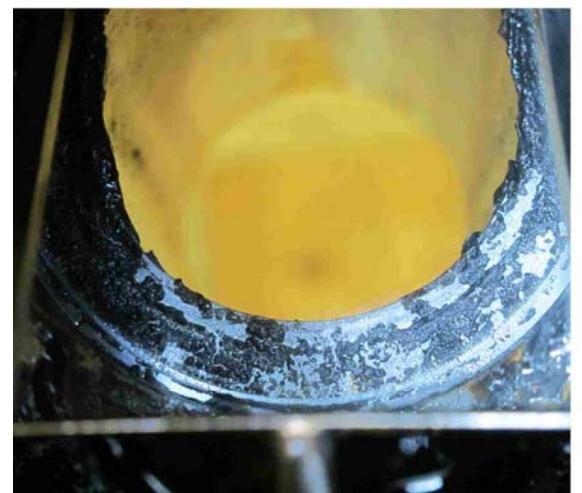
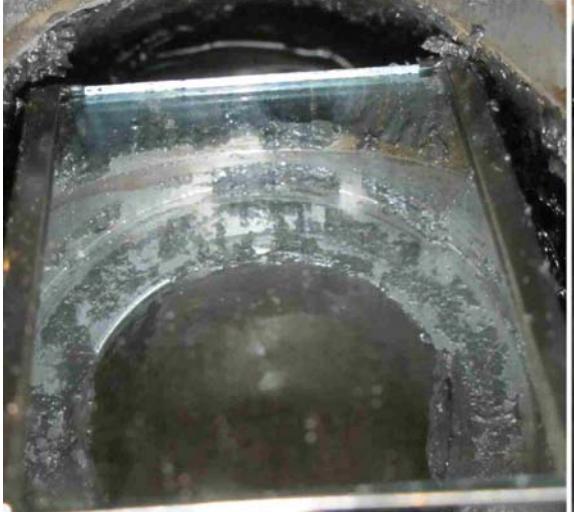
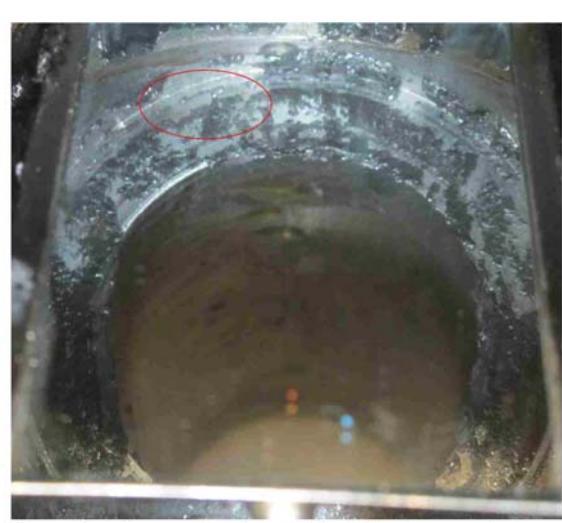
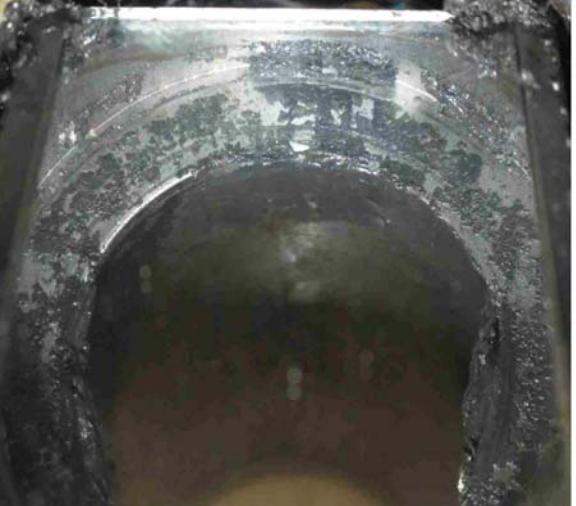
Nov 2: The seat pocket of valve 6 at the time corrosion began in valve 5.

Nov 11: Corrosion formed at the base of the seat pocket. (top of the picture)

Figure 10: Pictures of the seat pocket of Valve 6.

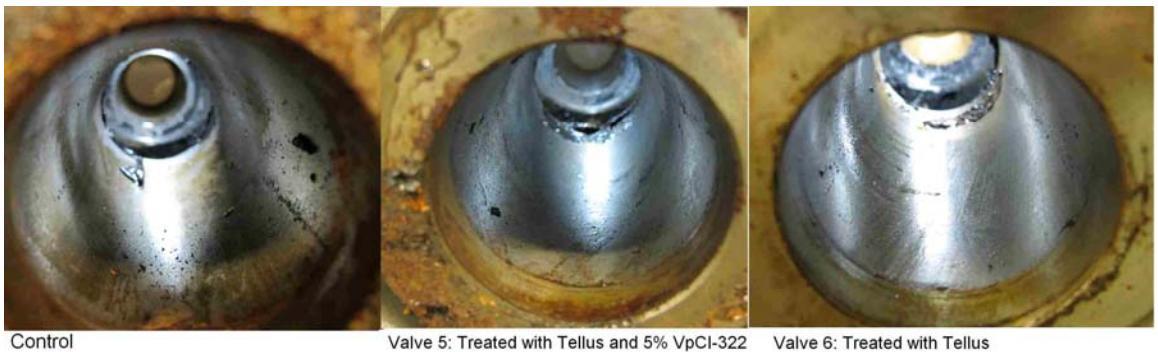
The corrosion in the bores of both Valve 5 and 6 developed similarly. Figure 11 below shows a comparison of the bores of Valve 1, 5, and 6 which shows that the corrosion was reduced by both oil treatments. Based on this project there is not a clear benefit of using VpCI-322 in Shell Tellus oil. In order to determine the best procedure for pressure testing with oil additional tests should be conducted.

Valve 5: Treated with Tellus and 5% VpCl-322 Valve 6: Treated with Tellus Figure 11: Comparison of the bores from the control and valves treated with Tellus oil.
