## *Evaluating Six Year Old VpCI-126 Film and Starbright Cutting Fluid*

**Project #:** 07-135-1125

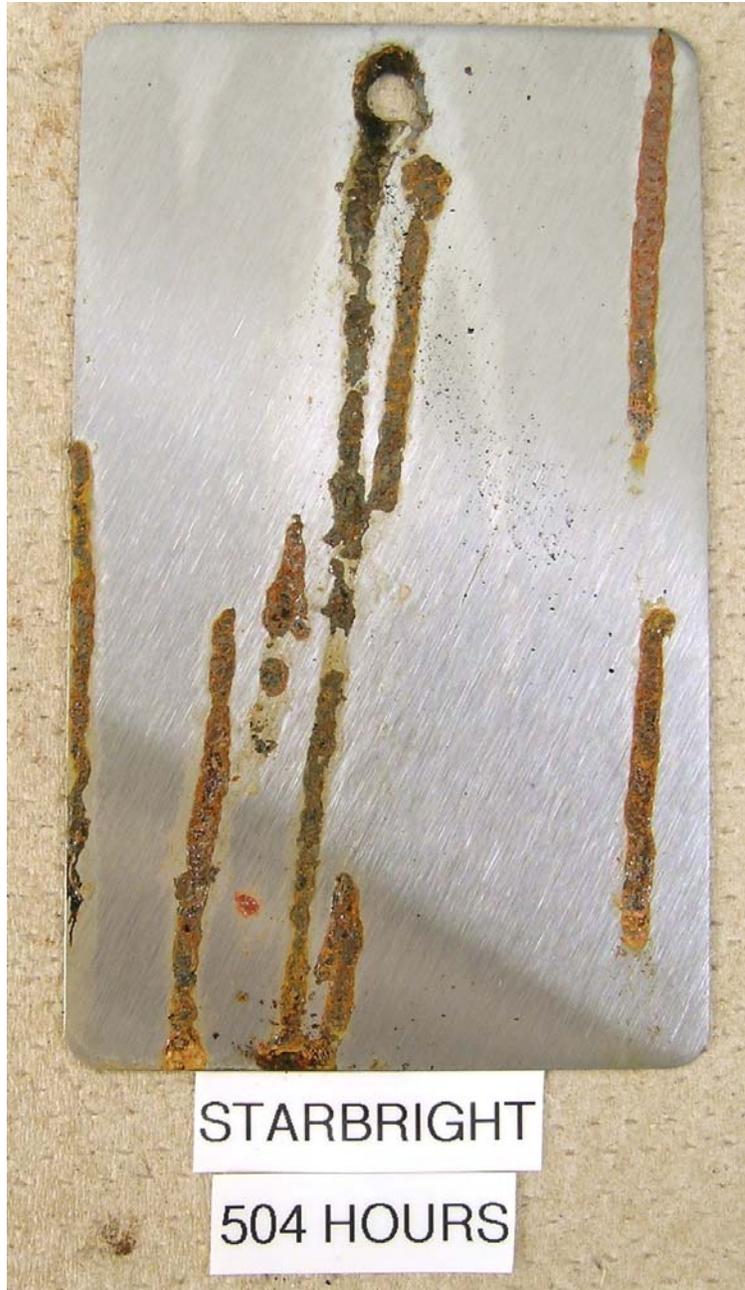
- 1) The control panel was severely corroded after 504 hours. Corrosion covered >90% of the surface area of the panel.
- 2) The panel coated with Starbright 455 was moderately corroded after 504 hours. Corrosion covered 25% of the surface area of the panel.
- 3) The panel coated with EcoLine Cutting Fluid was very lightly corroded after 504 hours. Five small spots (~2mm) were present on the panel, constituting less than 1% of the total surface area of the panel.

**Starbright 455 Cutting Fluid, after 504 hours in humidity.**

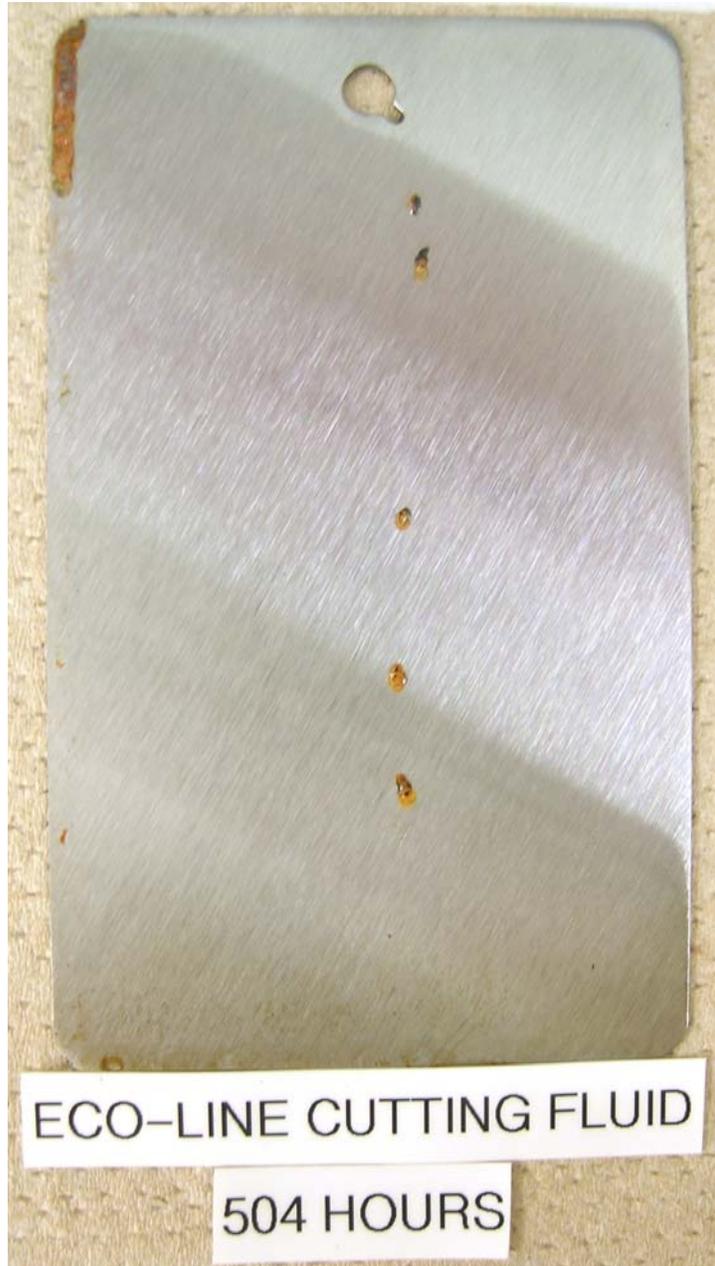
**Eco-Line Cutting Fluid (2.5% solution), after 504 hours in humidity.**
