Evaluation of Corrosion Protection Properties of Armor Film used by Customer

Project #: 16-256-1125.supplemental.bis

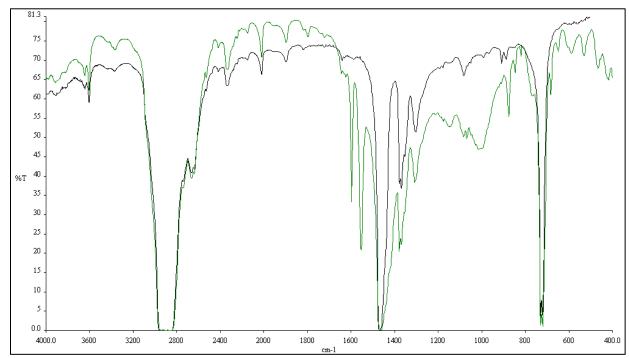
FTIR Analysis

Above: Armor film (green line, higher baseline %T) compared to polyethylene control (black line, lower baseline %T)

> FTIR analysis shows the presence of desiccant and coloring. Either the desiccant material is added to the film for its bulk properties (and is therefore not very effective as a desiccant), or the film has already been saturated. No nitrite was found.

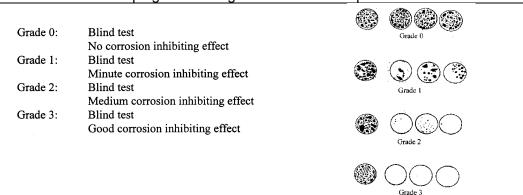
VIA Test Results for Armor Film Control Plug 1 Plug 2 Plug 3

All three plugs must be grade 2 or better to pass the test

Interpretations: The submitted Armor film does not pass any of Cortec's standard corrosion preventive tests, according to the results above. It did not perform any better than the control polyethylene film for protecting copper nor carbon steel in the contact phase, according to the razor blade test. It also didn't perform any better than the control in protecting against corrosion in the vapor phase, according to VIA results.
