## CASE HISTORY SPOTLIGHT

## Case History #596: Stone Cladding Tile Repair with MCI®

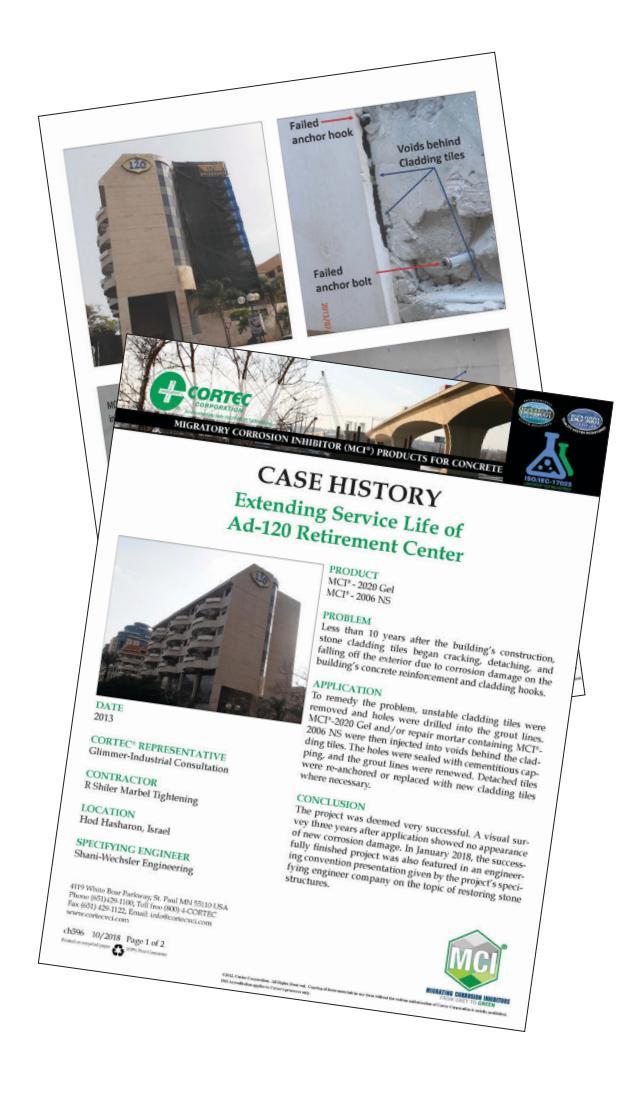
A residential building less than 10 years old began to have trouble with stone cladding tiles falling off the exterior. The culprit was corrosion on concrete reinforcement and stone cladding anchors.

To repair the structure, unstable cladding tiles were removed. Holes were drilled into grout lines to inject MCI<sup>®</sup>-2020 Gel beneath the surface. MCI<sup>®</sup>-2006 NS was also injected into voids behind the cladding tiles. Drill holes were sealed, grout lines renewed, and tiles were re-anchored and replaced where necessary.

The project was considered a success. A visual survey three years later found no sign of further corrosion damage. The project was even featured in a presentation on restoring stone structures given by the specifying engineer at an engineering convention about five years after the repair.
