CASE HISTORY

VpCI®-416 & VpCI®-426 Used For Reservoir Restoration

DATE
July 2008

LOCATION
Zagreb, Croatia

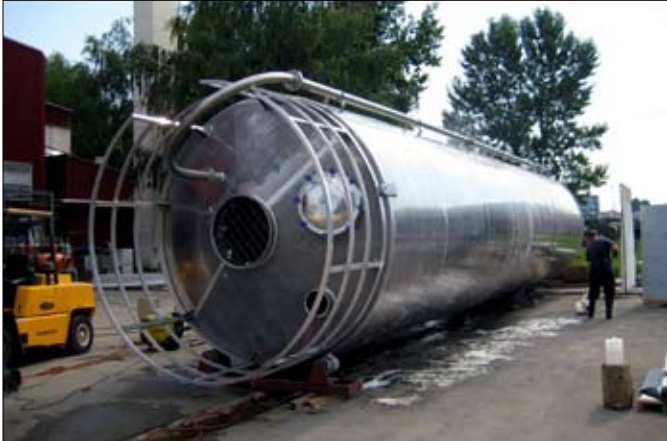
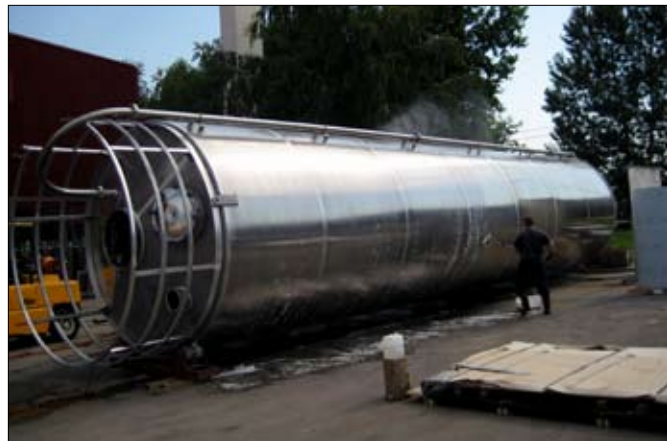
PROBLEM
The aluminum plated reservoir surface was damaged from dirt, grease, and corrosion. Pecon required the reservoir to be clean and corrosion free before shipping.

APPLICATION
VpCI®-426 was diluted with water 25-30% and a mechanical brush was used to remove the dirt, grease, and corrosion. After cleaning, the reservoir was rinsed with VpCI®-416, which was diluted with water 25%. The surface was air dried and then loaded for shipment.
