Flexcrete Limited
MONOLEVEL FC⁺
MCI[®] Modified Fairing Coat
Site Evaluation

October 2002

MONOLEVEL FC⁺ MCI[®] Modified Fairing Coat Site Evaluation

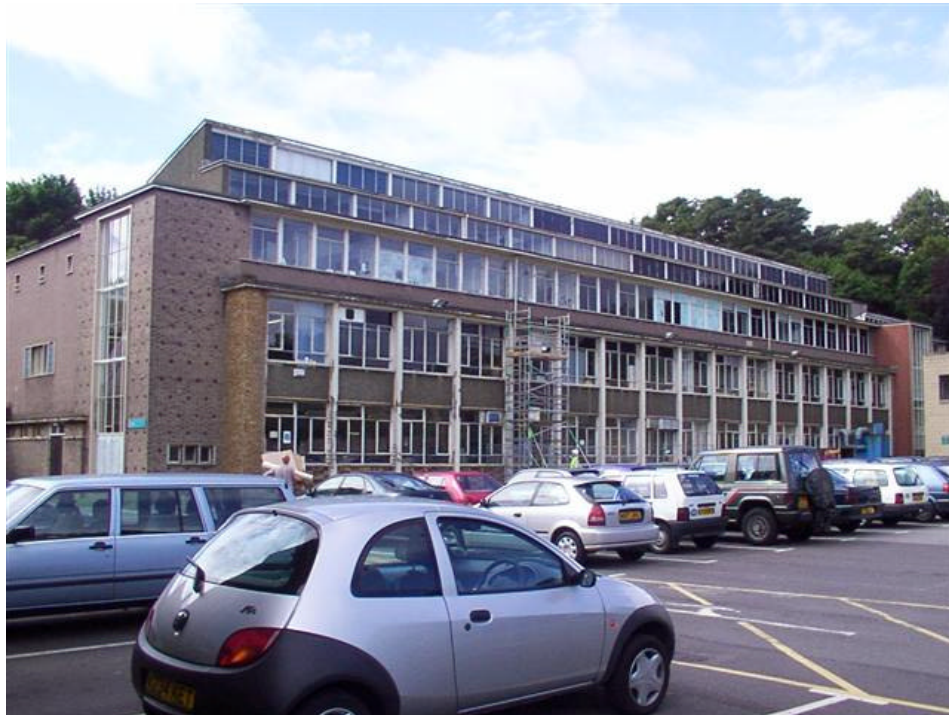
Figure 1: North Elevation.

The structure is built in an old quarry, adjacent to the cut face of the quarry walls. This offers environmental protection to the rear (south) elevation of the property, whilst the front (north) elevation faces the campus car park and is more exposed (see Figures 1 & 2). The structure was constructed in the early 1960s. The envelope is clad in part by pre-cast concrete panels with an exposed aggregate finish, glazing and partially by brickwork cladding.

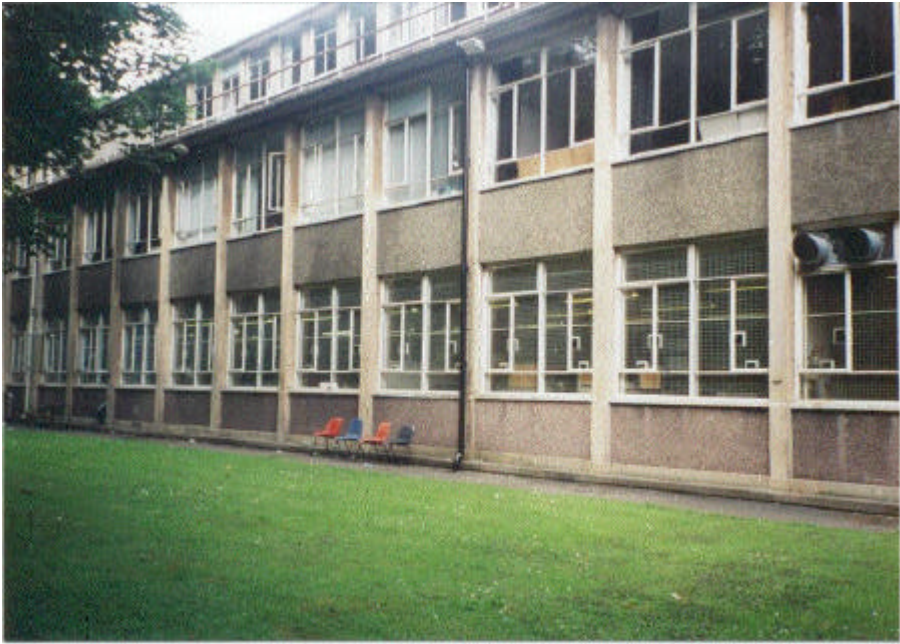
Figure 2: South Elevation.

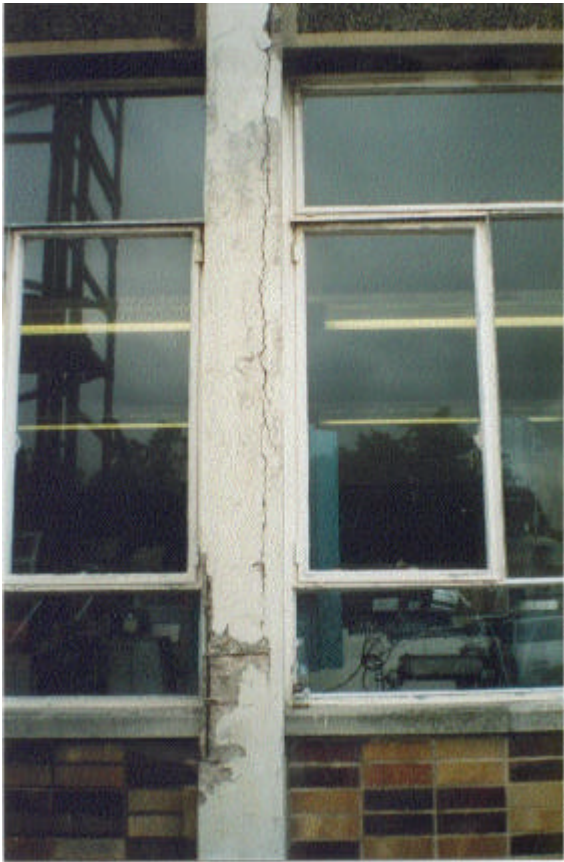
The main vertical structural members are concrete encased steel stanchions and it is these columns that were selected for the trial applications. The same form of column is also employed internally. A number of the external columns have already suffered damage due to corrosion of the secondary reinforcement; particularly in areas of low cover (see Figure 3).

Figure 3: Typical Damage to Columns.

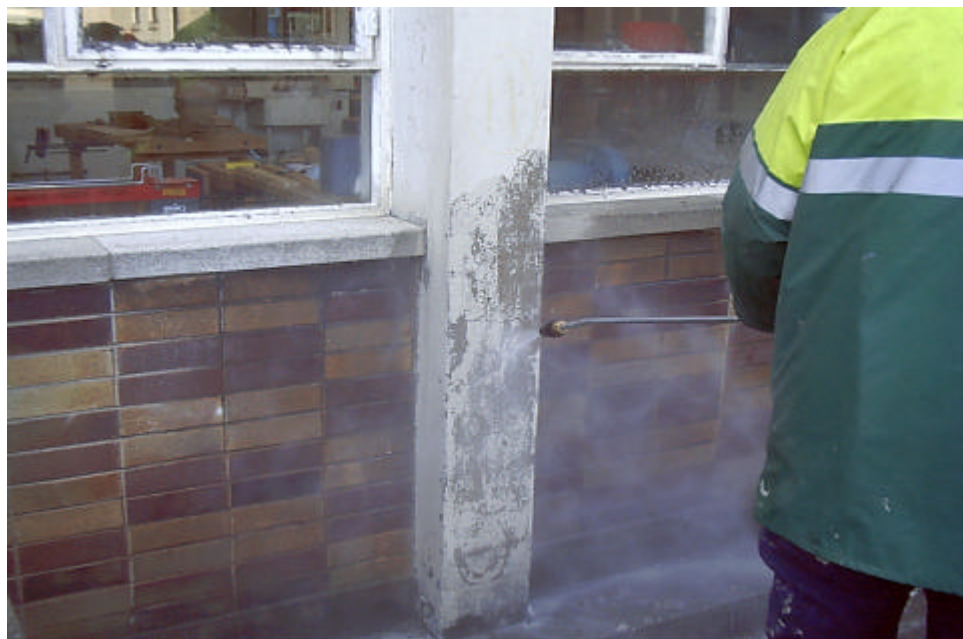
Figure 4: Surface Preparation by Water Jetting

Prior to applying the fairing coat it was necessary to carry out a degree of surface preparation. For the external columns this consisted of medium pressure water jetting (Figure 4) which also removed the remaining weathered masonry paint from the North Elevation. For the painted internal column an industrial hot air gun was employed to remove the various paint layers.

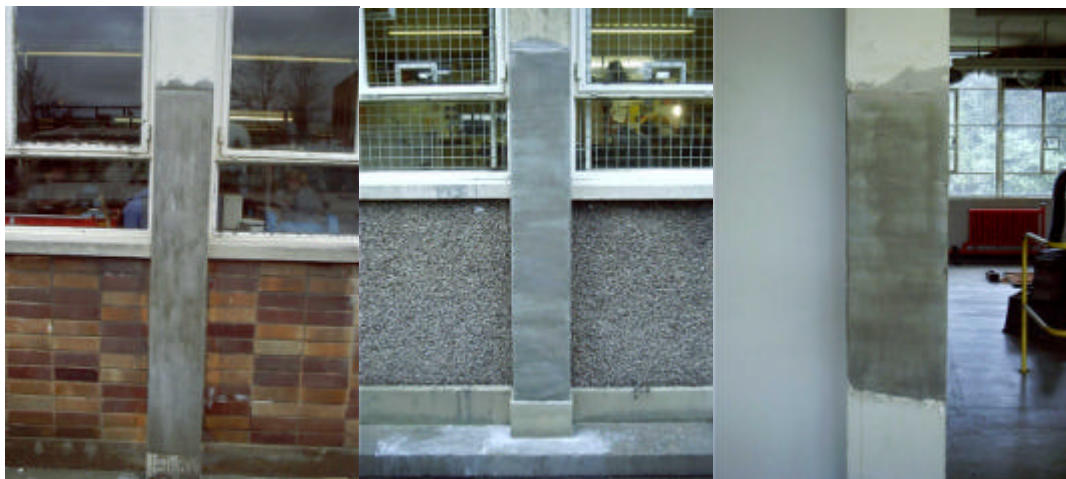
Application to all three test areas was carried out on 7th March 2002 and the finished coatings are shown in Figure 5.

Figure 5: Test Areas (l-r): External-Exposed; External-Sheltered and Internal

The fairing coat was mixed and applied in accordance with the Manufacturer's recommendations and under the supervision of their technical representative. The coating was applied by trowel to a thickness of approximately 3 to 6 mm.

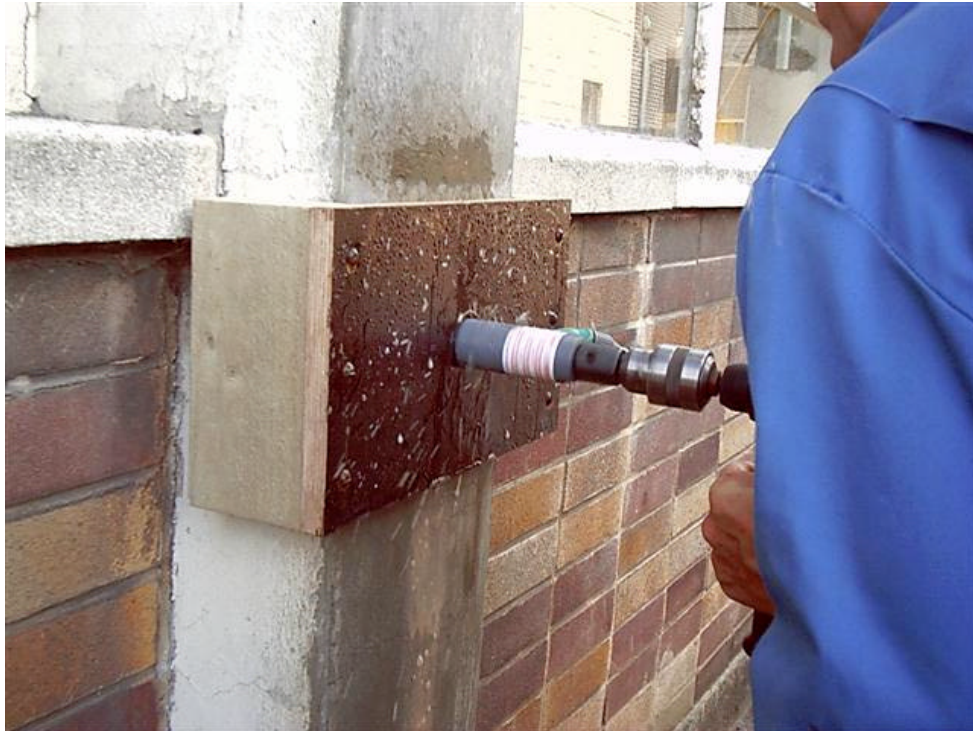
Figure 6: Obtaining Cored Samples for Analysis

Sampling was performed 1, 5 and 18 weeks after application and consisted of drilling small diameter cores (nom. 25 mm diameter) from which powdered samples were obtained, representing depth gradients of 0 to 10 mm, 10 to 20 mm, 20 to 30 mm, 30 to 40 mm and 40 to 50 mm (Figure 6 and 7). Additional control samples were also obtained from the fairing coat and parent concrete.

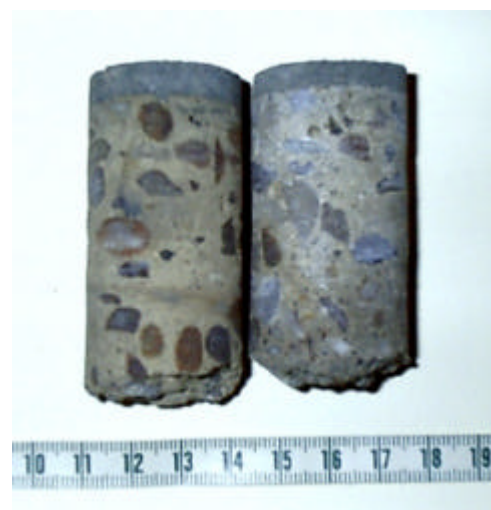
Figure 7:
Typical Cored Samples

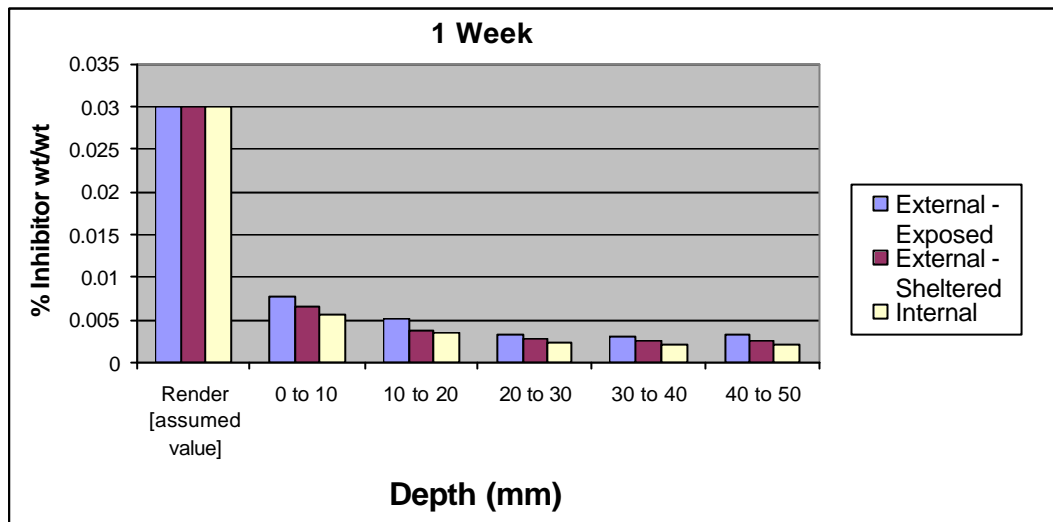
Figure 8: Inhibitor Gradient - 1 Week

The results obtained for the three locations at 1, 5 and 18 weeks are shown graphically in Figures 8, 9 and 10. The concentration of inhibitor is expressed as a percentage by weight of the sample.

The inhibitor concentration in the fairing coat has been assumed to be at the design level of 0.03% for the first two readings (Figures 8 and 9) but was determined at values of between 0.015% and 0.02% after 18 weeks exposure (Figure 10).

The results shown in Figures 8 to 10 indicate slight differences in the diffusion behaviour of the inhibitor dependant upon exposure condition. Most notably, the external-exposed test area generally achieved the highest rate of inhibitor ingress, followed by the external-sheltered with the internal area showing the lowest ingress.

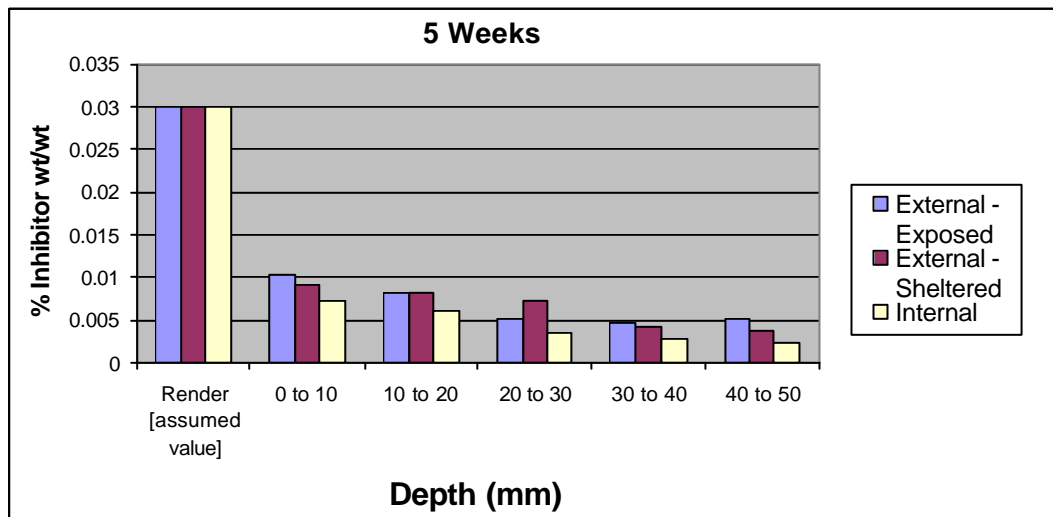
Figure 9: Inhibitor Gradient - 5 Weeks

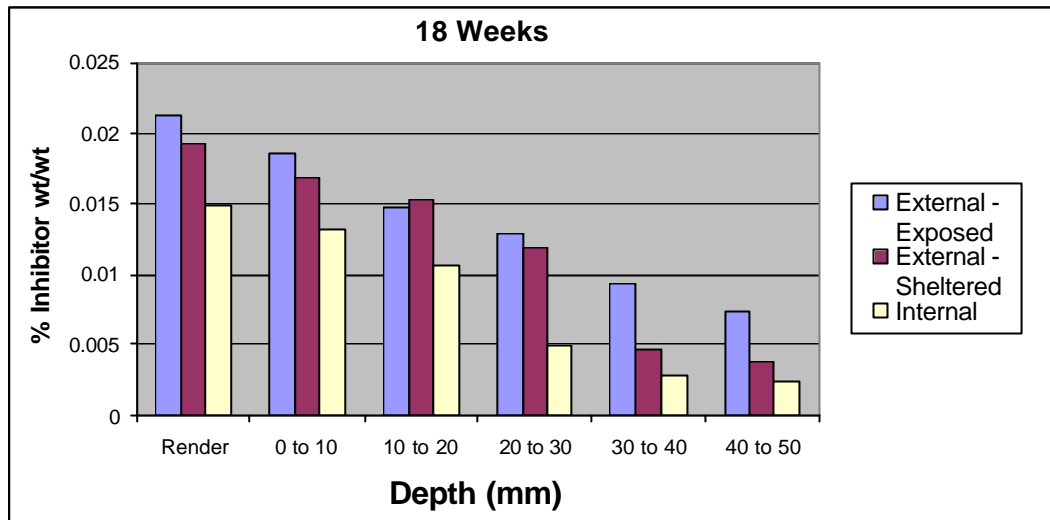
Figure 10: Inhibitor Gradient - 18 Weeks
