VpCI™ SOLUTIONS FOR MILITARY APPLICATIONS

CASE HISTORY

Refurbishment of Military Displays

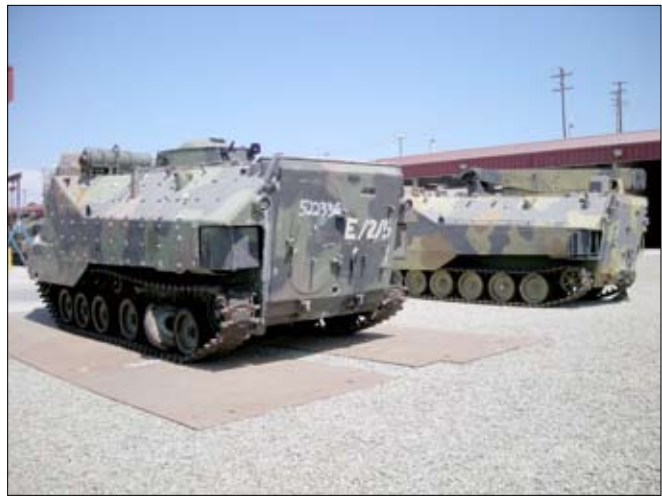
Before

Two static display museum pieces (AAV's) needed corrosion removal, protection, and a new durable top coat. The first AAV had been retired for approximately 10 years and was only in need of a top coat. The second, had been sunk off the coast of Okinawa Japan and had remained under water for 3 months. The steel parts were heavily corroded and the aluminum parts, which make up most of the body, were heavily oxidized.

All surface rust was removed from the rims, tie downs, and bolt heads with wire brushes and scrapers. Surfaces were wiped with Isopropyl Alcohol and VpCI™ CorrVerter® was applied liberally with a brush. Aluminum oxidation, barnacles, and all loose paint was removed with wire brushes, wire wheels, electric sanders, and scrapers. Rough surfaces were then "feathered" with fine grit sandpaper. All surfaces were once again wiped clean with Isopropyl Alcohol. VpCI™-375 was then applied, first by brush to cut in the hard to reach areas and corners. Then the nose, back, and doors of the AAV's were rolled out with a paint roller. All other surfaces were sprayed with an airless sprayer.

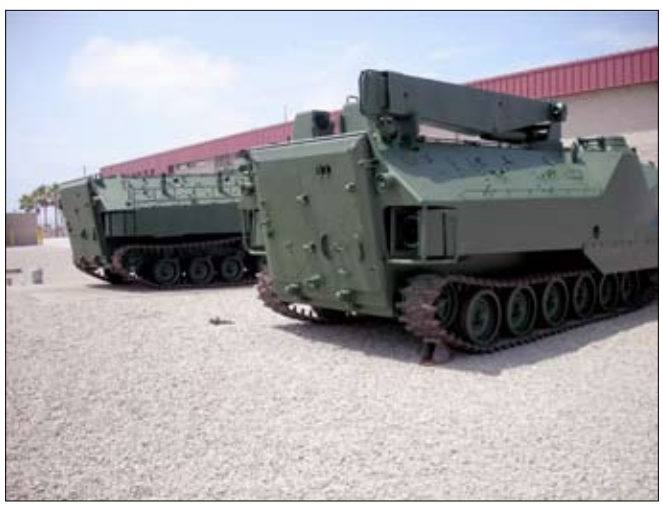
After

Cortec's VpCI™-375 and VpCI™ CorrVerter® were the perfect products for the job, providing little need for touch up.
