VAPOR PHASE CORROSION INHIBITORS (VCIs) FOR PROTECTING SHIPBOARD VOIDS

Kunigahalli L. Vasanth and William Needham
Naval Surface Warfare Center Carderock Division, Code 613
9500 MacArthur Boulevard, West Bethesda, MD 20817-5700

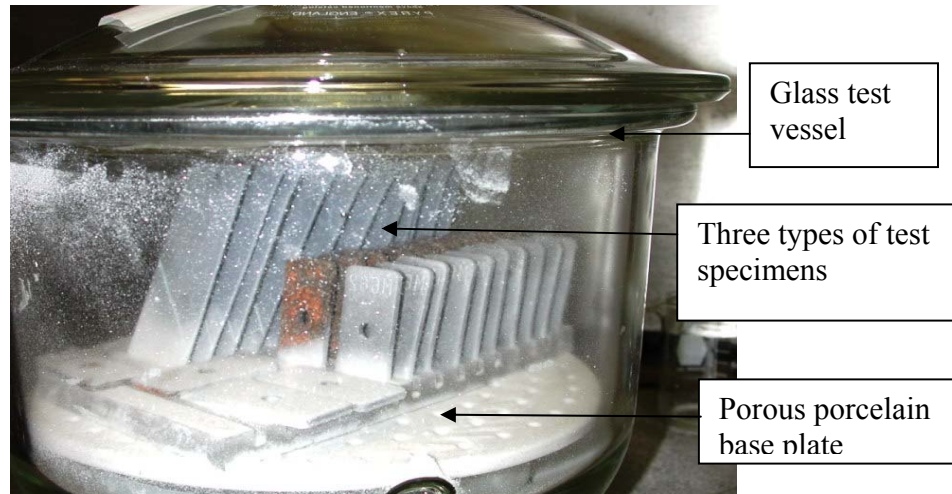
FIGURE 1- A typical test vessel with three types of specimens exposed to VCI A

The spray application of aqueous solution of VCI B2 was chosen to determine if it would provide a more uniform application than VCI powder application which has the tendency to clog the spray applicator. VCI powders were blown into respective test vessels through a 1" plastic tube using an Abrasive Spot Blaster, Model SB 9005 and laboratory compressed air at a pressure of approximately 10-12 psi. A fiberglass mat was used to cover the top of the test vessel during blowing of the VCI powder to prevent any loss. Once the powder installation was complete, the fiberglass mat was replaced with a tight fitting glass cover and was allowed to stand under laboratory conditions. After 24 hours of conditioning, all of the test vessels were maintained at a R. H. level of about 95% by keeping 500ml of 3% glycerine solution in water in a plastic tray at the bottom of each test vessel. A typical test vessel with all the three types of specimens and VCI A powder installed is shown in Figure 1.

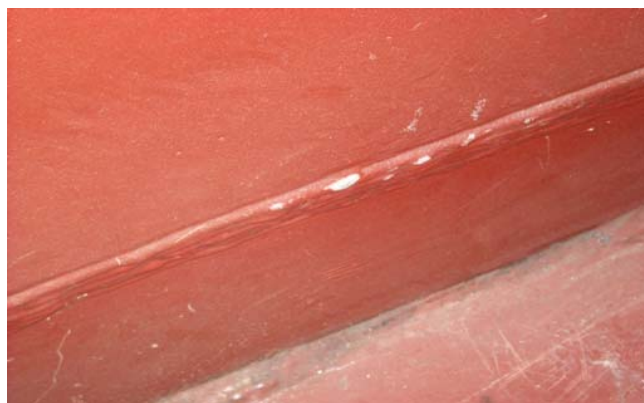
FIGURE 2 - Control Group Void, 03-143-6-V showing some areas of coating damage

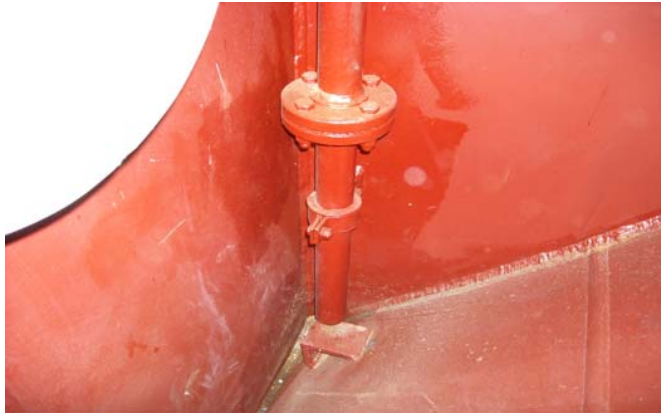
FIGURE 3 - Control Group Void 8-210-9-V

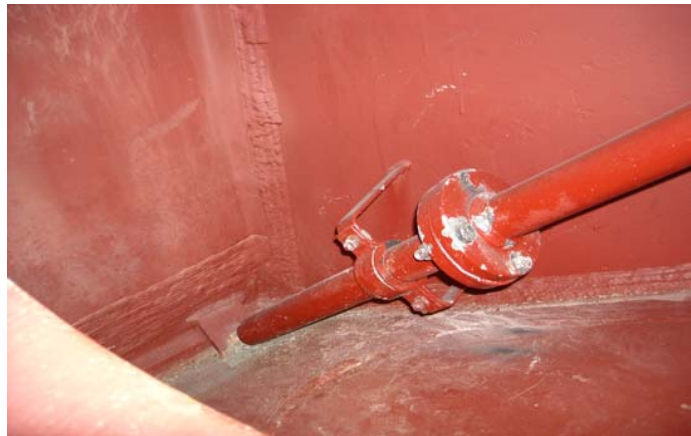
FIGURE 4 - Group F Void, 8-250-5-V showing a coating damaged pipe

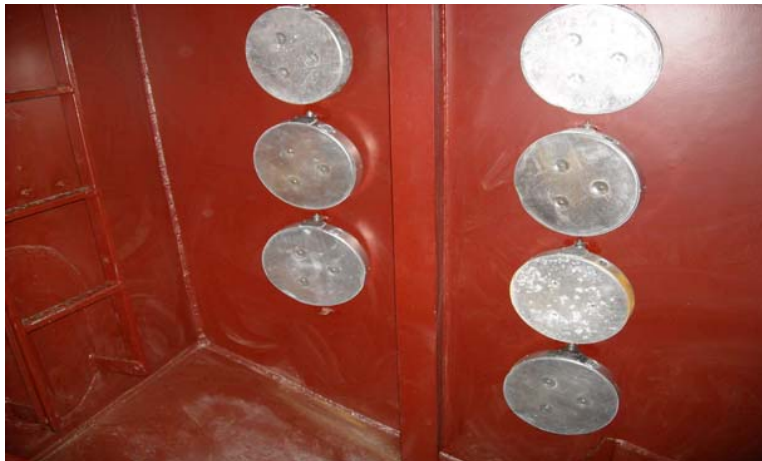
FIGURE 5 - Another View of Group F Void, 8-250-5-V with Regenerated Desiccant Containers

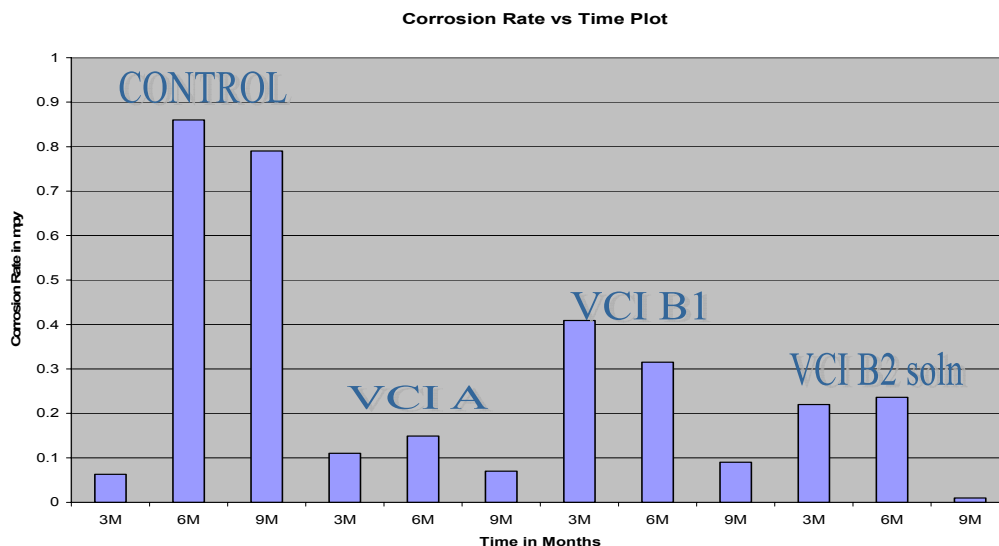
FIGURE 6. Corrosion rates for bare steel coupons removed at different time intervals from four Test Vessels.

Three bare steel coupons were removed from each test vessel after each exposure interval and the average weight loss was determined. The corrosion rates were calculated from the average coupon weight loss data³. The corrosion rates obtained are plotted versus exposure time for coupons removed from each test vessel and are given in Figure 6.

As can be seen in Figure 6, the corrosion rate for control specimens after a 9 month exposure is the highest and that for VCI B2 solution sprayed specimens the lowest. The corrosion rates of specimens exposed to VCI B1 powder are lower than the corrosion rates for control specimens of 6 and 9 months exposure but higher than the corresponding values of specimens exposed to VCI A. One specimen removed after 9 month exposure to VCI A showed one or two corrosion spots (see Figure 8, specimen B19) all other VCI A exposed specimens looked clean and without corrosion. The specimens treated with aqueous solution of VCI B2 had a lower corrosion rate than the specimens exposed to VCI B1 powder. But, both the specimens exposed to VCI B1 powder and VCI B2 solution showed spotty corrosion (Figures 9 and 10). Such spotty corrosion may be attributed to insufficient concentration of the inhibitor to protect the entire surface of the specimens. It is known that for optimum inhibition, the concentration of an inhibitor must exceed a certain critical value. Below this optimum concentration, it increases the corrosion at localized areas⁶. Overall, the results show that although all the VCIs tested are effective in controlling corrosion of carbon steel under a high humidity level of about 95% R.H., VCI A showed the best performance. The VCI molecules from the vapor-phase corrosion inhibitors adsorb on bare steel surfaces under high humidity conditions leading to formation of invisible mono-molecular layers which in turn inhibit or protect the steel surface from corrosion²⁻³.

A slightly lower effectiveness of VCI B1 powder versus VCI A powder may be attributed to the lower dosage of the former. For example, 4g of VCI B1 powder was installed versus 25g of VCI A powder for the same volume of the test vessel. These dosages for VCI application were given by the vendors for their respective products. Though not very significant, the solution spray of VCI B2 showed a slightly better corrosion control than the VCI B1 powder. This is worth noting since the application of solution spray can overcome the difficulties of clogging when a powder VCI is installed with a spreader.

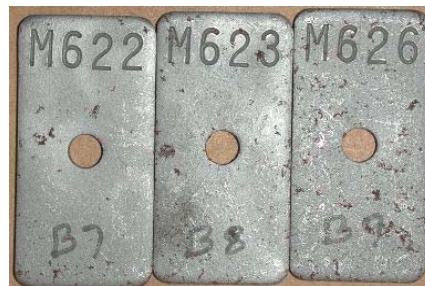
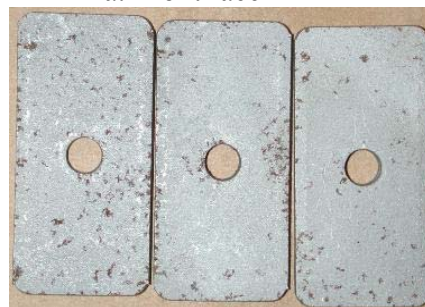
**FIGURE 7 - Control carbon steel specimens after 9 months exposure:
a) front face and b): rear face**

Representative carbon steel specimens taken out after nine months exposure from the control, VCI A, VCI B1 and solution of VCI B2 installed test vessels are shown in Figures 7-10. Bare carbon steel coupons from the control test vessel showed some corrosion spots while those exposed to VCI A powder appear mostly clean with only one or two corrosion spots. However, both the test vessel and specimens exposed to VCI A had a lot of condensation making it slippery to remove the samples. The sides of the test vessel and the specimens were wet. Two reasons were postulated for this condition: (1) VCI A powder mix may contain some desiccants that were saturated and (2) the chemicals in the propriety VCI A powder mix are hygroscopic in nature. Bare carbon steel coupons exposed to VCI B1 powder showed a number of corrosion spots compared to those exposed to aqueous solution spray of VCI B2 and to those exposed to VCI A and control specimens. While VCI B1 powder and VCI B2 solution are from the same vendor, the results show that the effectiveness of VCI B2 solution is slightly better than the VCI B1 powder on bare carbon steel coupons. This supports the earlier statement made at the beginning that a solution spray of a VCI may result in a better corrosion control than VCI powder application. This can be attributed to a more uniform distribution of VCI solution spray than the VCI powder distribution onto steel coupons.

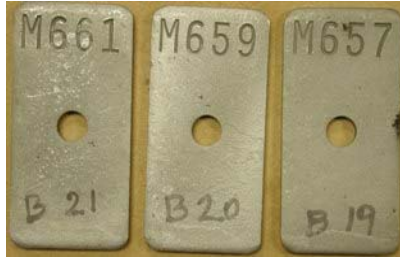
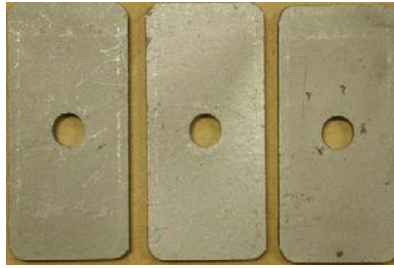
**FIGURE 8 - Carbon Steel specimens after 9 months exposure to VCI A:
a) front face, b) rear face**

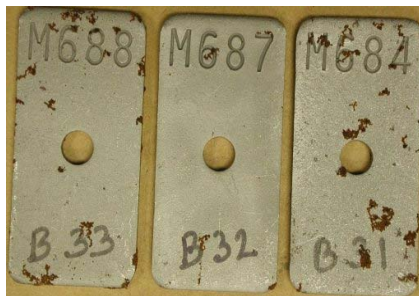
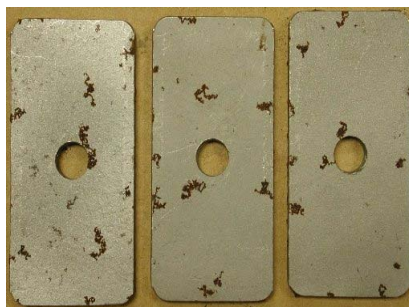
**FIGURE 9 - Carbon Steel specimens after 9 months exposure to VCI B1 powder:
a) front face, b) rear face**

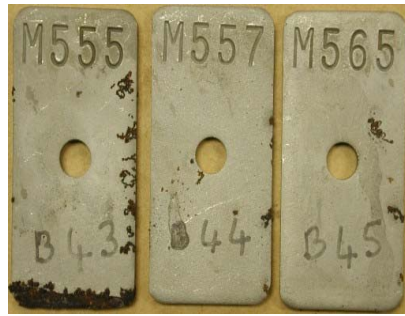
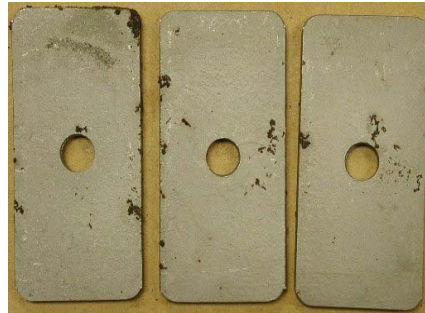
**FIGURE 10 - Carbon steel specimens after 9 months exposure to VCI B2 solution:
a) front face, b) rear face.**

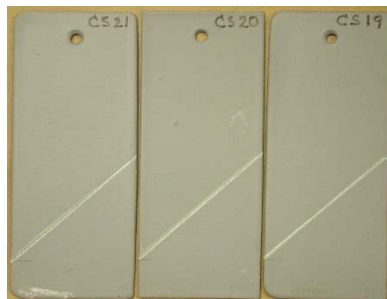
**FIGURE 12 - Coated and scribed steel coupons after 9 months exposure to VCI A showing no
corrosion in the scribes**

Only one of the coated and scribed steel coupons exposed in the control test vessel showed very slight corrosion in the scribes (Figure 11). The coated and scribed carbon steel coupons that were maintained above 95% R. H. did not show any corrosion when exposed to these VCIs for 9 months (Figures 12 and 13).

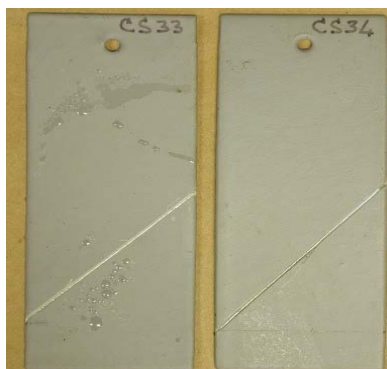
FIGURE 13 - Coated and scribed steel coupons after 9 months exposure to VCI B2 solution showing no corrosion in the scribes

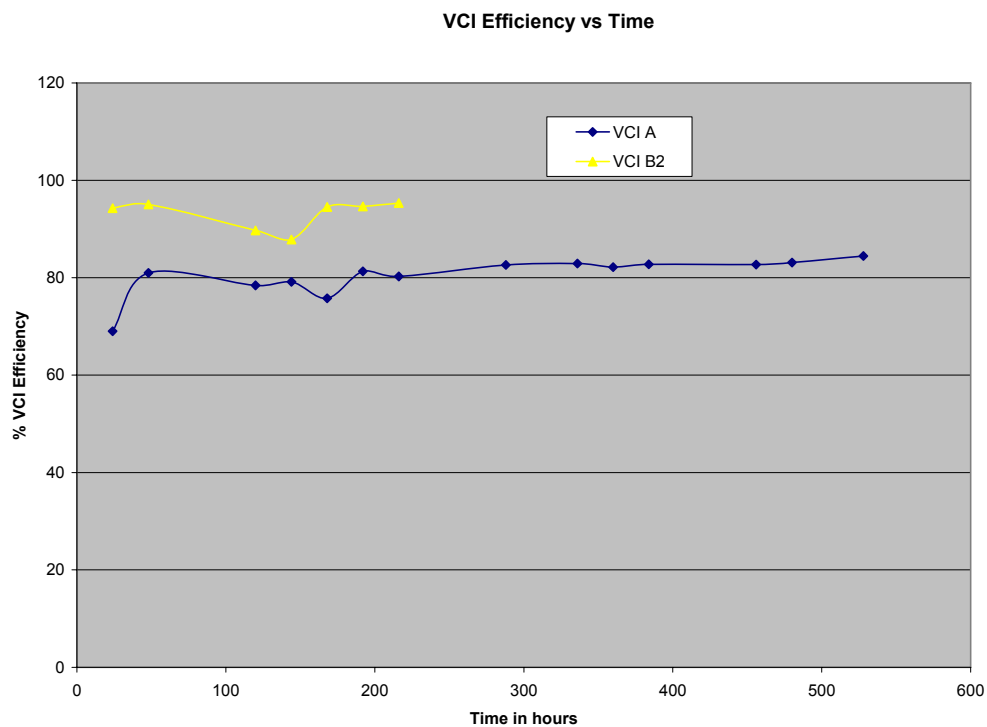
FIGURE 14 - Efficiency of VCI A and VCI B2 versus exposure time in hours

Inhibitor efficiencies were calculated using corrosion rate data obtained by Tafel scan method when 2% VCIs were added to 0.1M NaCl solution. The inhibitor efficiencies of VCI A and VCI B2 in 0.1M NaCl for protecting bare carbon steel specimens are plotted versus time in hours in Figure 14. The efficiency of VCI A was at about 69% after 24 hours and then increases to about 81% in 48 hours, later on maintains its level of efficiency within +/- 3% deviation. The efficiency of VCI B2 starts at a higher level of 94% after 24 hours and maintains at approximately the same level with similar deviation. The efficiency trends of both VCI A and VCI B2 are similar in nature although when VCI B2 was added to 0.1M NaCl solution, it did not form any precipitation while VCI A formed a light red precipitate.
