Rust Converter with Improved Adhesion for Topcoats

Sanja MARTINEZ¹, Boris MIKŠIĆ², Ivan ROGAN³, Antonio IVANKOVIĆ¹

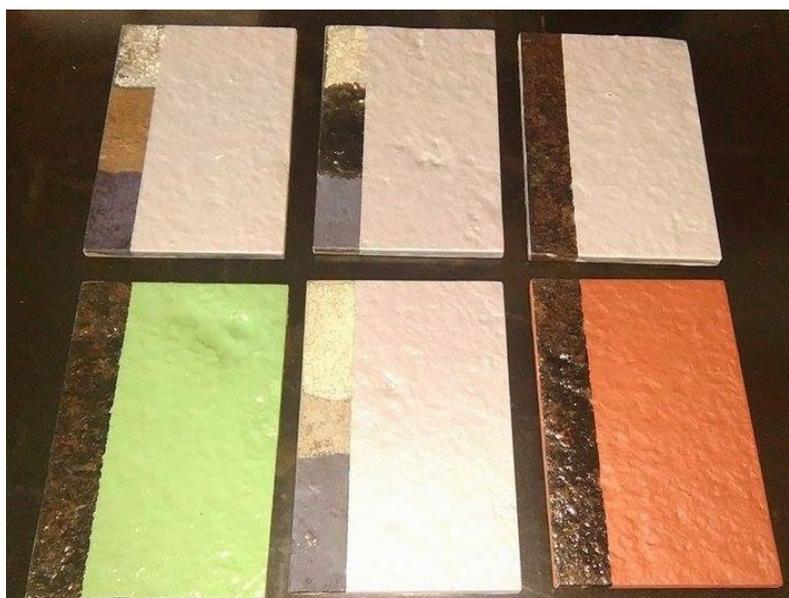
Figure 2. Specimens with applied rust converters and polymer coatings prior to EIS measurements.

DeFelsco PosiTector 6000 with SPG probe was used for measuring surface roughness. One sandblasted and one as received plate, were cut into 10 cm x 15 cm samples. Rusted samples were hand tool cleaned. VpCI CorrVerter and two commercial converters, one tannin based and one phosphoric acid based, were applied to the surface of the specimens according to the instructions of the rust converter manufacturers. The plates were further coated with one layer of epoxy, polyurethane and alkyd coatings, 100 μm in thickness. Coating was done by conventional air spraying, by professional applicators. The specimens prior to impedance measurements are shown in Figure 2,

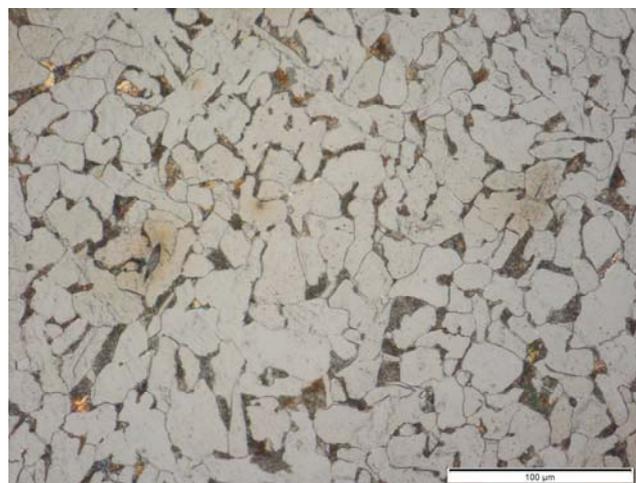
Figure 4. Microscopic image of the metallographic sample prepared from the investigated steel plate.

Figure 4 shows a microscopic image of the metallographic sample prepared from the investigated steel plate. It is readily observed that the steel has ferrite-pearlite microstructure with visible inclusions. Inclusions were further studied by SEM/EDS. Figure 5 a shows the morphology of an inclusion and Figure 5 b, its EDS map.
