Corrosion Testing of Small Metal Bearings

Project #: 13-132-1825.bis

Date: July 25, 2013

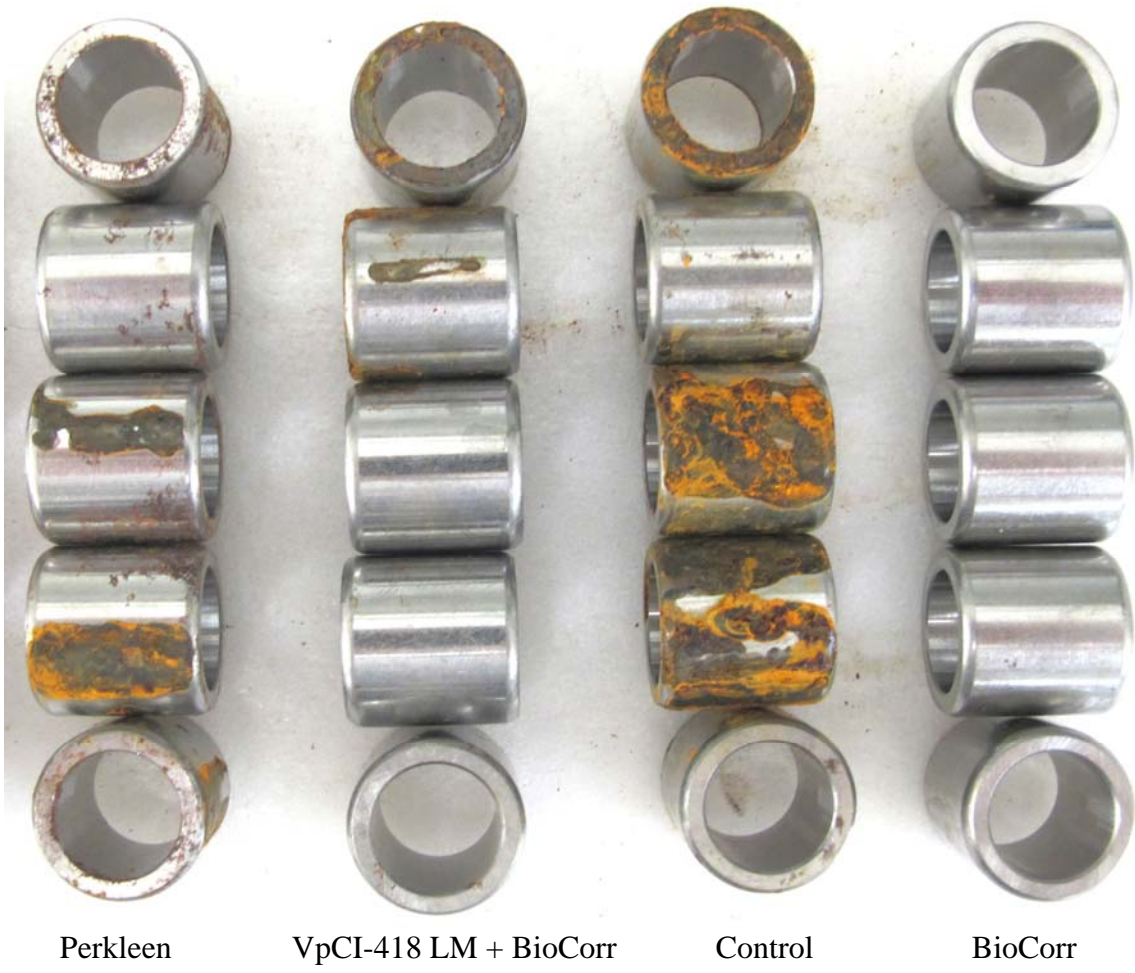
Photos: Taken after 648 hours of humidity testing

Treatment	Time until Failure
Control	24 hours
VpCI-418LM + BioCorr	600 hours
BioCorr	DNF
Perkleen	384 hours

Interpretations: The results show that BioCorr provides the best corrosion protection and there was no improvement by adding VpCI-418 LM as a cleaner before coating in BioCorr. Using VpCI-418 LM may improve corrosion protection in most cases if the parts are not properly cleaned otherwise; however, in this test the parts had already been thoroughly cleaned in methanol.
