***Evaluating Rust Preventive Systems for  
Crankshaft Sections***

**Project #:** 13-156-1825.bis

**Date:** September 26, 2013

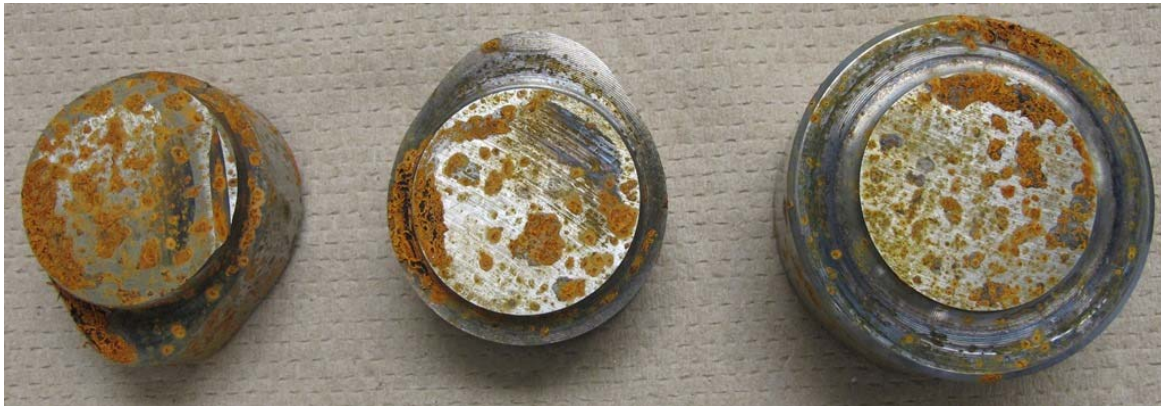
Figure 1: Cinguard 20, BioCorr, and VpCI-329D (left to right) treated parts, after 600 hours of testing. These parts were not wrapped in film for testing.

Product(s) Used	Time to Corrosion (Hours)
Cinguard 20	48
BioCorr	72
VpCI-329D	72
Blue Film (Current)	120
Yellow Film	72
Cinguard 20 + Yellow Film	24
VpCI-126 Blue Film	288
BioCorr + VpCI-126	600
VpCI-329D + VpCI-126	DNF*

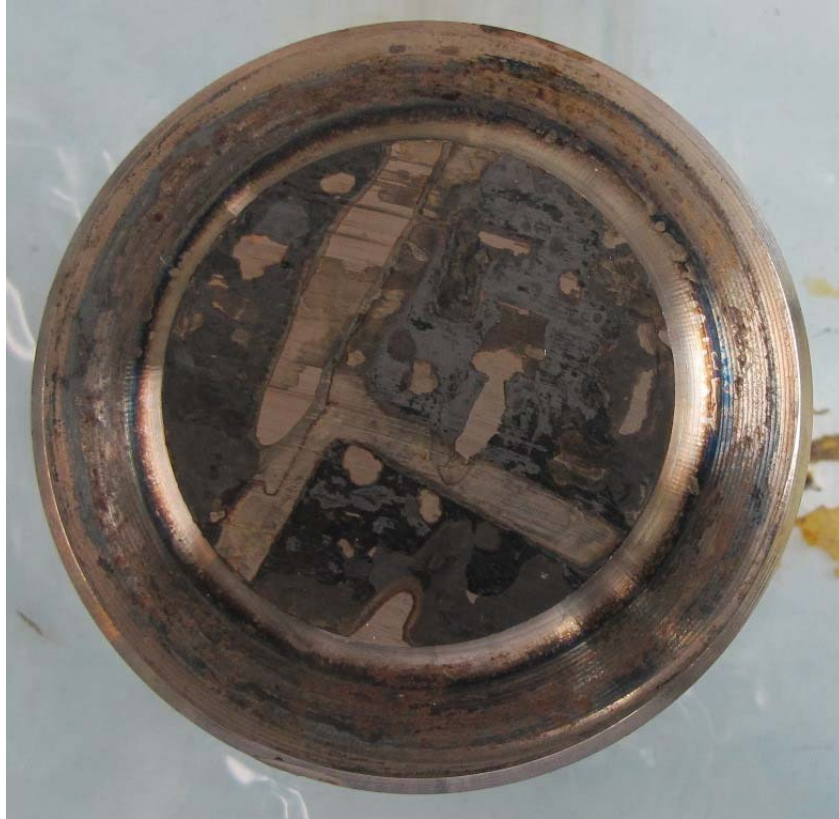
Figure 2: Blue film (current) wrapped part, after 600 hours of testing.

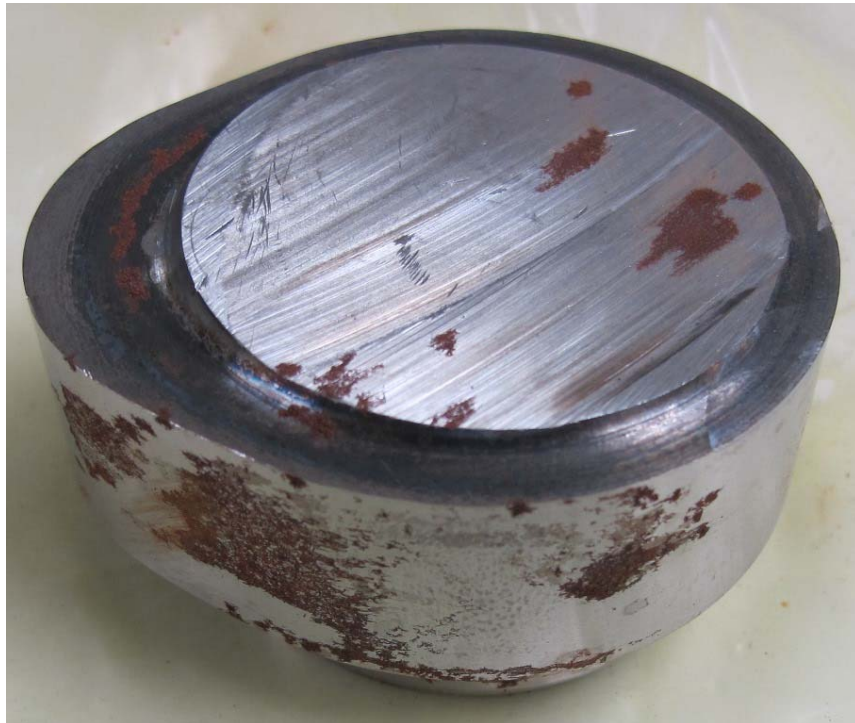
Figure 3: Yellow film wrapped part, after 600 hours of testing.

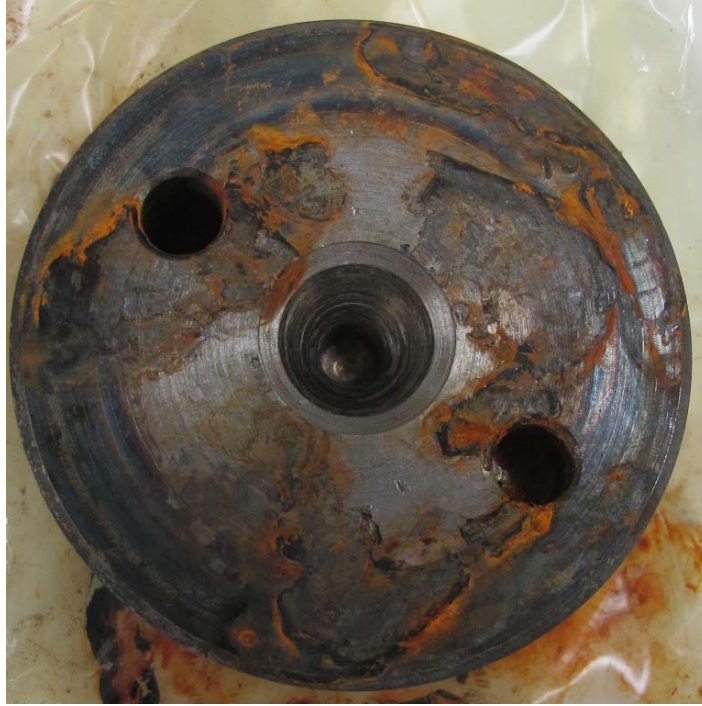
Figure 4: Cimguard 20 + Yellow film wrapped part, after 600 hours of testing.

After 600 hours of testing in ASTM D-1735 water fog conditions, the best corrosion protection system was VpCI-329D and VpCI-126. The system of BioCorr and VpCI-126 provided similar protection. The part treated with Cinguard 20 and packed in yellow film (while the part was still wet) had the most severe corrosion at the end of testing.

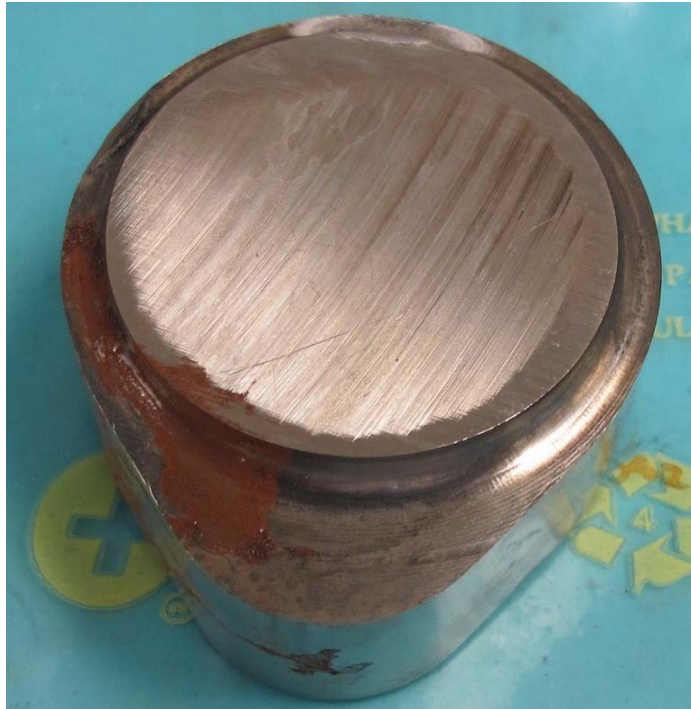
Figure 5: VpCI-126 wrapped part, after 600 hours of testing.

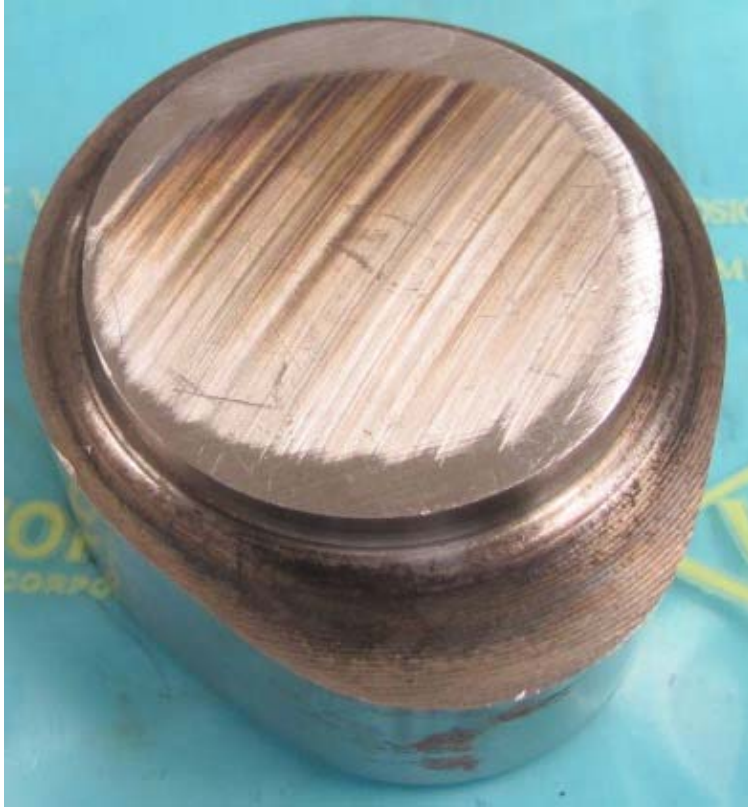
Figure 6: BioCorr + VpCI-126 wrapped part, after 600 hours of testing.

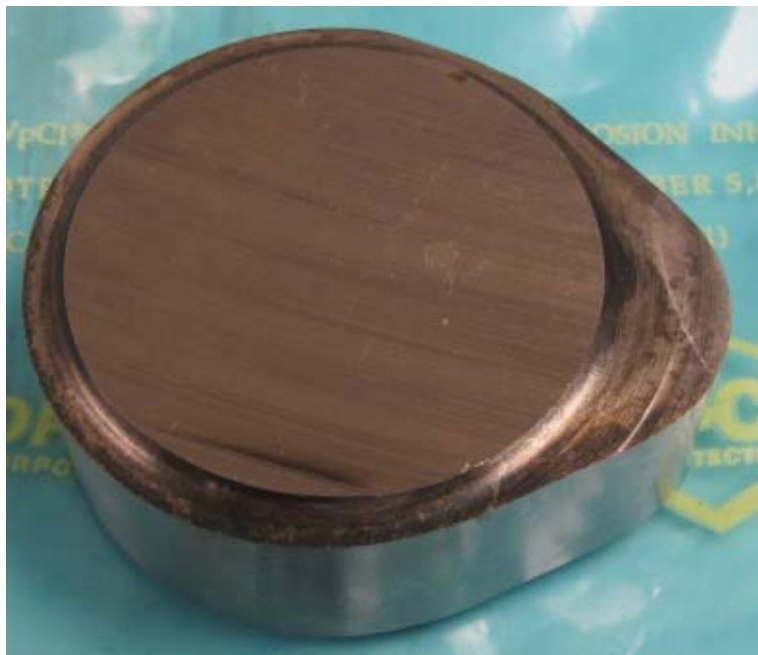
Figure 7: VpCI-329D + VpCI-126 wrapped part, after 600 hours of testing.
