Evaluating the Effectiveness of VpCI-126

Project #: 15-197-1125.bis

Background: Customer wanted testing performed to compare the difference in protection between desiccant and VpCI-126 bags. To evaluate the protection characteristics three bags full of springs were sent to Cortec’s laboratory for accelerated weathering in humidity chambers.

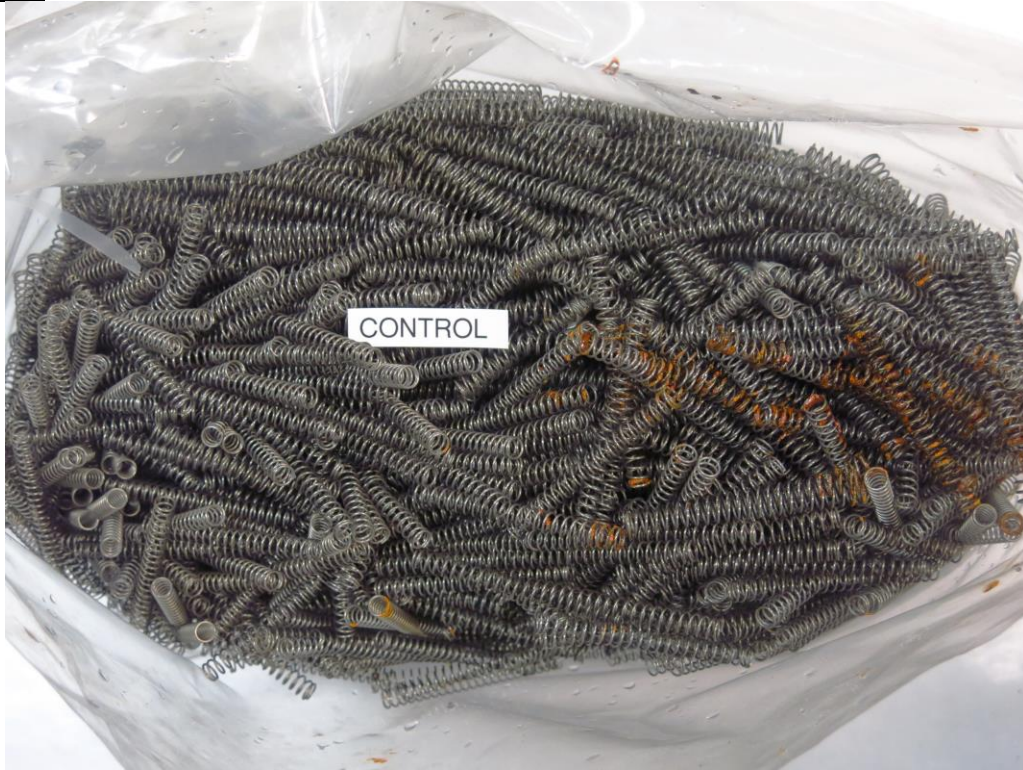
Photo 1: The control bag after 2300 hours of humidity testing

Protection Method	Observations
1	4-mil PE	Rust was first noticed on 10/22/15 (bottom of bag) Majority of rust was found on top at the end of testing
2	4-mil PE + Desiccant	Moisture on the bag obscured the corrosion until the end of the test. Rust was only seen on the top of the springs.
3	VpCI-126	No corrosion

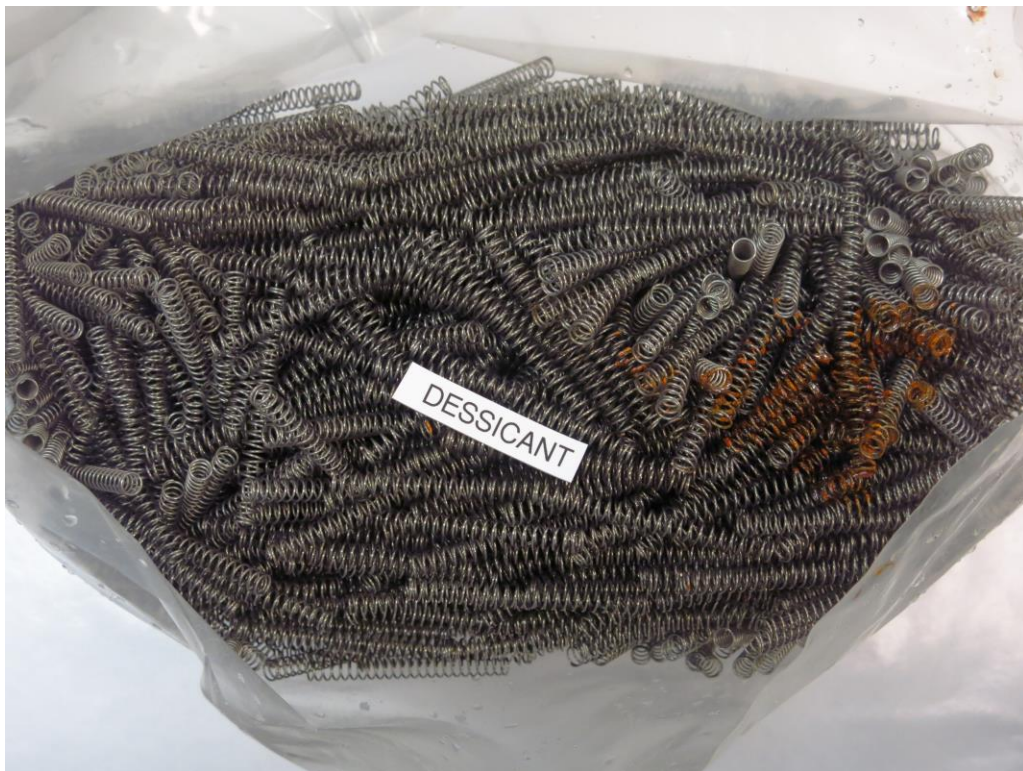
Photo 2: The desiccant bag after 2300 hours of humidity testing. Desiccant was located on the bottom of the bag.

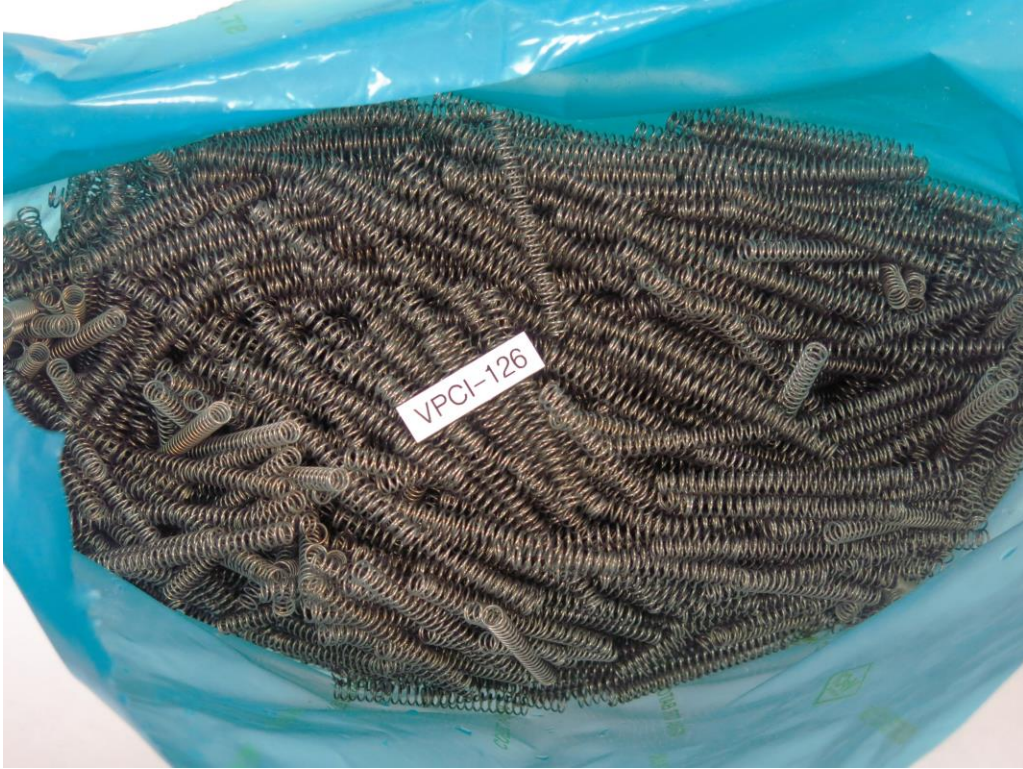
Photo 3: The VpCI-126 bag after 2300 hours of humidity testing

The results of this test show that VpCI-126 provides superior protection over the amount of desiccant used in this test. Where desiccant eventually becomes saturated with moisture, the active protection within the VpCI-126 bag will maintain protection even in the presence of moisture.

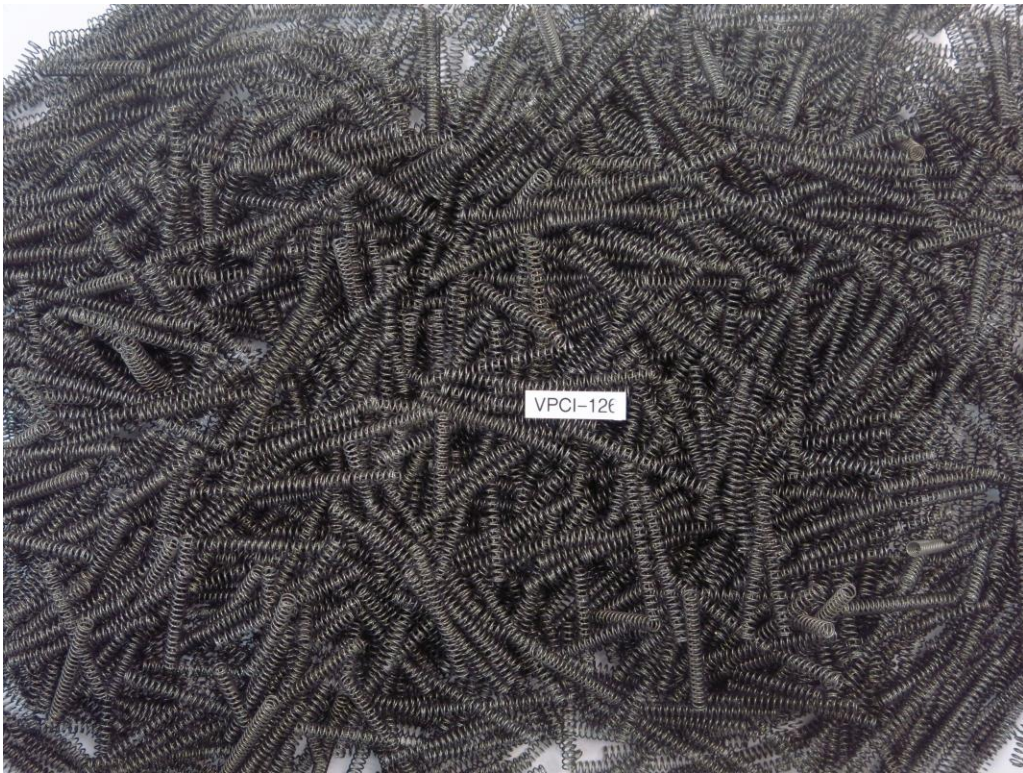
Photo 4: The VpCI-126-protected springs after 2300 hours of humidity testing. Springs were removed from the bag to inspect for any signs of corrosion which may not have been apparent from initial inspection.
