Evaluating Packaging and Corrosion Prevention Options for Components

Project #: 16-274-1825.bis

Method: Humidity Chamber Testing (ASTM D-1735 Conditions)

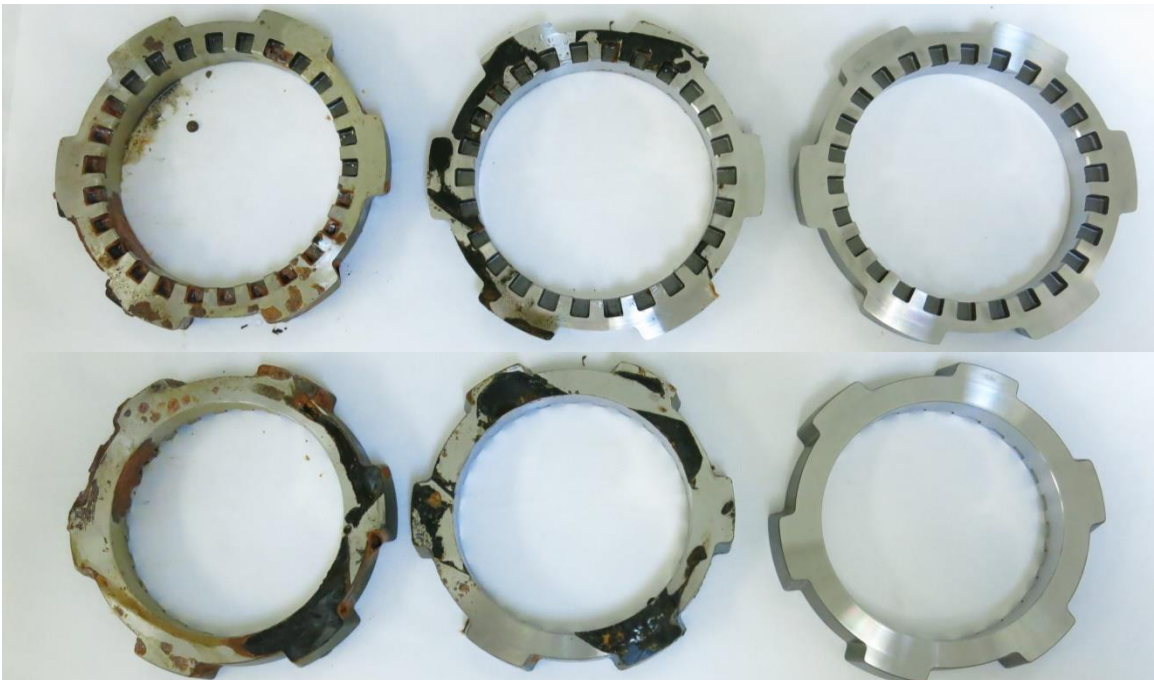
Picture 4: Small Locking Plates – Turned, from left to right: Control, ZeRust Paper, Cortec VpCI-126 film + VpCI-146 paper.

All control parts, tested without rust preventative, failed in less than 24 hours, as expected in the accelerated corrosion conditions of ASTM D-1735. While the protection of parts was extended using the ZeRust ExCorr paper, without a sufficient moisture barrier the paper soon became saturated with water. Once saturated, moisture being held on the surface of the parts promoted corrosion, causing significant failure. Though the onset of failure was delayed, significant corrosion developed as a result of the constant contact with the saturated paper. Parts packaged in Cortec's recommended packaging system (VpCI-146 + VpCI-126) should show significant improvement over other packaging systems tested, where no rust developed over the 500 hours of testing.

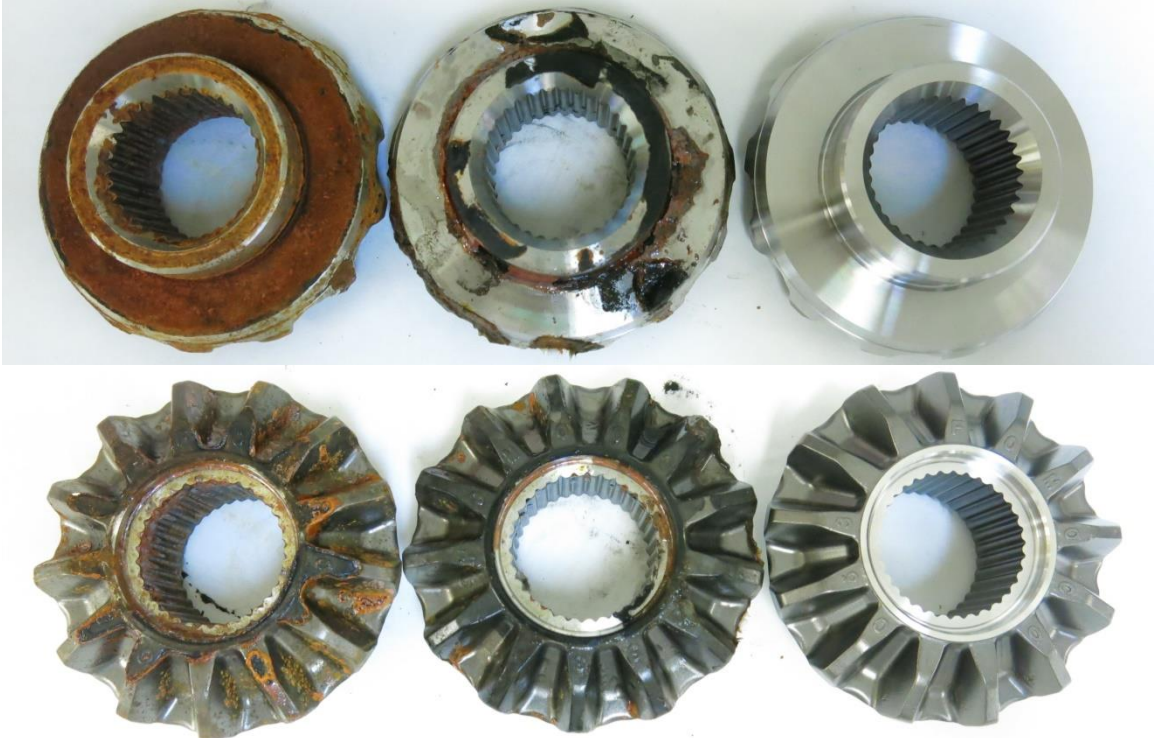
Picture 7: Side Gears – Turned, from left to right: Control, ZeRust Paper, Cortec VpCI-126 film + VpCI-146 paper.

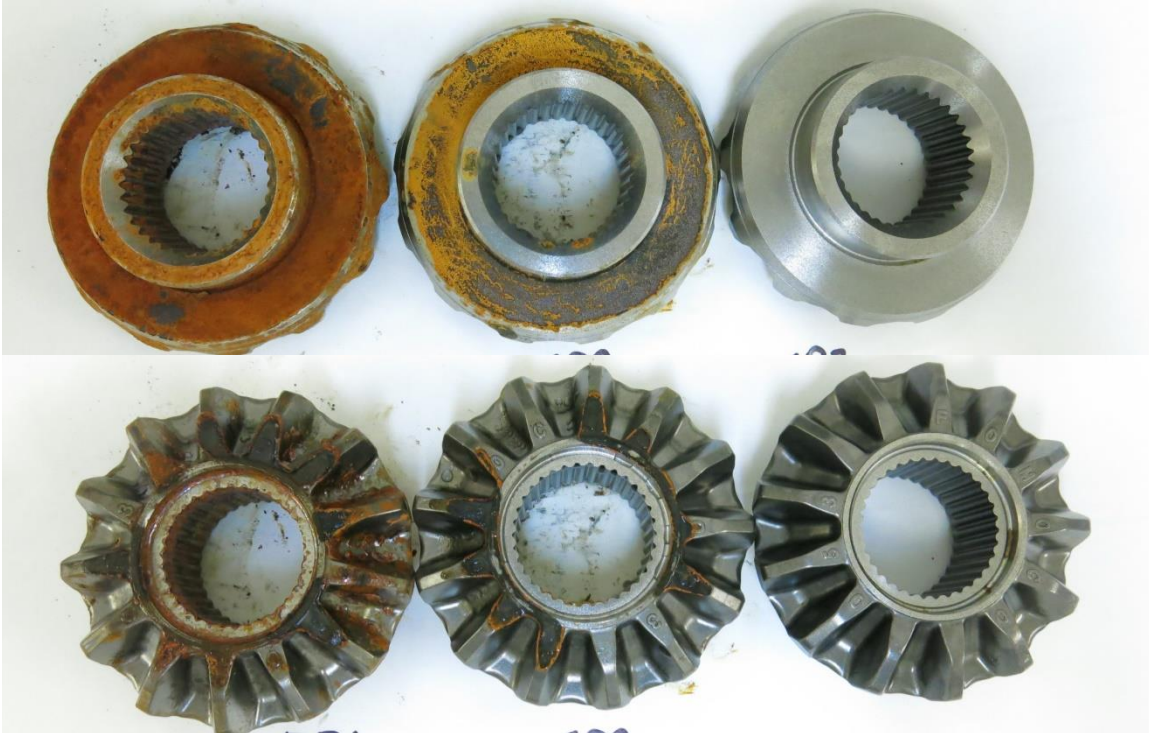
Picture 9: Side Gears – Rust Preventative, from left to right: Compound RP-99S, BioCorr, BioCorr + VpCI-126 bags + VpCI-146 paper.

In humidity testing BioCorr Rust Preventative outperformed Madison Chemical's Compound RP-99S by both delaying the onset of corrosion and limiting spread of corrosion after onset. As with parts not protected with BioCorr, the addition of VpCI-146 paper and VpCI-126 bags proved to be an effective packaging method, preventing corrosion on almost every test part.

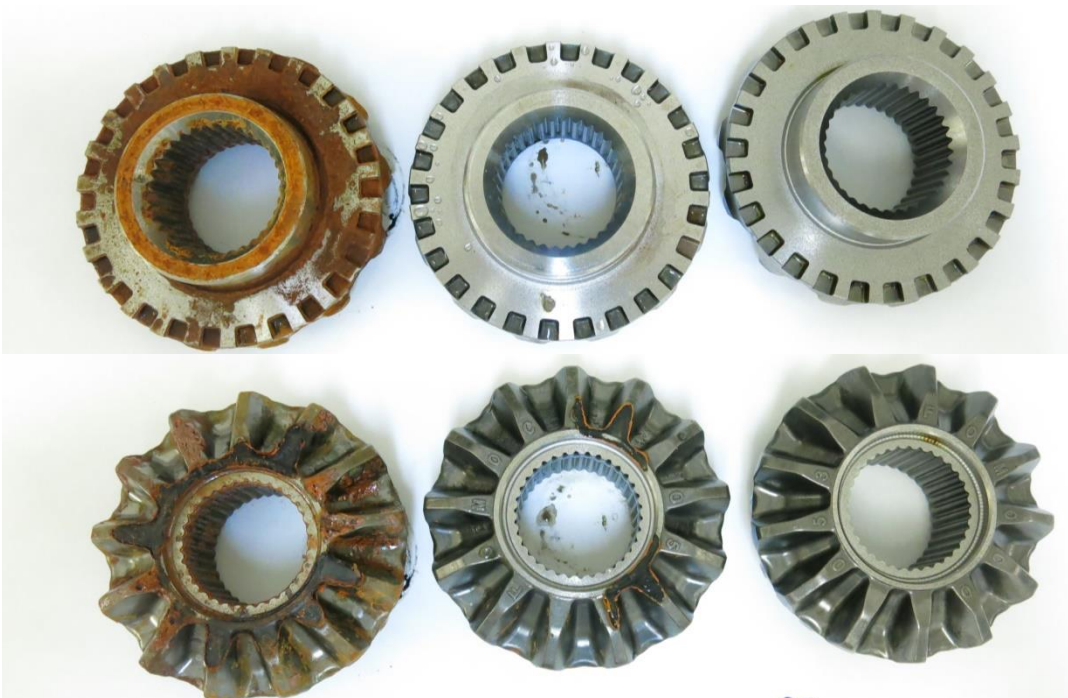
Picture 12: Locking Side Gears – Rust Preventative, from left to right: Compound RP-99S, BioCorr, BioCorr + VpCI-126 bags + VpCI-146 paper.

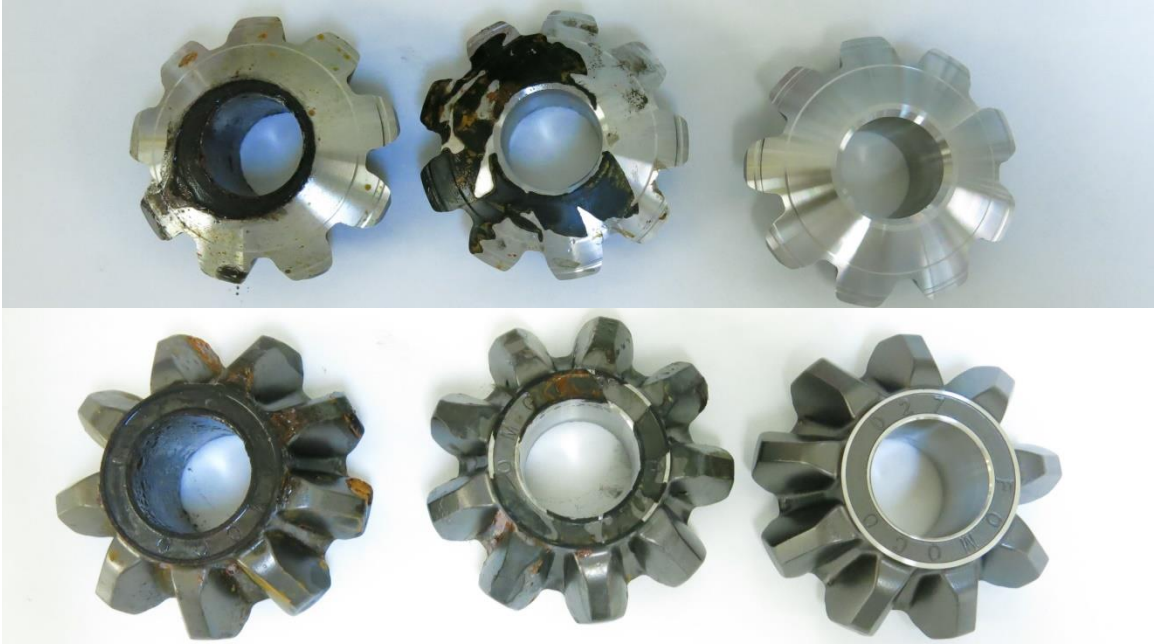
Picture 13: Pinions – Turned, from left to right: Control, ZeRust Paper, Cortec VpCI-126 film + VpCI-146 paper.
