NEWS ALERT

Caisson Legs on Offshore Platform Protected with a Vapor Corrosion Inhibitor

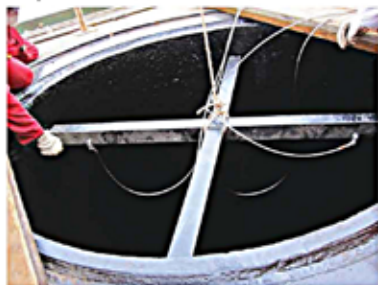
Steel frame setup for suspending VCI pouches.

A pilot study, discussed in CORROSION 2014 paper no. 4200, "Protection of Offshore Platform Caisson Legs with a Vapor Corrosion Inhibitor—A Case Study," by T.A. Rahman Al-Sayed, A.F. Eid, M.M. Al-Marzooqi, and U. Jacir, was then conducted to evaluate the use of vapor corrosion inhibitors (VCIs) to protect the integrity of the structure. Treatment started by spraying the internal diameter of the leg with a water-based solution containing a VCI with a biocide treatment. This was followed by fogging the internal space with an amine carboxylate VCI. Finally, a string of pouches containing VCI powder was suspended on hangers to assure continuous saturation of inhibitor in the space. Corrosion coupons were installed 6 m below the manhole before closing it. The corrosion coupons were retrieved and evaluated at different time intervals.
