# CASE HISTORY

## Gas Station Fuel Tank Sump Restoration

Los Angeles, CA

August 2017

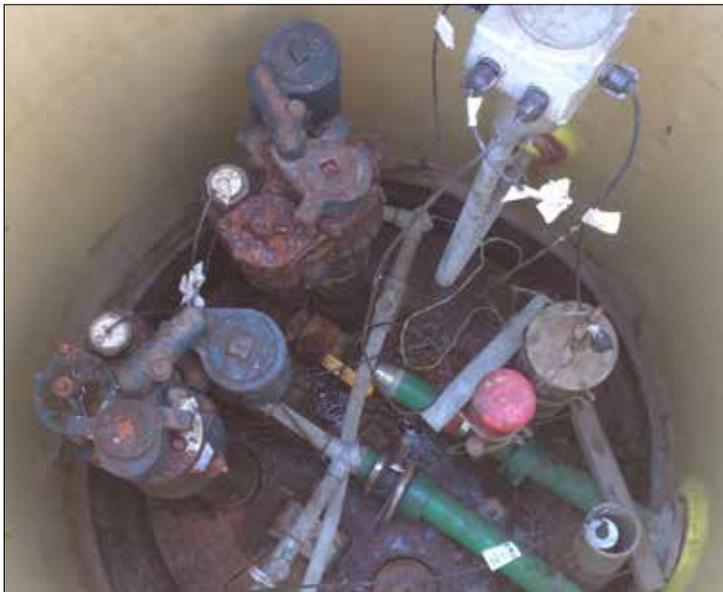
Rusty sump at first station before treatment.

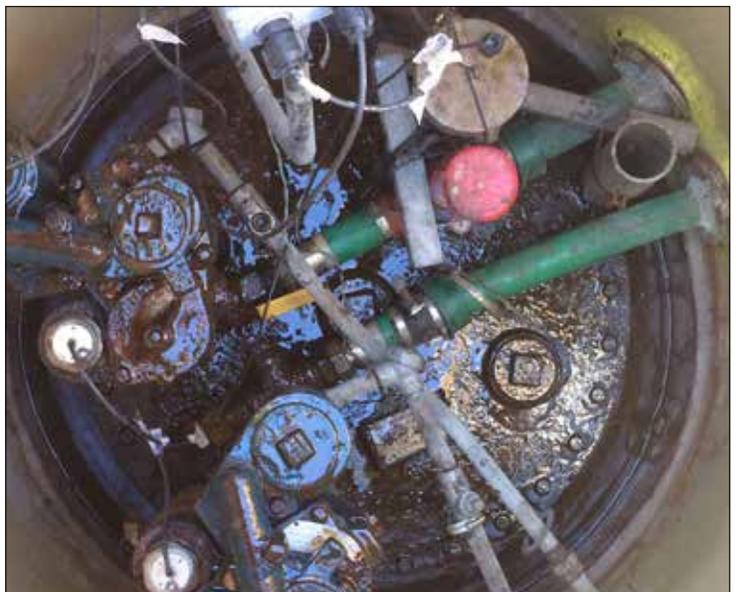
VpCI®-423 soaking on rusted parts.

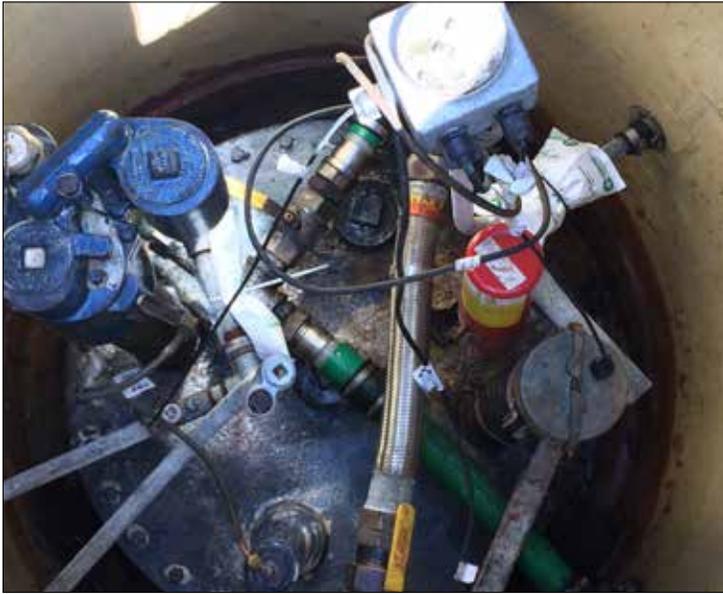
Cleaned, coated, and VpCI® treated sump at first station.

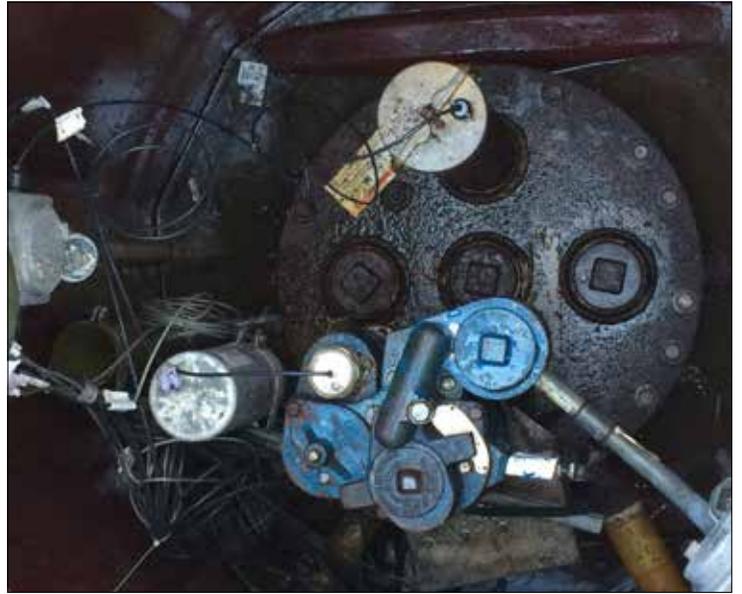
Rusty sump at second station after initial power wash

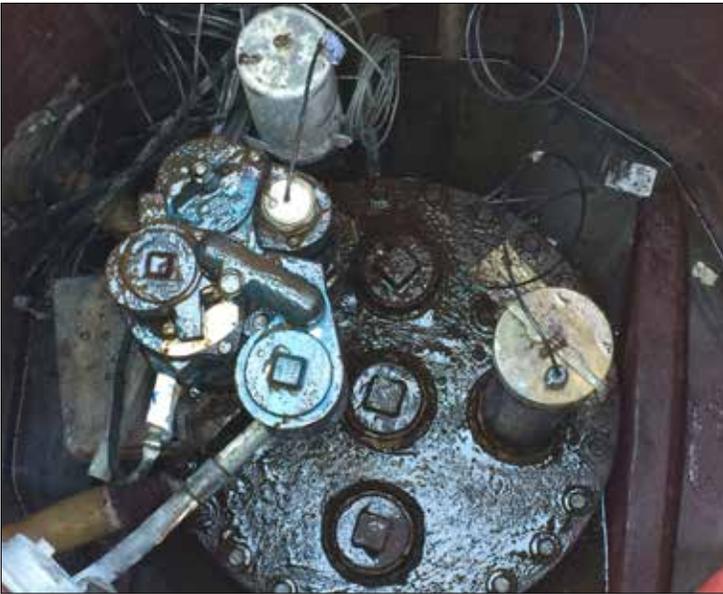
VpCI®-423 soaking on metal parts for rust removal.

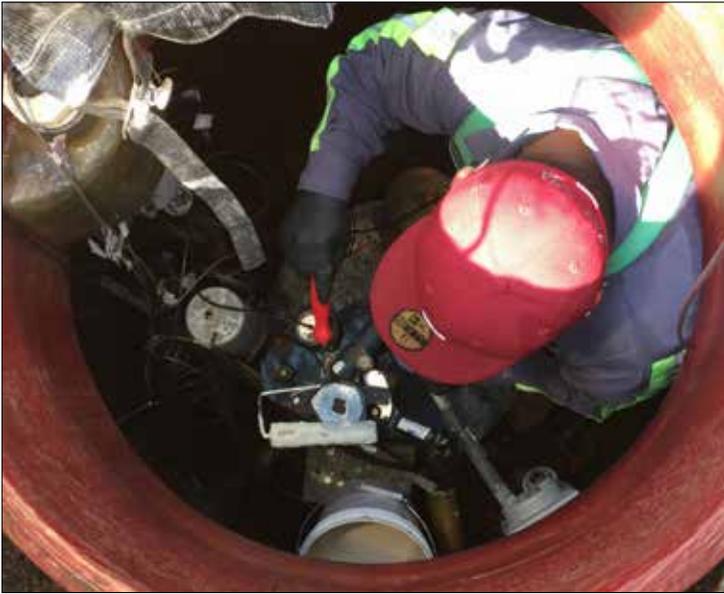
Coating components with VpCI®-391.

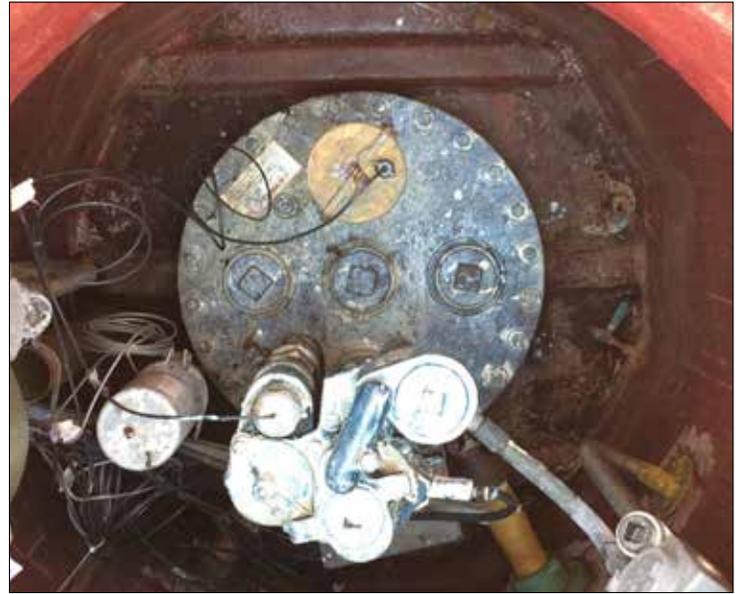
A cleaned sump coated with VpCI®-391.

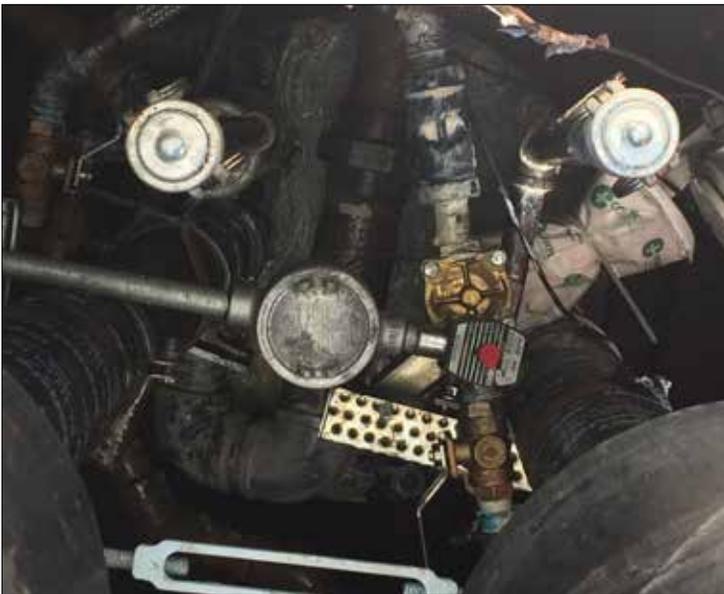
A cleaned and coated sump with a VpCI®-308 pouch tied in to saturate the space with vapor phase corrosion inhibitors for extra protection.
