## **Mitigating Soil-Side Corrosion on Crude Oil Tank Bottoms Using Volatile Corrosion Inhibitors**

### **ABSTRACT**

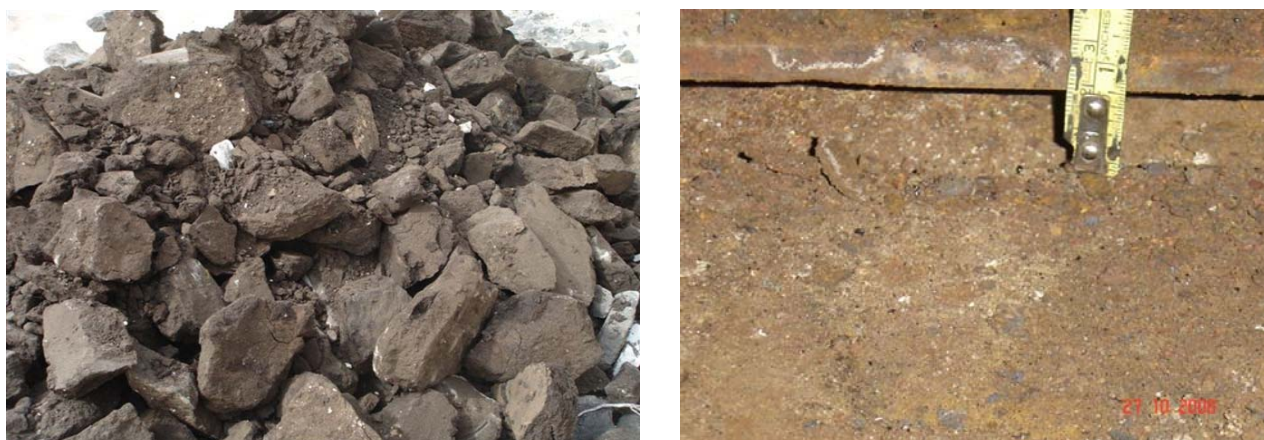
**Figure 1: Oily sand excavated from below floor plates; air gaps (5-50 mm) under floor plates.**

For many years throughout the entire Middle Eastern region it has been a common practice for most operators to construct AST floors on tank pads consisting of thick layers of bituminous (oily) sand. The formula for the mixture and the thickness of the oily sand varies throughout the region. Research indicates that the sand contains varying levels of chlorides and moisture. The research also indicates frequent challenges controlling corrosion on the soil side of the tank floors<sup>2 3</sup>. The Yu paper<sup>1</sup> concluded that many corrosion issues are likely related to the inability of cathodic protection (CP) current to flow through the oily sand and effectively distribute throughout the tank floor plate surface. The oily sand presents a high resistance barrier to flow of CP current to the tank floor. Numerous air gaps between the oily sand surface and the tank floor surfaces also negate CP effectiveness, Figure 1. The paper<sup>1</sup> recommended that vapor phase corrosion inhibitors should be injected into the gaps under tank bottoms to mitigate the severe soil-side corrosion as a supplement to the existing CP system.

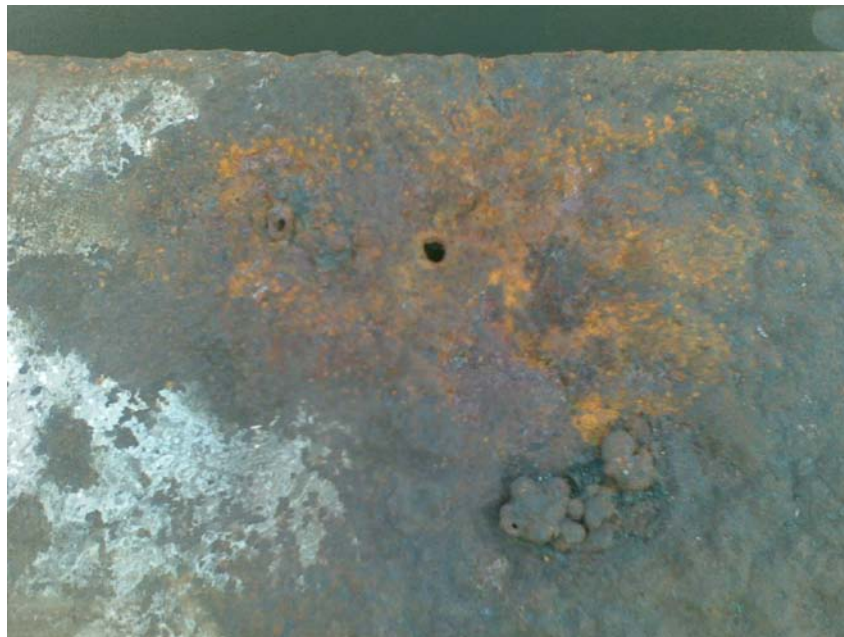
**Figure 2: Soil-side corrosion on pilot project floor plate.**

Unlike some of the past floor inspection reports at this facility, the report from the floor inspection identified corrosion in the 6 meter area but also significant random corrosion under many plates throughout the entire floor. Figure 2 provides an example of severe soil-side corrosion on this tank. Figure 3 identifies the different degrees of corrosion from the tank floor inspection report. The inspection results coupled with the existence of the grout under the floor plates caused the project to be revised. The scope of work was modified to include application of VCI chemistry under all plates that had experienced corrosion – not just the plates in the 6 meter perimeter area.

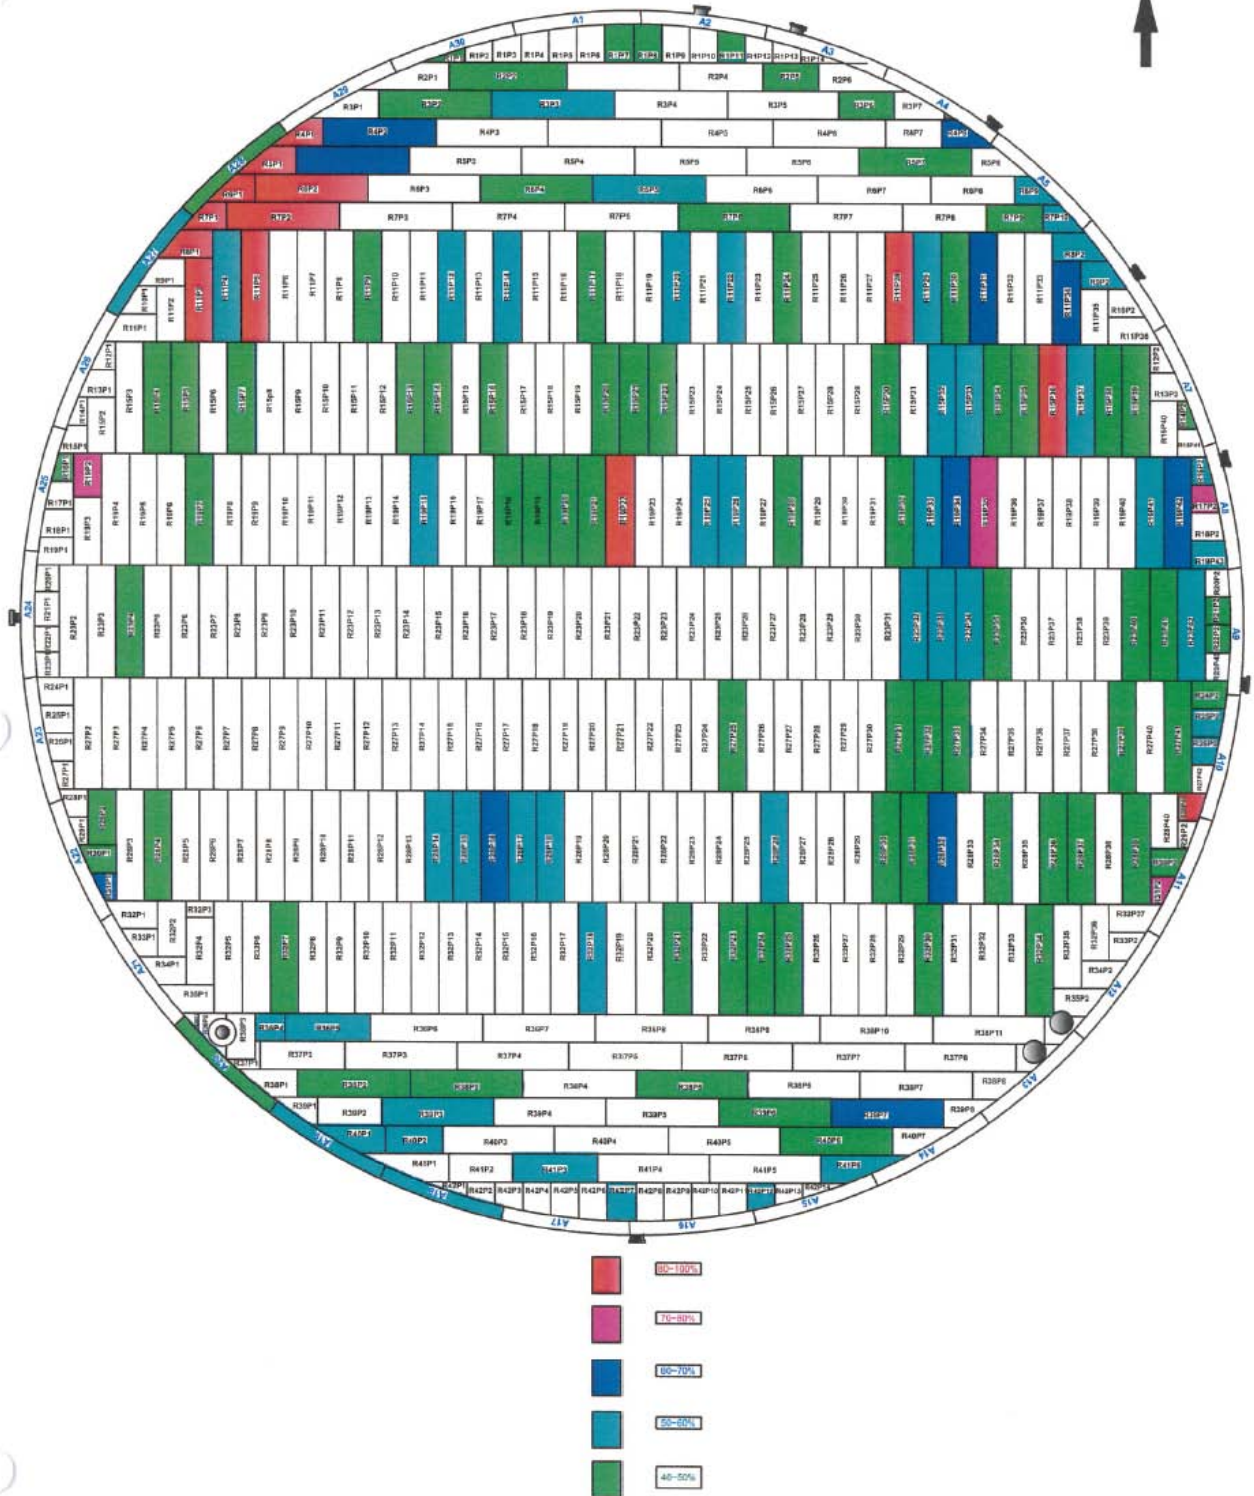
# Floor Inspection Results Pilot Project Tank

**Figure 3: MFL floor scan results for VCI pilot project tank.**

The corrosion rate monitoring system was installed per the original design. The system was installed 2 months prior to the application of the VCI. The locations of the ER probes were chosen by using the MFL scan drawing to identify the area where severe corrosion was noted and the floor plates were not going to be replaced, Figure 7.

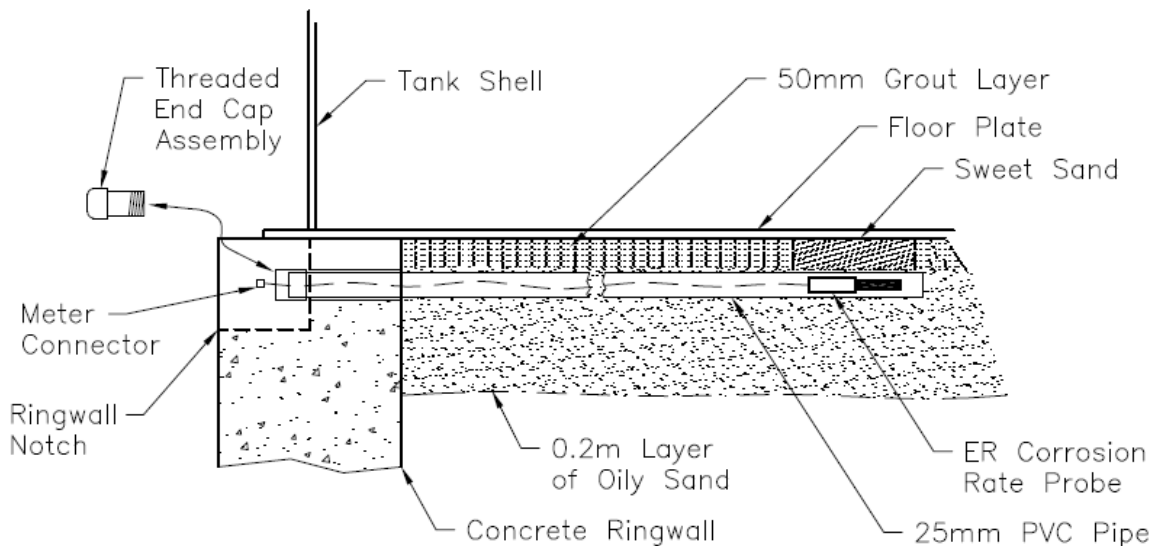
**Figure 4: Typical ER probe installation with grout removed above probe location.**

The floor plate was cut-out above the end of four PVC pipes and the cement grout was removed. Sweet sand was backfilled over the PVC pipe in the ER probe locations, Figure 4. Two of the probes were installed inside slotted PVC pipe located beneath the grout. The floor plate was not removed above these installations, Figure 5.

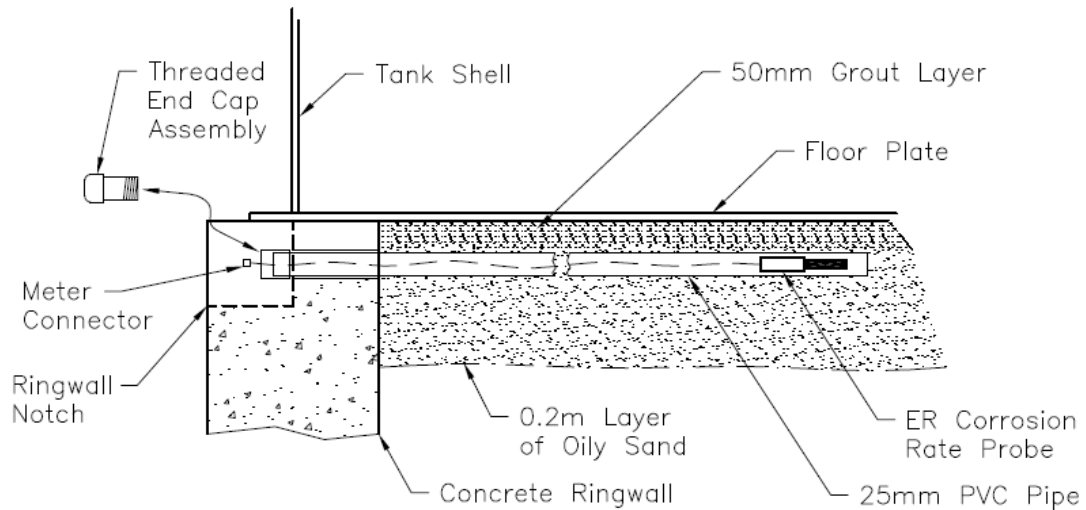
**Figure 5: Typical ER probe installation without grout removed above probe location.**

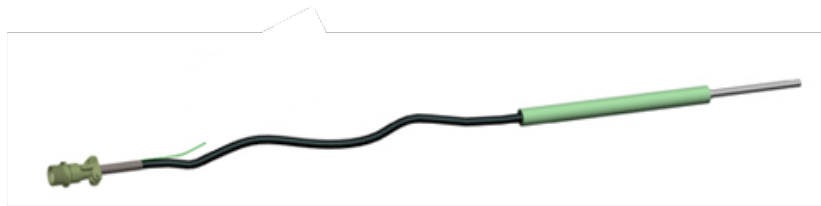
**Figure 6: ER corrosion probe used for pilot project.**

The ER probe chosen for the project is depicted in Figure 6. This probe configuration was chosen for compatibility with the PVC access pipes installed immediately under the floor plates. Data from the probes was obtained by connecting to a meter supplied by the probe manufacturer.

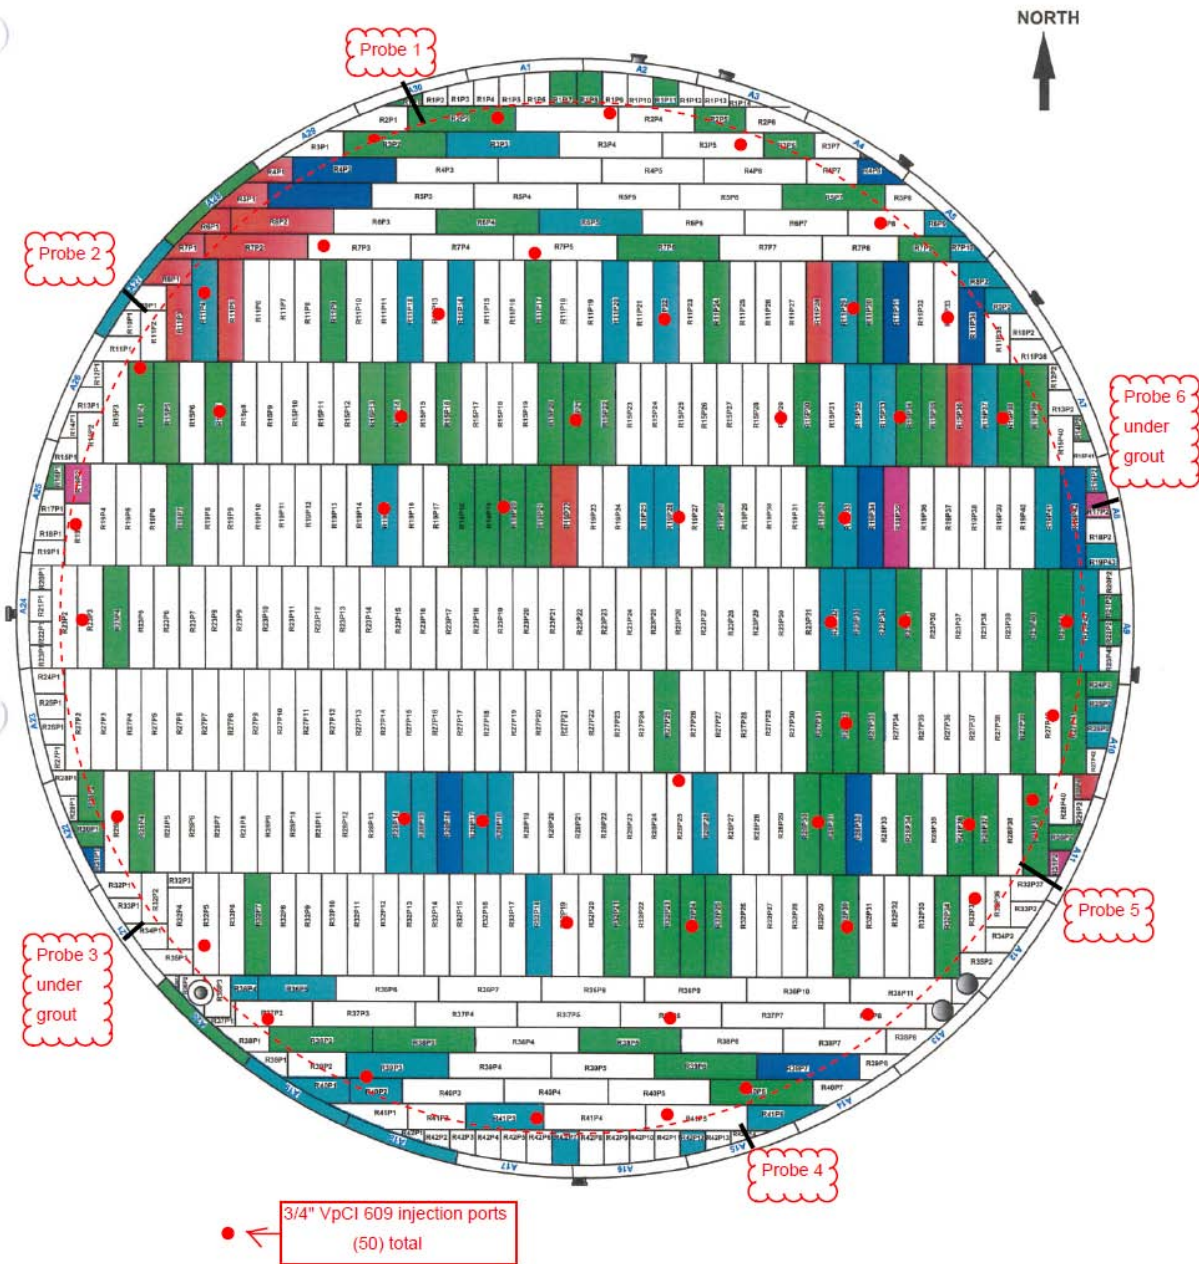
Figure 7: Plan view with ER probe and VCI injection port locations.

A combination of two methods for delivery of both a liquid and a powder VCI were originally specified. The revised plan included injection of VCI powder only through (50) x 20 mm threaded temporary injection ports in the floor plates. The design addressed the 6 meter perimeter floor plate area; and also includes the interior floor plates where corrosion was identified on the MFL Report, Figure 7. Pneumatic equipment was used to effectively distribute 9.5 kilograms of VCI powder through the temporary injection ports under the floor plates a minimum 10 meters in all directions. Steel plate patches were welded over each port after the VCI applications were completed.

The ER probes were located (2 to 4) meters inside the tank perimeter because that was the historical location of the most severe corrosion on ASTs at this facility. Note the proximity of the VCI injection ports to the ER probe locations in Figure 6. The VCI injection ports were not close to the probes. The ports were 6 to 10 meters away from the probes and outside of the concrete grout layer. This design enabled the project team to evaluate the VCI overall effectiveness and molecular distribution through the very dense oily sand and the cement grout applied under the perimeter floor plates, Figure 9.

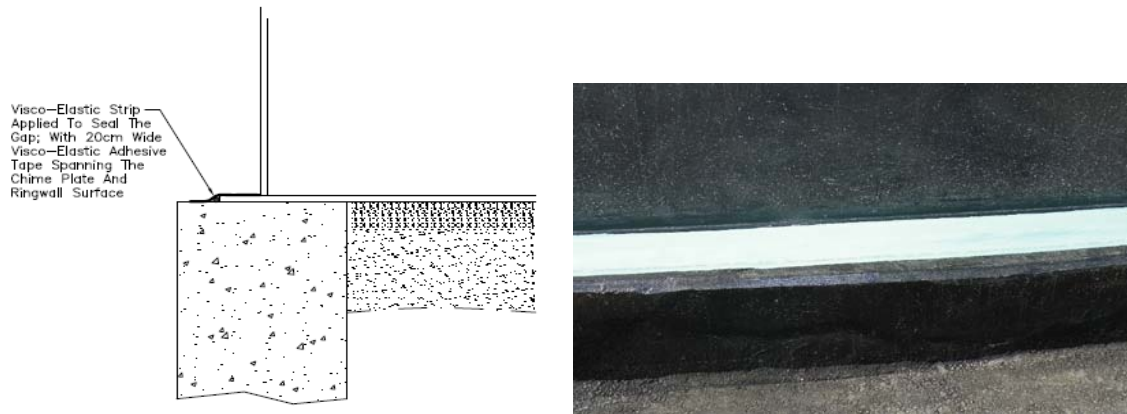
**Figure 8: Annular plate seal detail and photo.**

After proper surface preparation, a special visco-elastic sealant paste was to be applied into the gap between the annular plate and the ringwall. Next an adhesive visco-elastic tape was applied spanning the annular plate and ringwall surface, Figure 8.

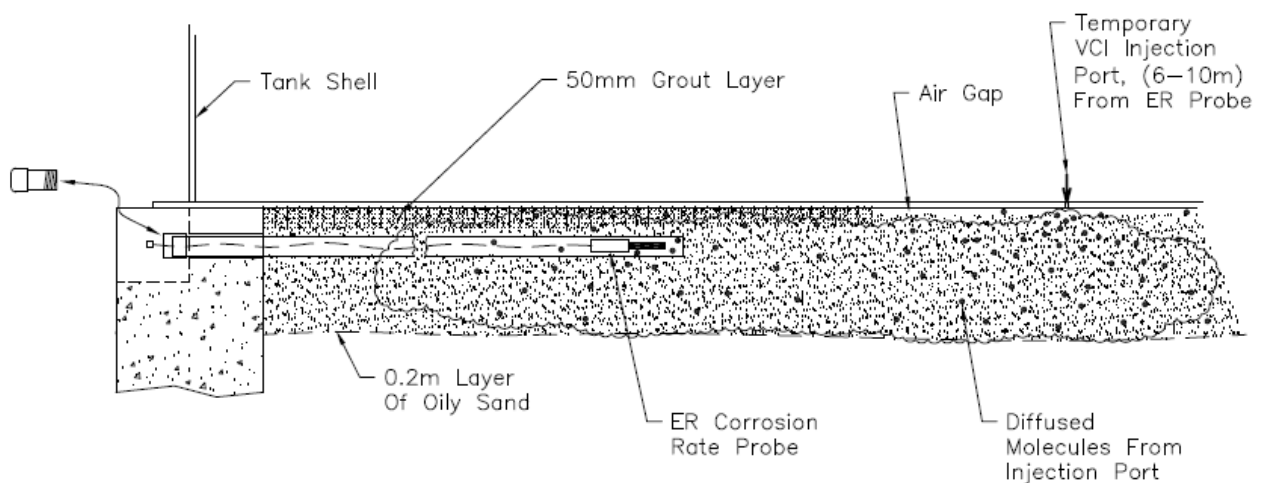
**Figure 9: Molecular distribution of the VCI through the undertank environment.**

This data clearly defines the effectiveness of VCI chemistry in mitigating corrosion within the very difficult environment under aboveground storage tanks. It is significant to observe Figure 9 and note the challenges for effective molecular distribution through the oily sand and cement grout. The project team considers the project a success based upon the initial data.
