**Utilizing Temperature and Humidity Sensors to Understand the Environmental Conditions of Export Packaging, and Utilizing this Data in Developing Corrosion Prevention Strategies**

**ABSTRACT**

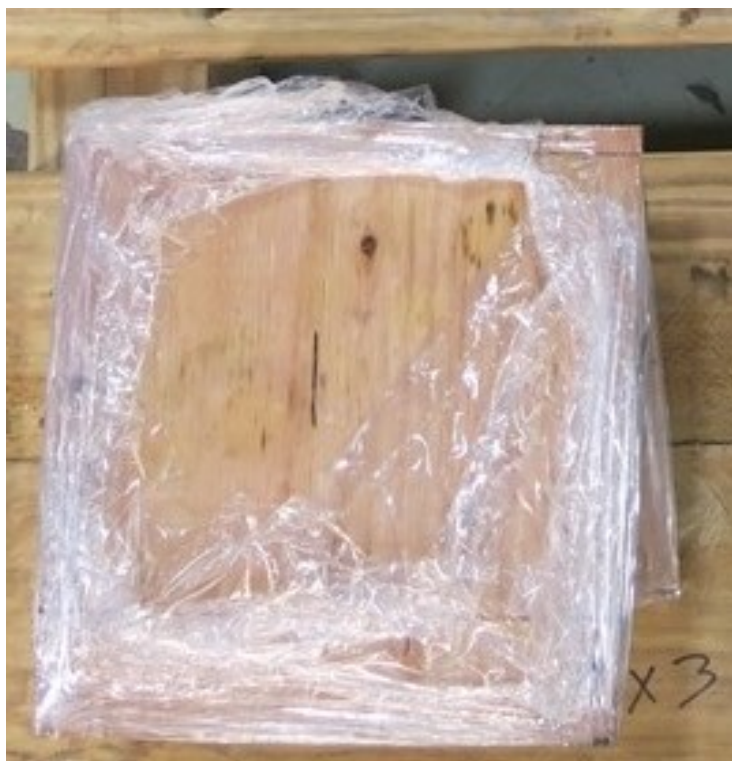
**Figure 1: Wrapped gear component prior to testing.**

This system was compared to the current, control system, as described above, with a single gear component in each pack (Figure 1).

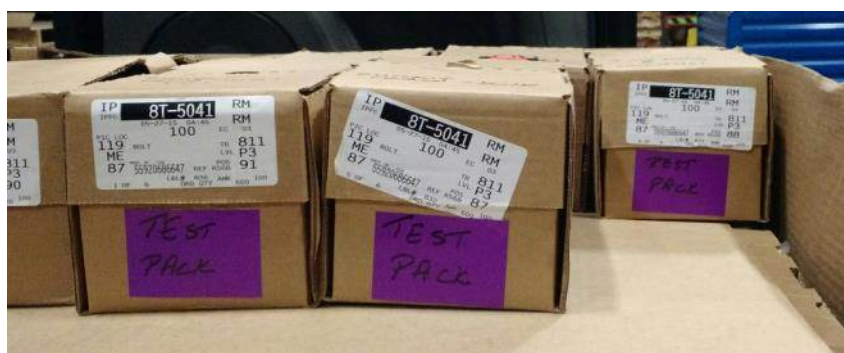
Figure 2: Boxes of parts stacked, prior to shipment.

The first real world analysis involved a shipment of metal components from Illinois, USA to China. The process involved packing machined parts in small boxes. Each box was lined with 50 micron non-VCI PE film, and within this film, parts were wrapped in VCI paper. Boxes were then bulk packed onto a pallet (Figure 2). The entire pallet of boxes would then be enclosed with a non-VCI PE shrink film. This system was compared to a second, less labor-intensive system, whereby the boxes were lined with VCI barrier paper, but no secondary bag. The entire pallet was covered with a non-VCI PE bag (Figure 3). Within each pack, a temperature and humidity sensor was placed in one box (Figure 4). Conditions were logged for the duration of the 51 day shipment process.

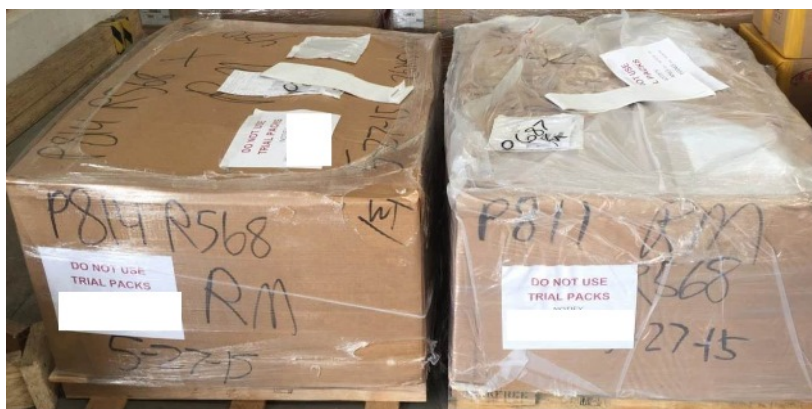
Figure 3: Test packs, prior to shipment. Shrink wrapped pallet on the left, PE liner and bag on the right.

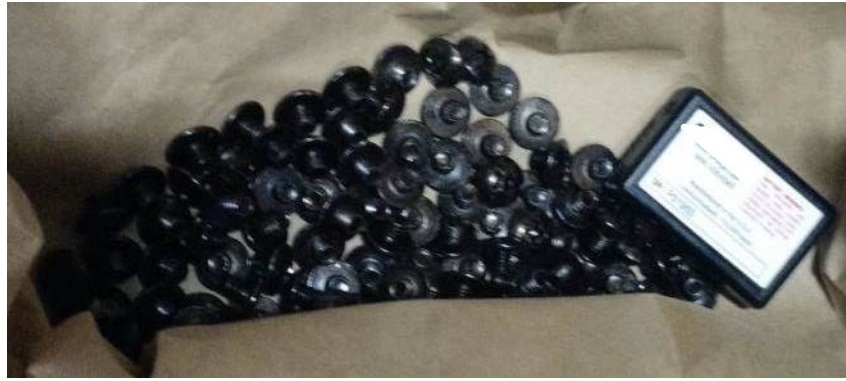
**Figure 4: Boxed parts prior to shipment, with sensor in place.**

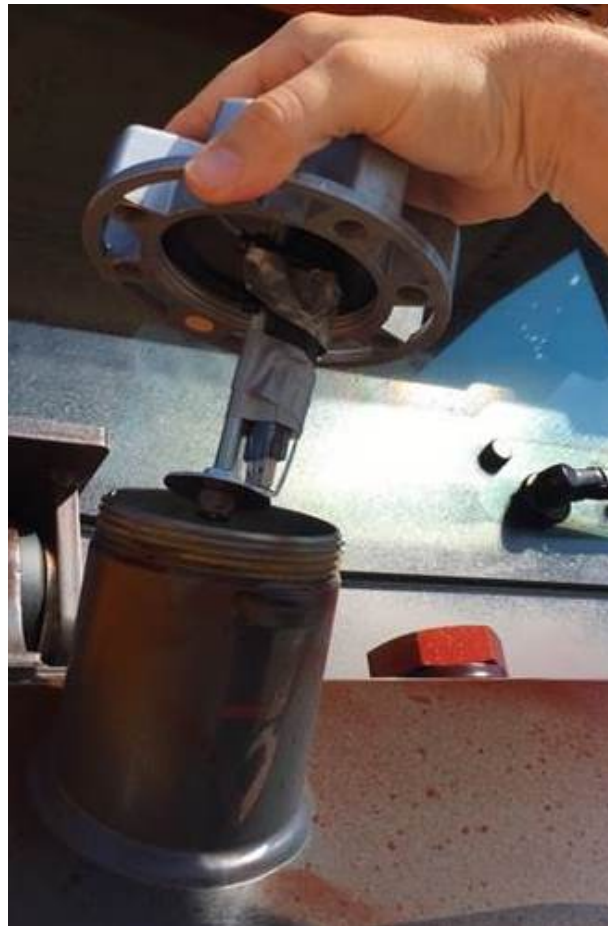
**Figure 5: Temperature and humidity sensor attached to modified fuel cap.**

The second real world analysis involved evaluating temperature and humidity conditions experienced by crawler units shipped from Iowa, USA to Brazil. Two temperature and humidity sensors were placed on the crawler; one attached to a modified fuel cap (Figure 5), and a second attached to a hose on the vehicle exterior (Figure 6). The first sensor allowed for measurement of conditions experienced inside a partially filled biodiesel fuel tank, where the end user had been experiencing repeated corrosion problems during overseas shipment. Two crawlers were sent; one with standard biodiesel fuel, and the second with a VCI additive (0.5% by tank volume) in the biodiesel. In addition to evaluating the conditions experienced in this shipment, the efficacy of the VCI additive was evaluated. It should be noted that only two sensors were available for this test. As such, both sensors were on/in the VCI treated crawler.

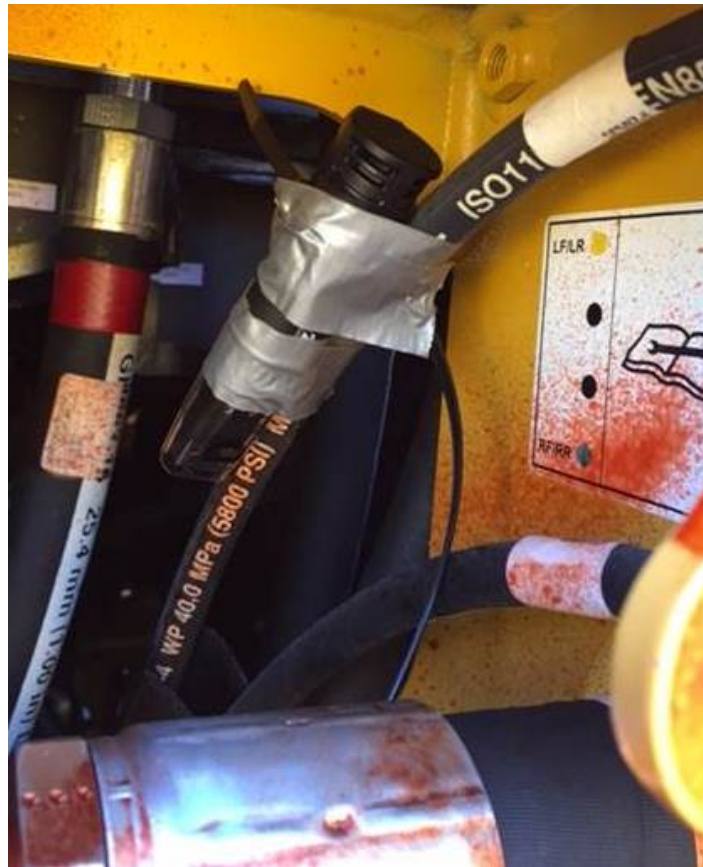
**Figure 6: Temperature and humidity sensor attached to hose on vehicle exterior.**

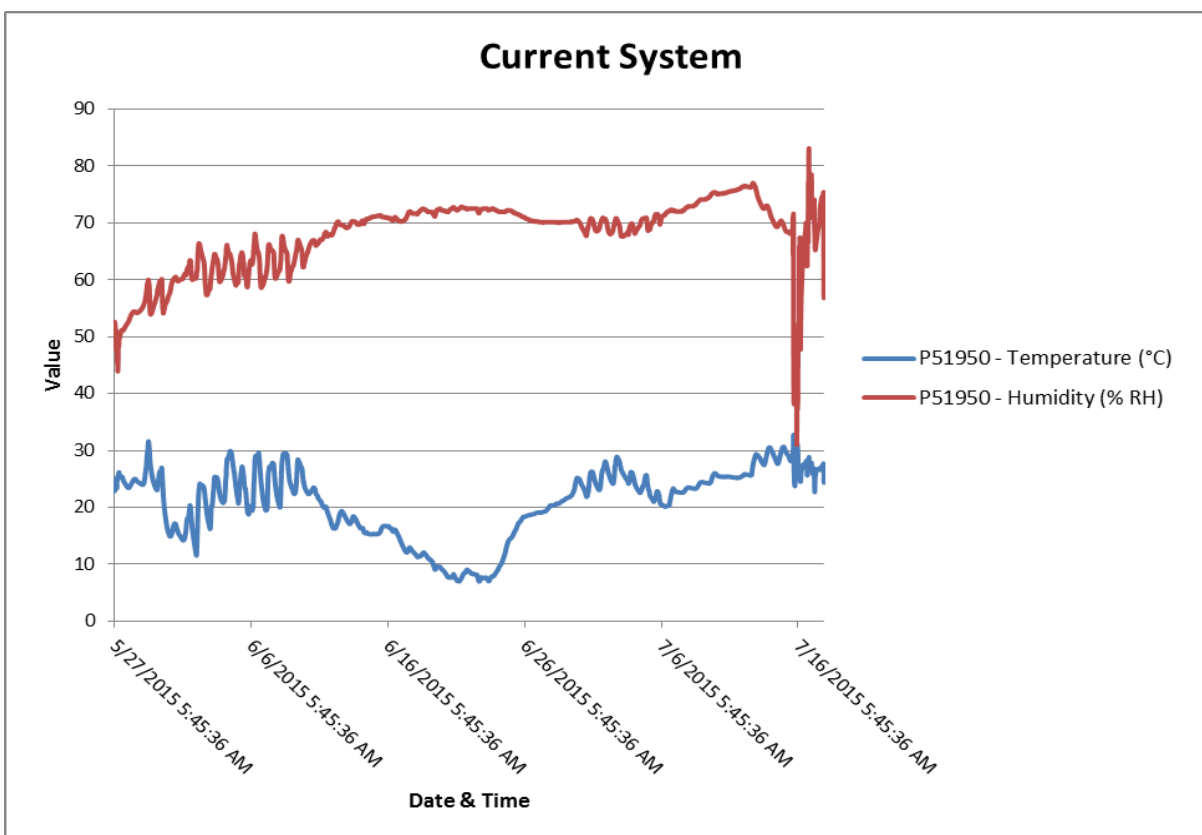
**Figure 11: Sensor data from an overseas shipment, USA to China. The data above were the conditions within the control (current) end user system.**

Average relative humidity within the shrink wrapped pallet was 68%, compared to 59% for the PE liner/bag covered pallet. The control pack exceeded 60% relative humidity within 4 days, compared to 31 days for the PE Liner/bag + VCI Barrier Paper system. Near the middle of the shipment, temperature dropped from 25C to 9C. During this time, the relative humidity within the shrink wrapped pallet did not change significantly (Figure 11). Conversely, changes in relative humidity within the second pack closely followed temperature changes during this time, and throughout the rest of the shipment (Figure 12). This suggests that the individual PE bag may be trapping moisture inside. Corrosion was not seen in parts from either packaging system, during this evaluation.

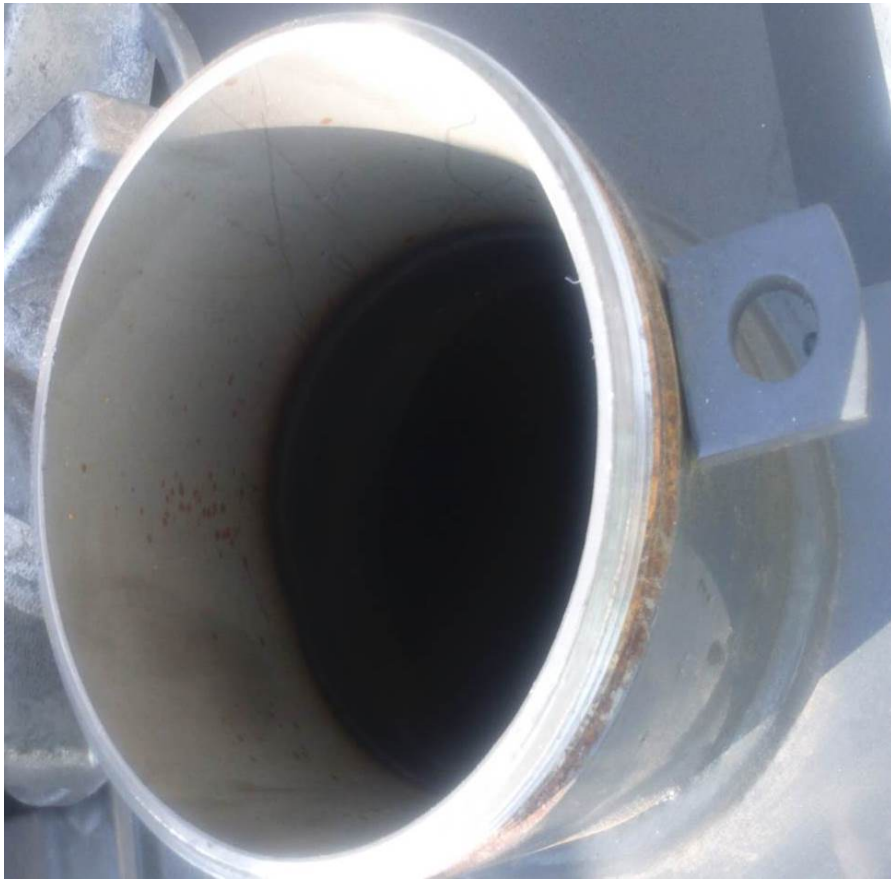
**Figure 15: Untreated fuel tank, after shipment. Corrosion is present in the fill neck, which is commonly seen upon receipt inspection.**

Additionally, corrosion was found in the fill neck of the untreated tank upon receipt inspection. In the tank treated with VCI, no corrosion was found. For the purposes of this evaluation, exterior surface corrosion was not monitored.

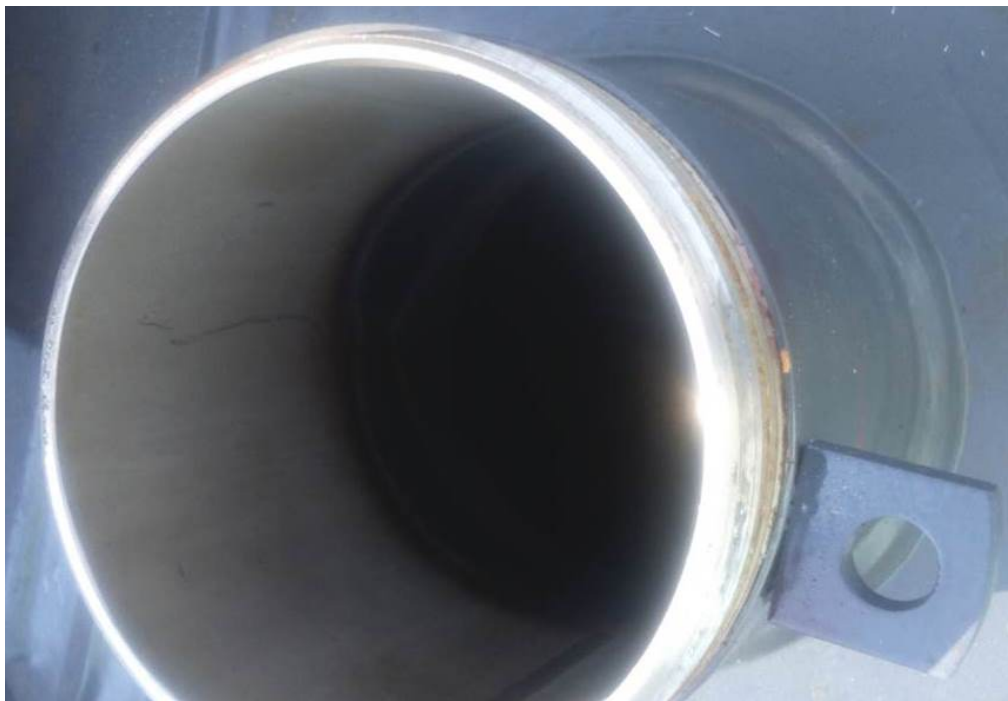
**Figure 16: VCI treated fuel tank, after shipment. No corrosion was visible.**
