## Protection of Corrosion under Insulation using Vapor Phase Corrosion Inhibitors, Corrologic V<sub>p</sub>CI-658

**CORTEC Corporation**

Behzad Bavarian, Yashar Ikder, Babak Samimi and Lisa Reiner  
Dept. of Manufacturing Systems Engineering & Management  
College of Engineering and Computer Science  
California State University, Northridge, USA 91330

April 2015

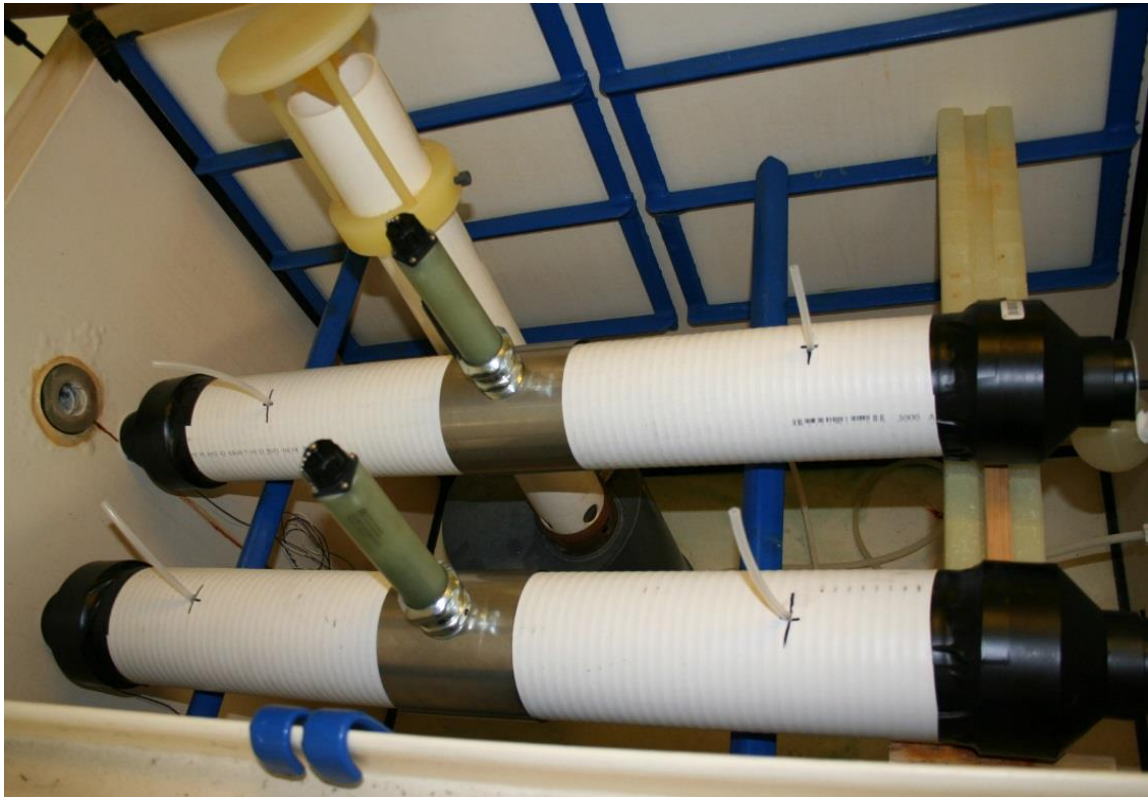
**Figure 3:** Assembled test samples in test chamber showing ER test probes and salt solution feed tubes. Every 48 hours, a 50 ml solution was injected at pipe/insulation interfaces.

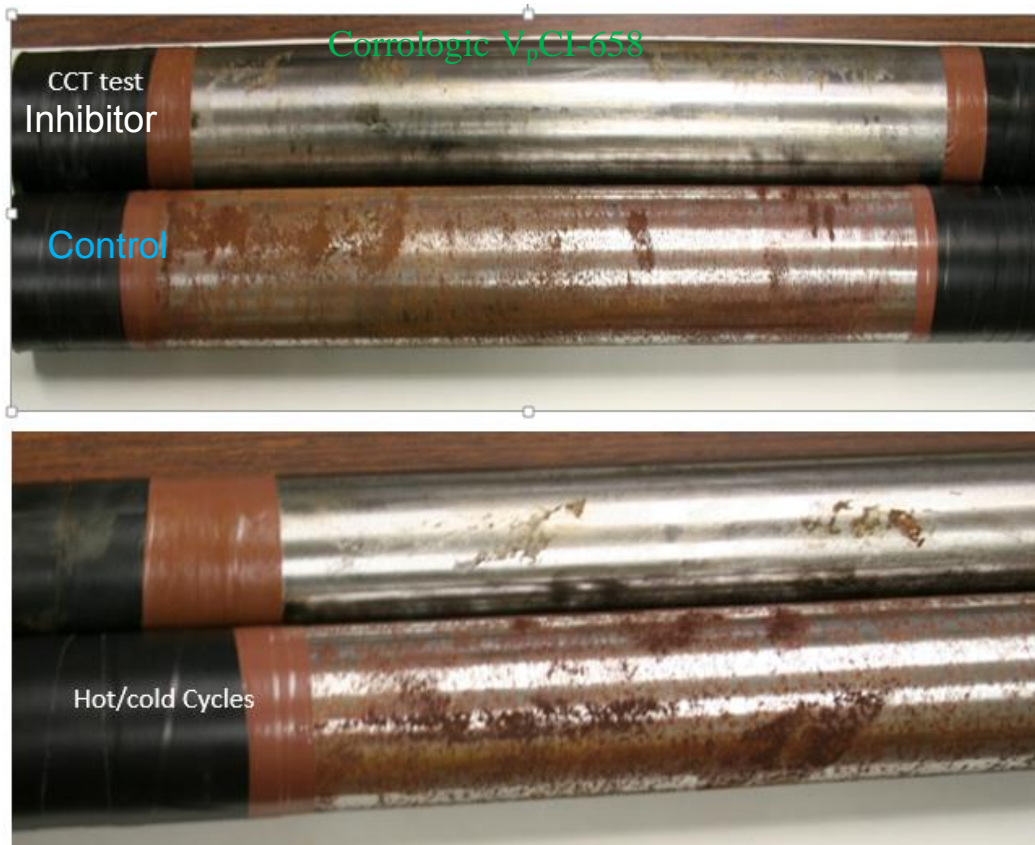
**Figure 8:** Corrologic V<sub>p</sub>CI-658 treated pipe shows no corrosion attack, while the control sample showed red rust formation at its interface.

As seen in Figures 7-21, the comparison of pipe interfaces after various exposure time ranging from 330 hours to 5,800 hours of testing shows significant corrosion attack and red rust formation for the sample with no inhibitor. The sample treated with inhibitor provided good protection for the pipe despite the harsh and continuously aggressive wet/dry environment inside the insulation. The inhibitor treated pipes were relatively clean and corrosion free. Further assessment of the test sample conditions were done by the ER probes that continuously measured the corrosion rate. As well, the electrode probe surface that sat flush with the metal pipe control sample, showed red rust formation (Figures 10, 19). The probe used to monitor the corrosion rate for the pipe protected with inhibitor was clean, showing no corrosion residue. Figure 21 shows clearly that addition of vapor phase corrosion inhibitor is very critical to improve life expectancy of the insulated pipes. Figure 22 compares the corrosion rates; the control sample with no inhibitor measured an average of 0.96 mpy and as high as 2.2 mpy at 110 hours of testing. The inhibitor treated sample had a corrosion rate that was very low in the range of 0.03 to 0.04 mpy. The results verified that Corrologic V<sub>p</sub>CI-658 managed to form a clear, dry, hydrophobic film on the pipe and protected the pipe surface.

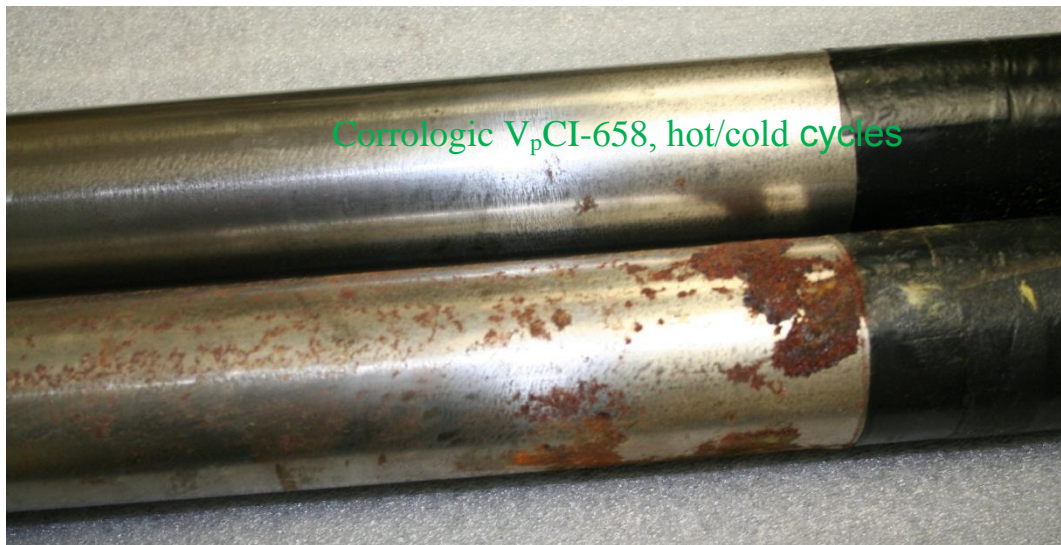
**Figure 9:** Comparison of surface of the insulation/pipe interfaces after 60 days (1440 hours), Corrologic V<sub>p</sub>CI-658 treated pipe shows no corrosion attack, while the control sample showed red rust formation at its interface.

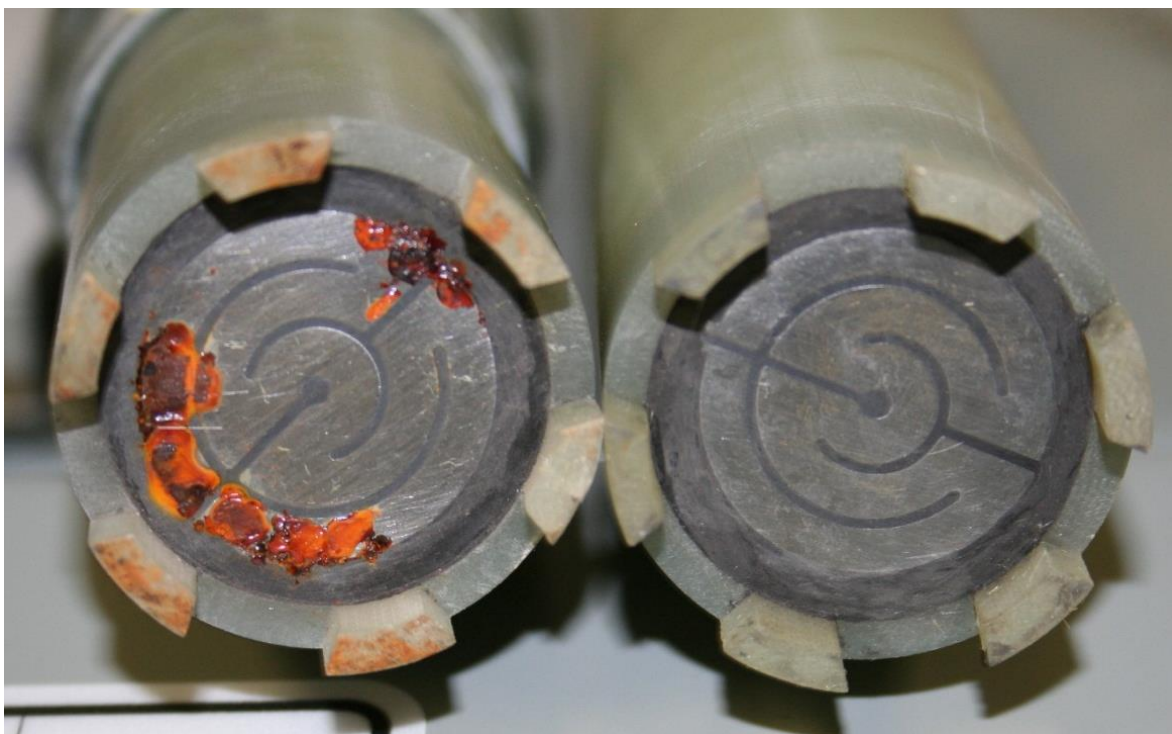
**Figure 10:** Comparison of electrical resistance probes used to measure the corrosion rate of the CUI samples after 60 days exposure. The control sample shows red rust formation; while sample treated with Corrologic V<sub>p</sub>CI-658 is clean and shows no corrosion residue.

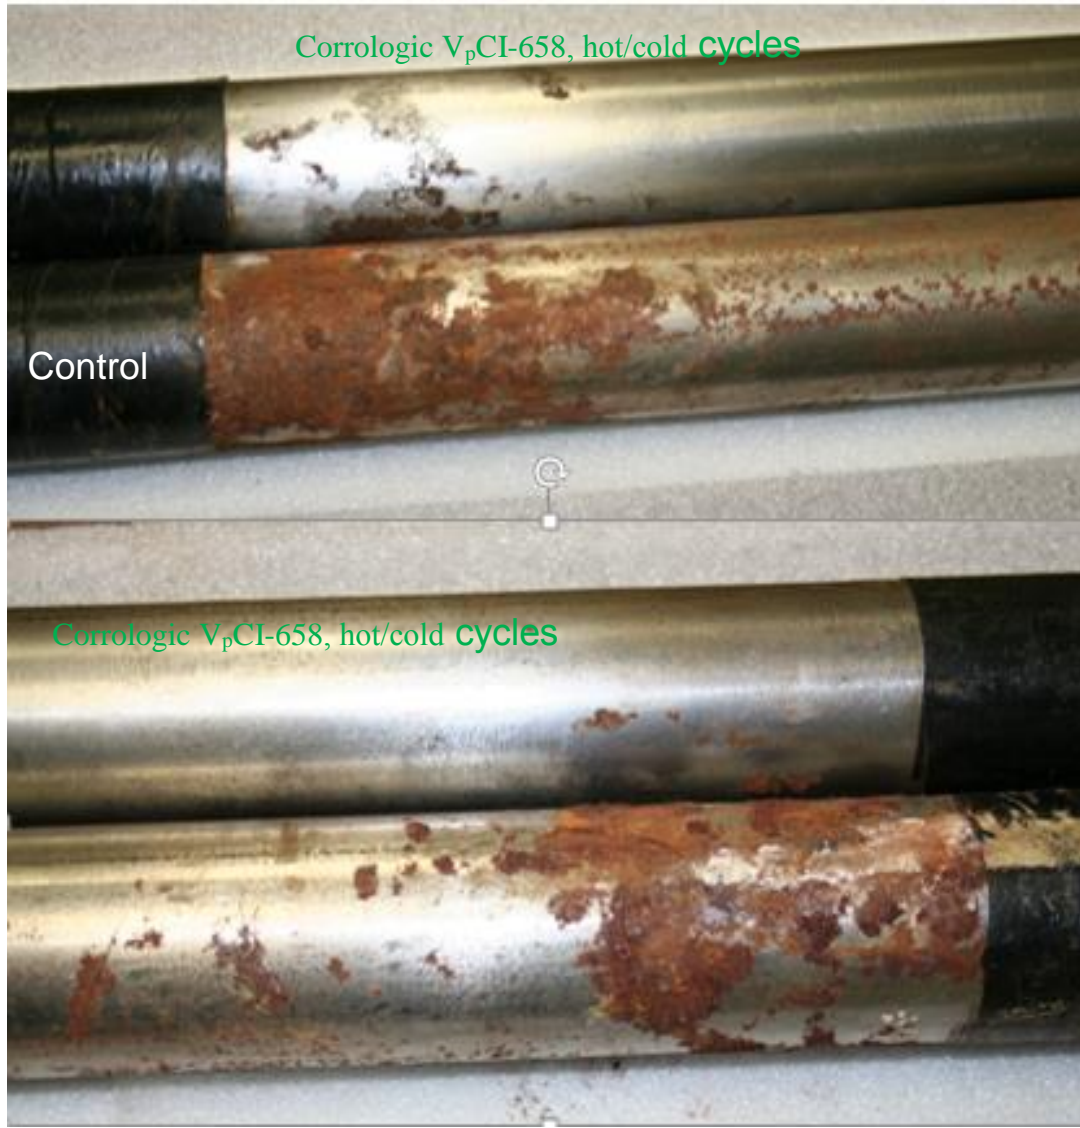
**Figure 12:** Comparison of surface of the insulation/pipe interfaces after 120 days (2880 hours), inhibitor treated pipe shows no corrosion attack, while the control sample showed red rust formation at its interface.

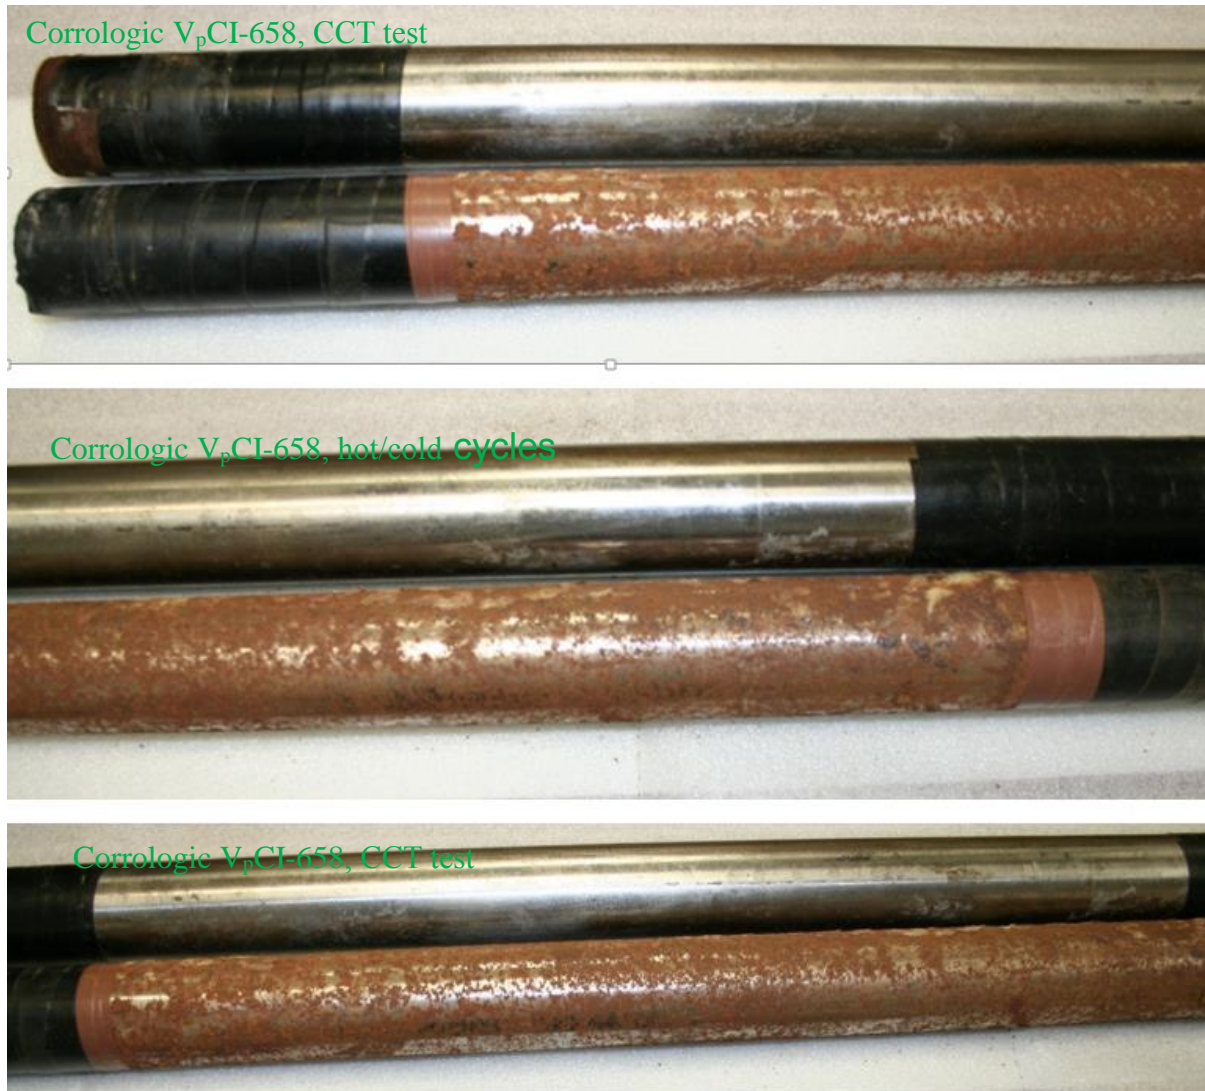
**Figure 13:** Comparison of surface of the insulation/pipe interfaces after 150 days (3600 hours), inhibitor treated pipe shows no corrosion attack, while the control sample showed red rust formation at its interface.

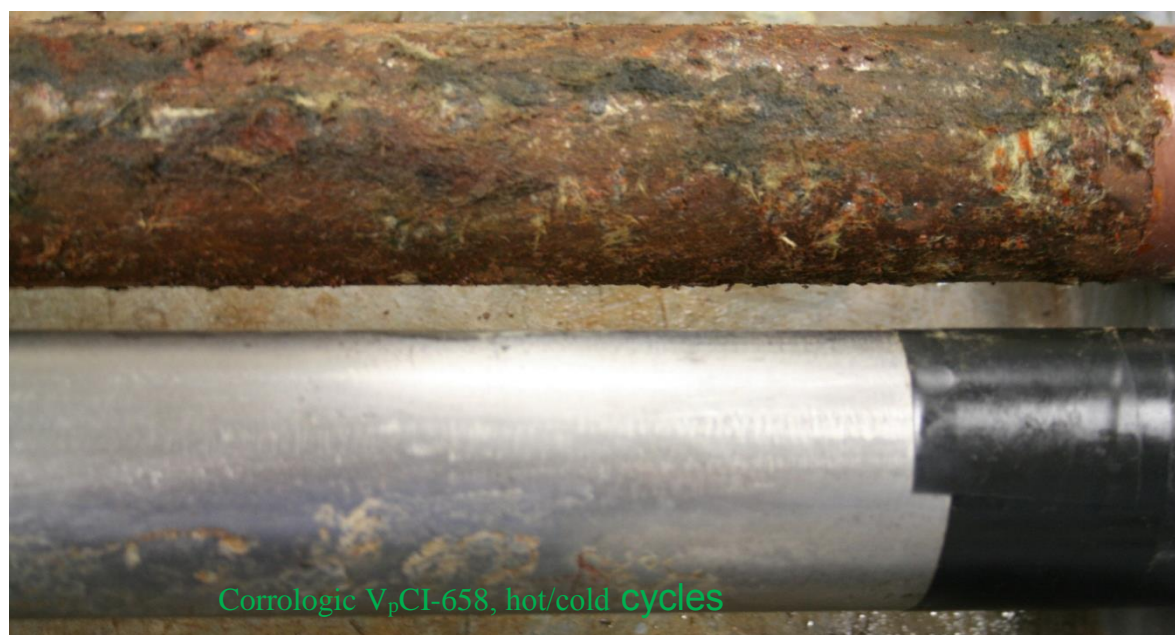
**Figure 15:** Comparison of insulation/pipe interfaces after 210 days (5,040 hours); inhibitor treated pipe shows no corrosion attack, while the control sample shows red rust formation.

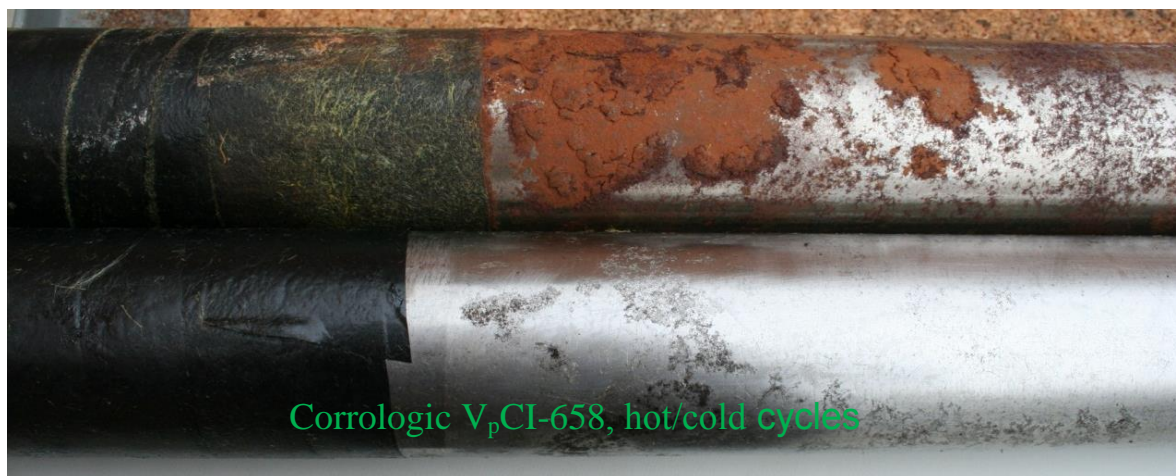
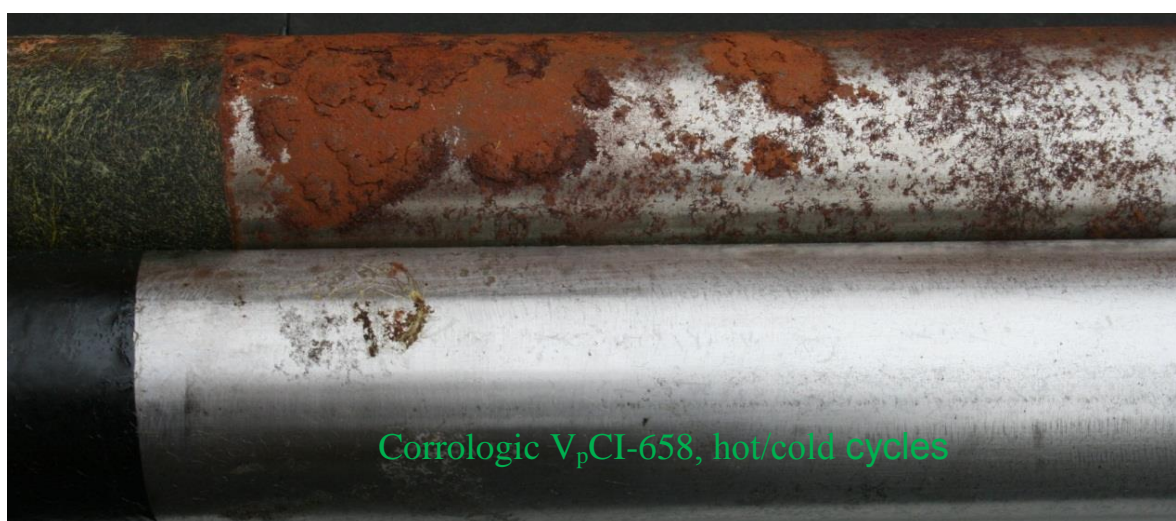
**Figure 17:** Hot/cold cycles - Comparison of insulation/pipe interfaces after 242 days (5,800 hours). Inhibitor treated pipe shows no corrosion attack, while the control sample shows red rust formation.

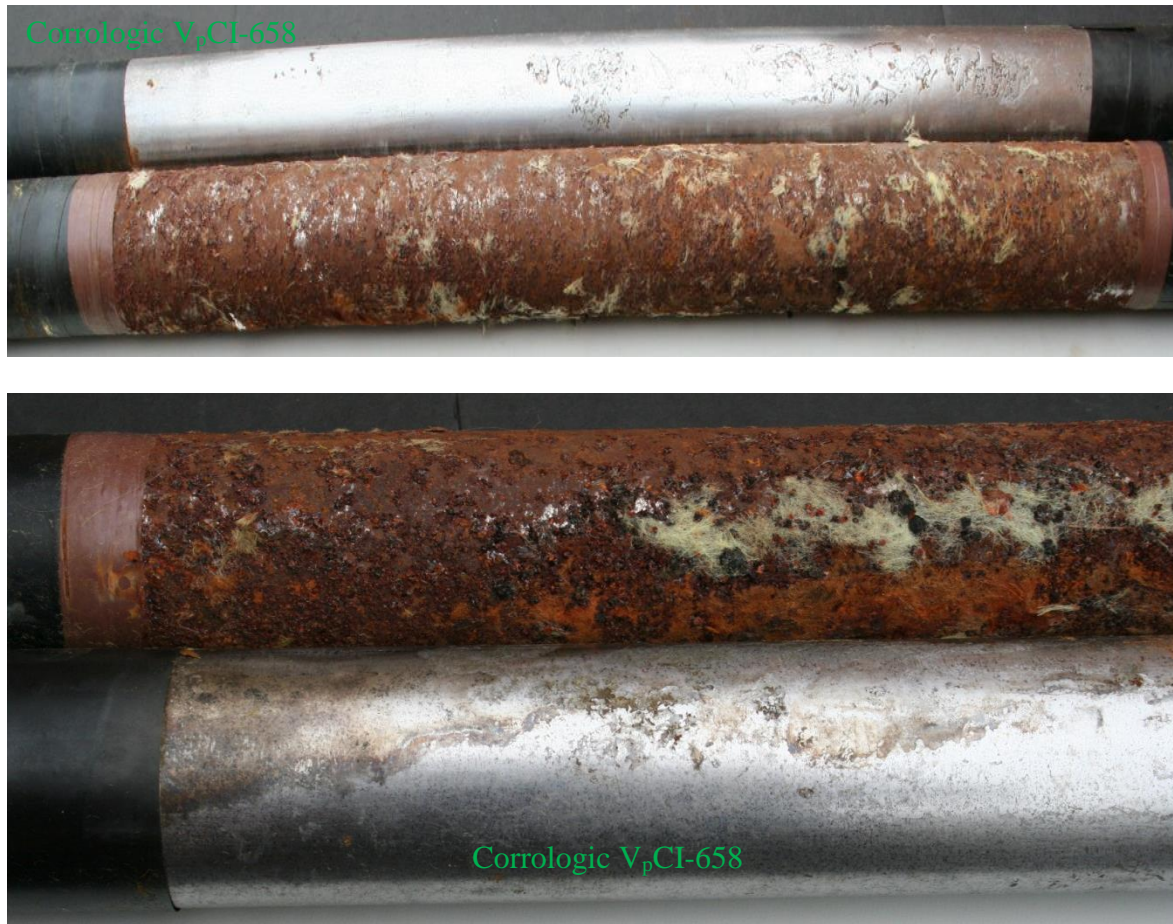
**Figure 18:** CCT corrosion tests - Comparison of insulation/pipe interfaces after 242 days (5,800 hours); Corrologic VpCI-658 treated pipe shows no corrosion attack, while the control sample shows red rust formation.

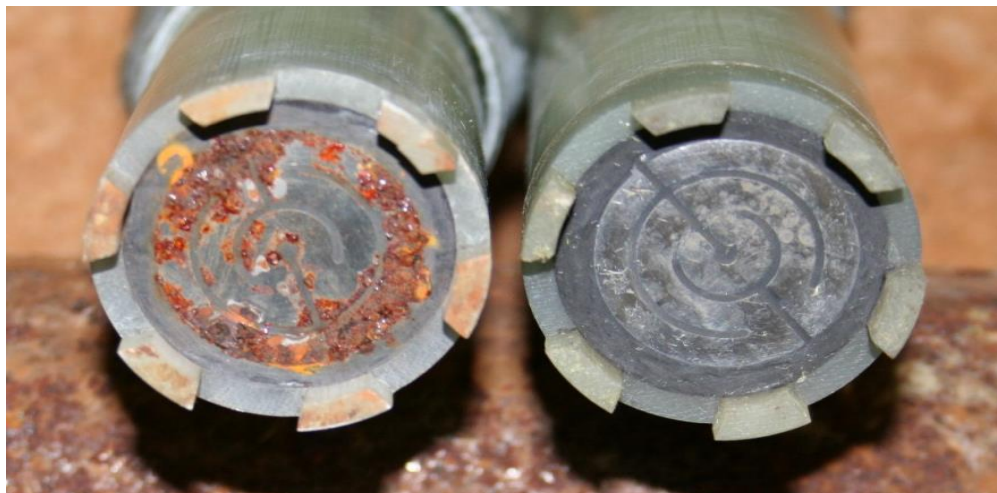
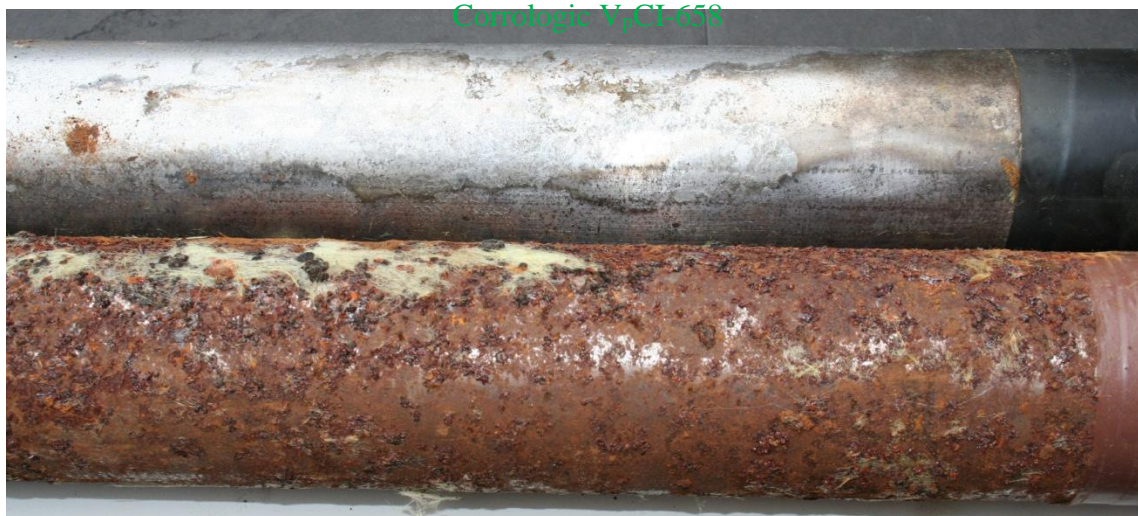
Corrologic V<sub>p</sub>CI-658

**Figure 19:** CCT GM protocol corrosion tests - Comparison of ER test probes and insulation/pipe interfaces after 242 days (5,800 hours); inhibitor treated pipe shows no corrosion attack, while the control sample shows red rust formation.

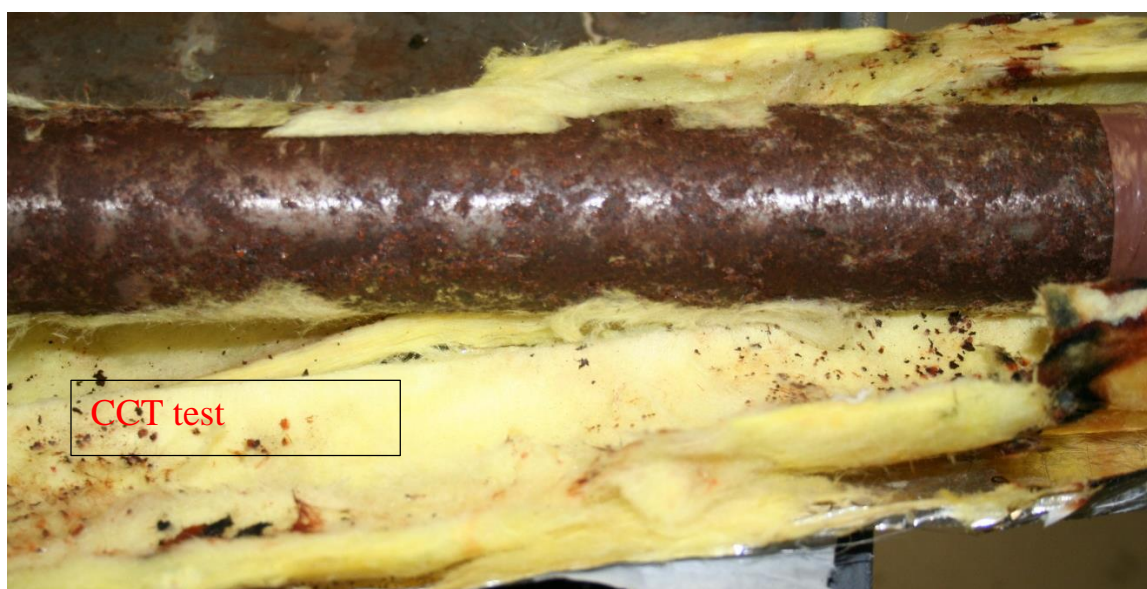
**Figure 21:** Photos of insulation/pipe interfaces after 242 days (5,800 hours): without Corrologic V<sub>p</sub>CI-658 treated pipe shows severe corrosion and red rust formation.

These results showed that an effective protective coating system under the insulation (Figure 21) is critical and requires the inclusion of vapor phase corrosion inhibitors to prolong the pipe integrity and lower inspection and maintenance cost.
