CORROSION MONITORING USING EMBEDDED
MINISENSORS ON REBARS IN CONCRETE
REHABILITATED WITH A VCI

General Building Research Corporation of Japan

Published: March 1997

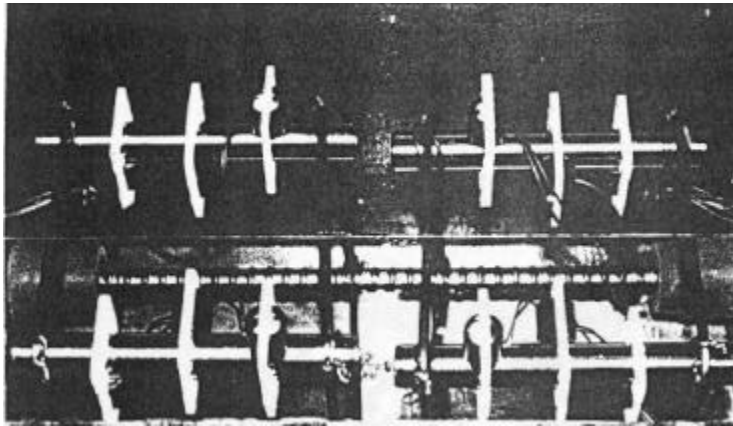
PHOTO - 1 Rebar arrangement in a mold

Test 1: For corrosion monitoring, minisensors were embedded in the vicinity of rebars in concrete specimens with a chloride ion content of 0kg/m^3 and 3kg/m^3 . The minisensors were embedded at a distance of 1mm from the top, bottom and sides of the rebars with a concrete cover of 2cm and 3cm (see Photos 1 and 2). The concrete specimens were demolded one day after casting of concrete, and monitored continuously at hourly intervals for 60 days while being kept in a damp environment at 20°C , relative humidity 100%.

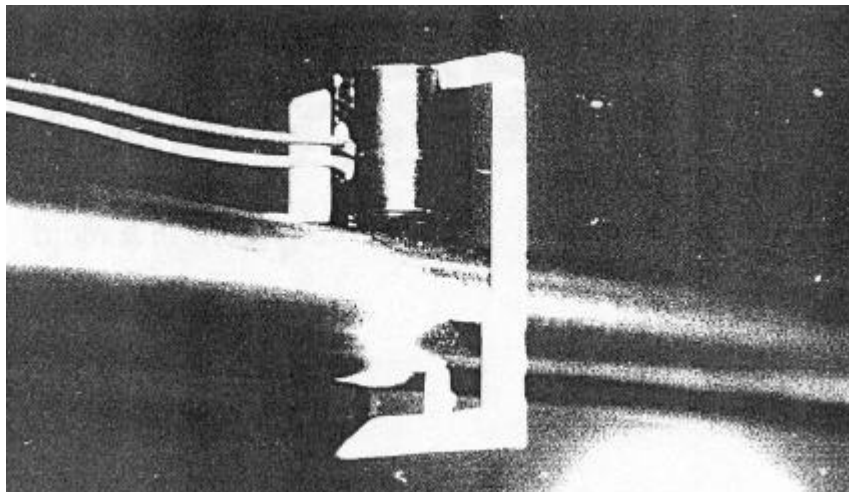
PHOTO-2 Minisensor attached to a rebar.

Minisensors can be installed in both newly constructed structures and existing ones. The sensors developed are only 10mm in diameter and 12mm in depth so they will never affect the durability of structures of the load carrying capacity. This paper reports one part of experimental results on rebar corrosion monitoring tests using embedded minisensors.

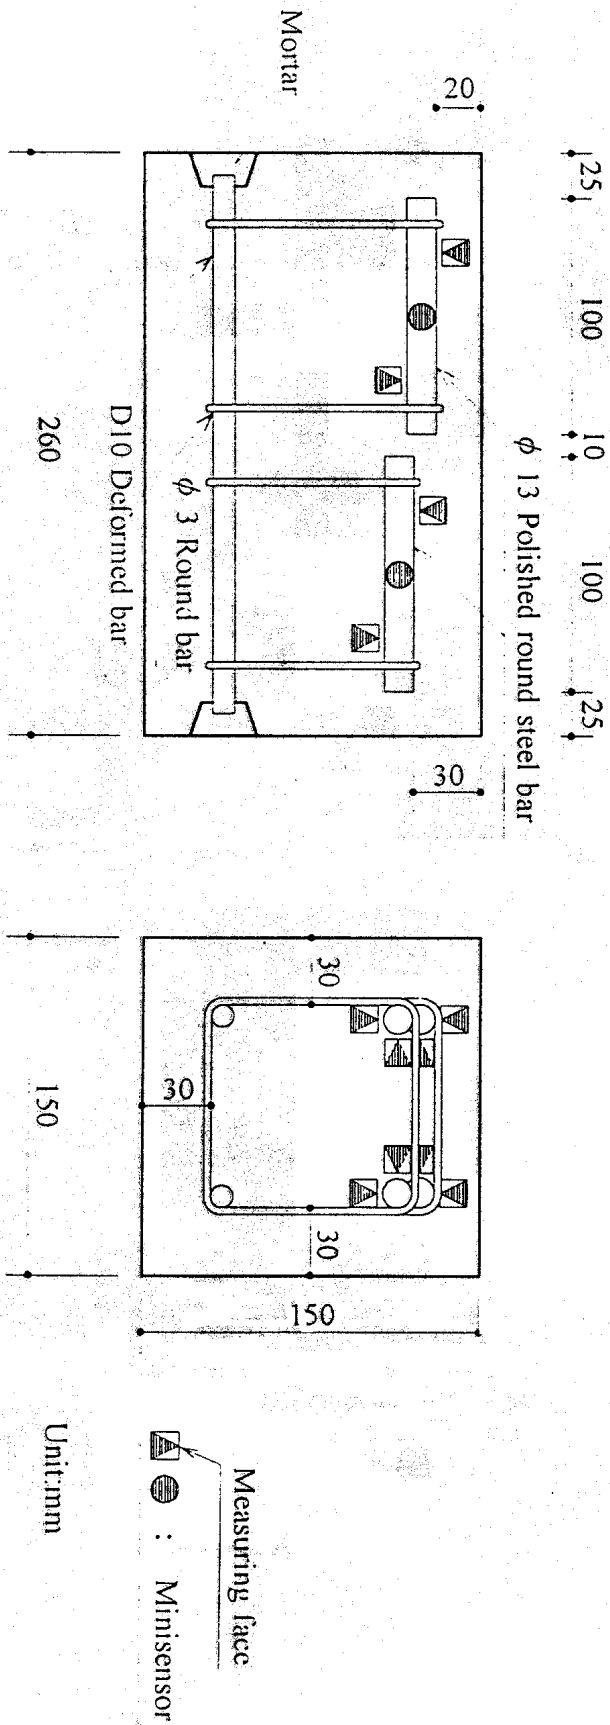
FIGURE-1 Reinforced concrete specimen

Both test 1 and 2 were conducted as follows. Reinforced concrete specimens with a W/C ratio of 65% were prepared with two polished rebars of 13mm in diameter and 100mm long embedded horizontally with a concrete cover of 20mm and 30mm, respectively (see Figure 1).

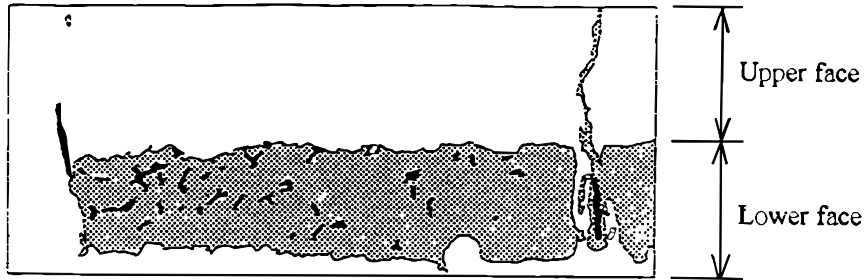
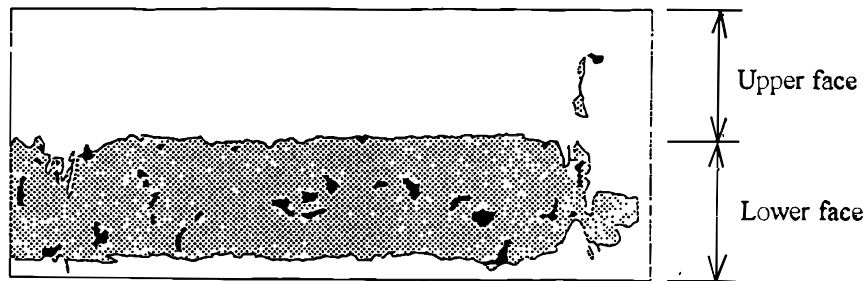
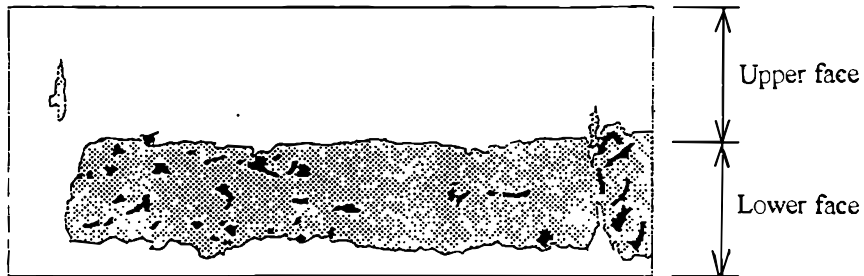
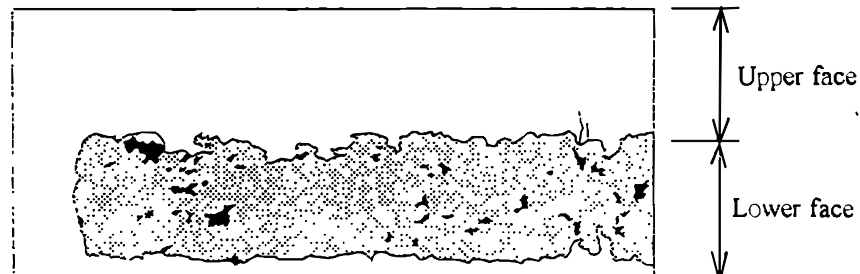
FIGURE - 2 Corrosion map after initial 60-day wet curing

Cover thickness=2cm

Cover thickness=3cm

□ : General corrosion

■ : Pitting corrosion

1) The natural potential measurements relating to the corrosion state were approximately 0mV against the specific reference electrode of the minisensor and -200mV for the specimens with a chloride ion content of 0kg/m³ and 3kg/m³, respectively. Converted to silver-silver chloride reference electrode potential, these measurements give approximately -100mV and -300mV (details of potential conversion to be reported at a later date), which corresponded to the corrosion state in the extracted bars (see Figures 2,3.1 and 3.2).

3) The electrolyte resistance measurements relating to the corrosion environment showed different tendencies depending upon the chloride ion content. The measurements remained more or less constant within a range of 1 ~ 5k Ω in the specimens without chloride ion, whereas in the specimens with 3 kg/m³ chloride ion, low readings were found at the underside of the bars, with a marked variation depending on the location of the minisensor. This fact was thought to be due to irregularities in corrosive environment adjacent to rebars (see Figures 2, 5.1 and 5.2).

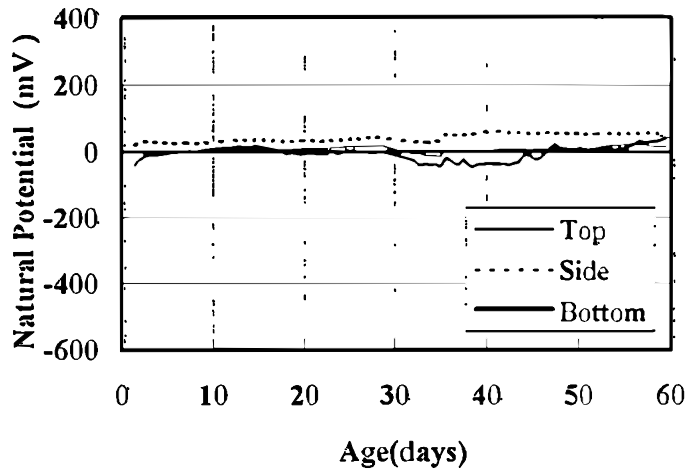
FIGURE-3.1 Changes in natural potential with time
(initial 60-days wet curing, $Cl^- = 0 \text{ kg/m}^3$,
cover thickness=3cm)

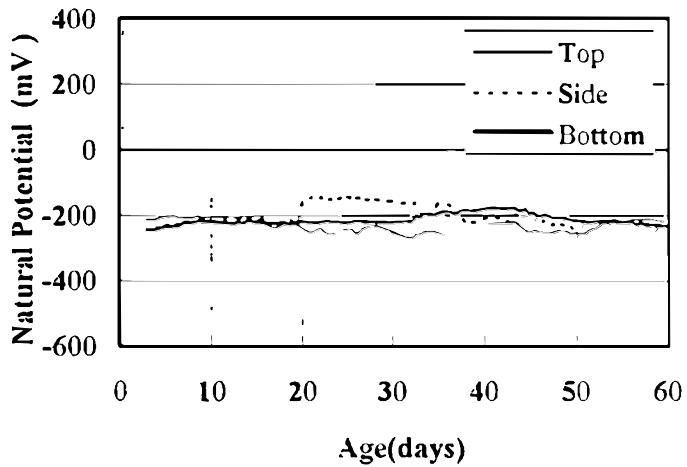
FIGURE-3.2 Changes in natural potential with time
(initial 60-days wet curing, $Cl^- = 3 \text{ kg/m}^3$,
cover thickness=3cm)

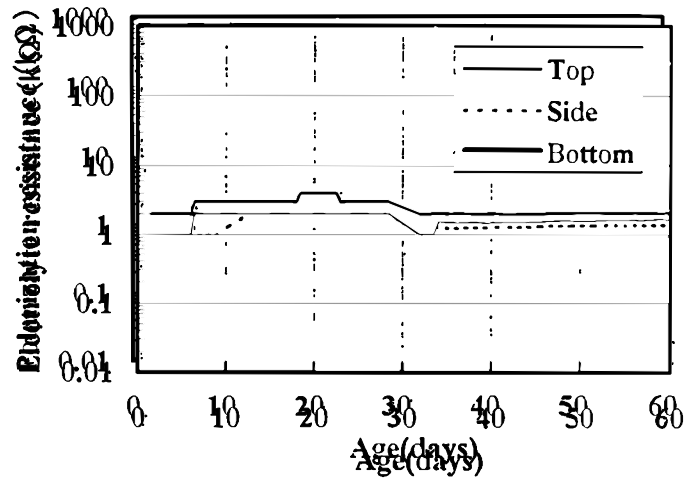
FIGURE-4.1 Changes in polarization resistance with time
(initial 60-days wet curing, $C_t=0\text{ kg/m}^3$,
cover thickness=3cm)

2) The polarization resistance measurements relating to the corrosion rate showed different tendencies depending on the chloride ion content. In the specimens without chloride ion, the polarization resistance start at around 10k Ω and increased with time, whereas in the specimens with 3kg/m³ chloride ion, measurements repeatedly fell below 10k Ω , although showing an overall tendency to increase (see Figures 4.1 and 4.2).

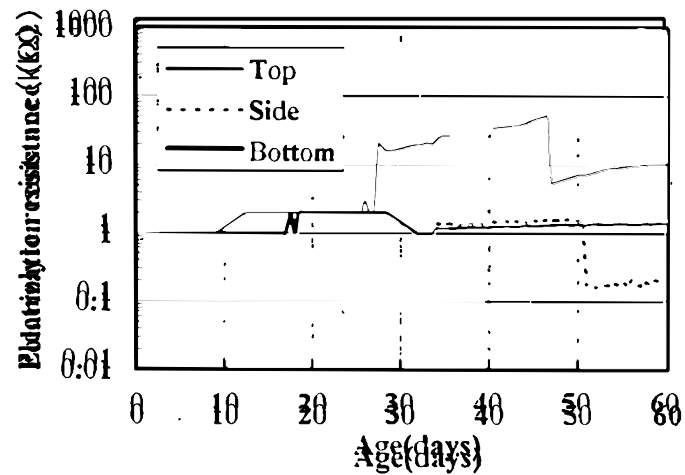
FIGURE-5.2 Changes in polarization resistance with time
(initial 60-days wet curing, $C_t=3\text{ kg/m}^3$,
cover thickness=3cm)

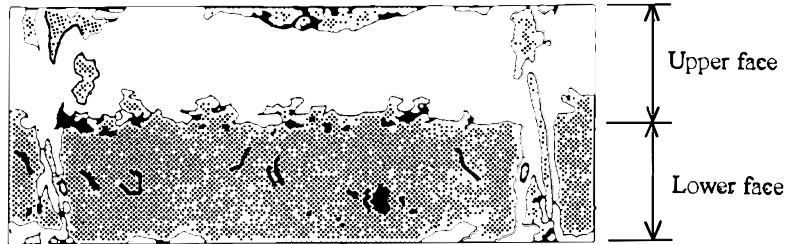
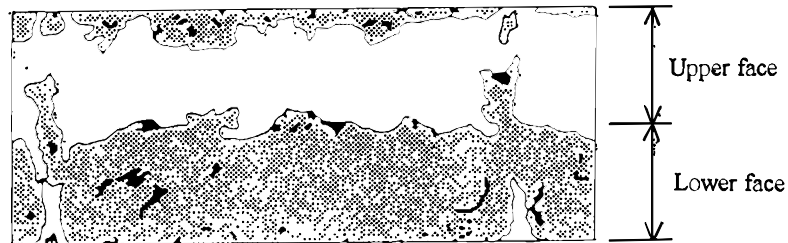
Cover thickness=2cm

Cover thickness=3cm

FIGURE-6.1 Corrosion map of specimens repaired with MCI2020 (428-day alternately drying & wetting curing)

1) According to the destructive test results, differences could be clearly observed between the repaired and unrepaired specimens in the form and extent of rebar corrosion after the accelerated curing (see Figure 6.1 and 6.2).

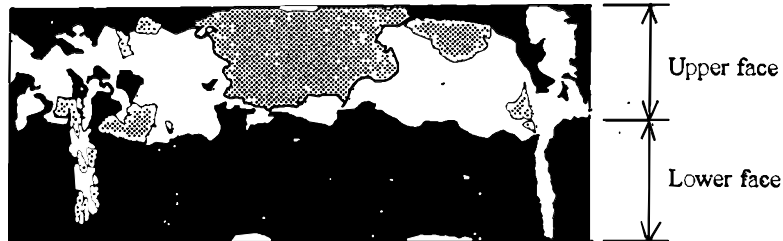
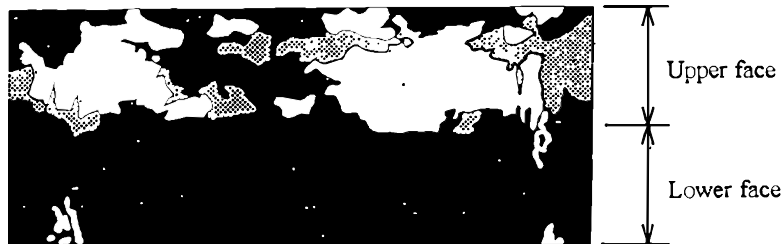
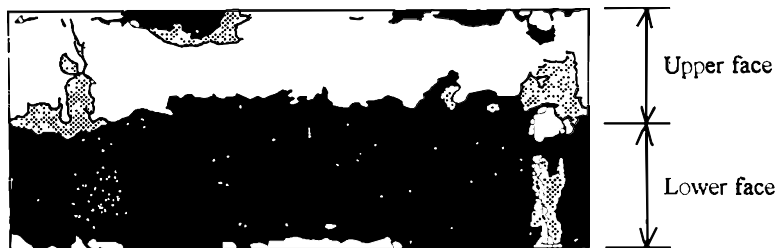
Cover thickness=2cm

Cover thickness=3cm

FIGURE-6.2 Corrosion map of unrepaired specimens
(243-day alternately drying & wetting curing)

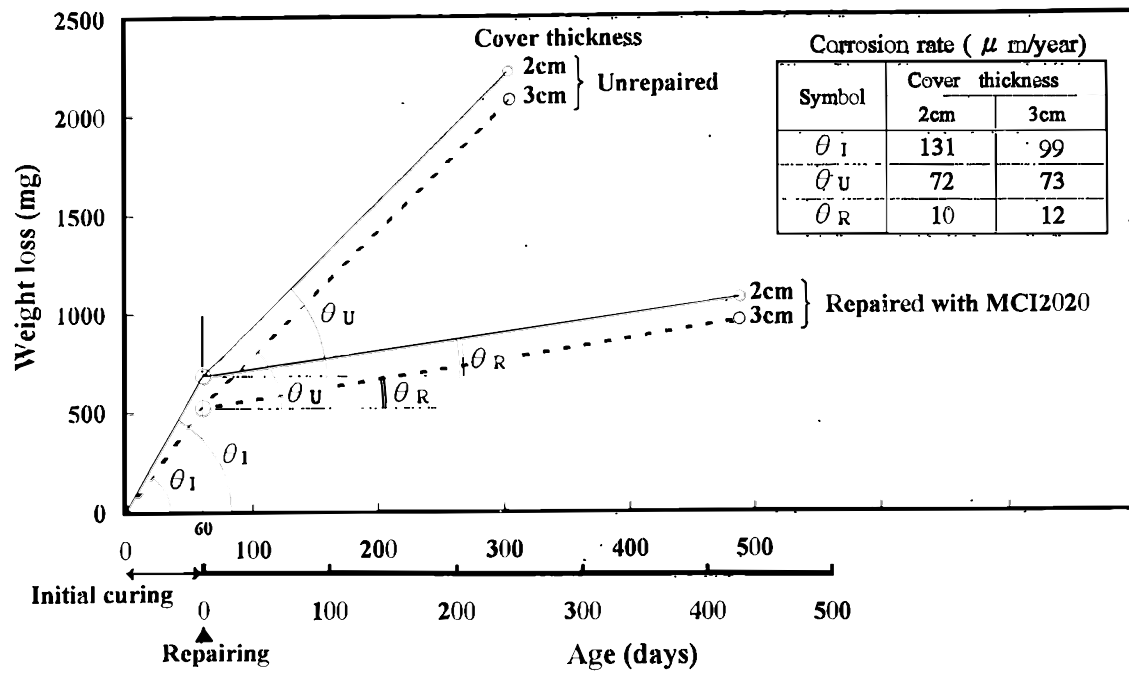
FIGURE-7 Comparison of corrosion rate

2) Based upon the weight loss measurements obtained from each two duplicate specimens, suppressing effects of the VCI on corrosion could be clearly identified in terms of corrosion rate (see Figure 7).

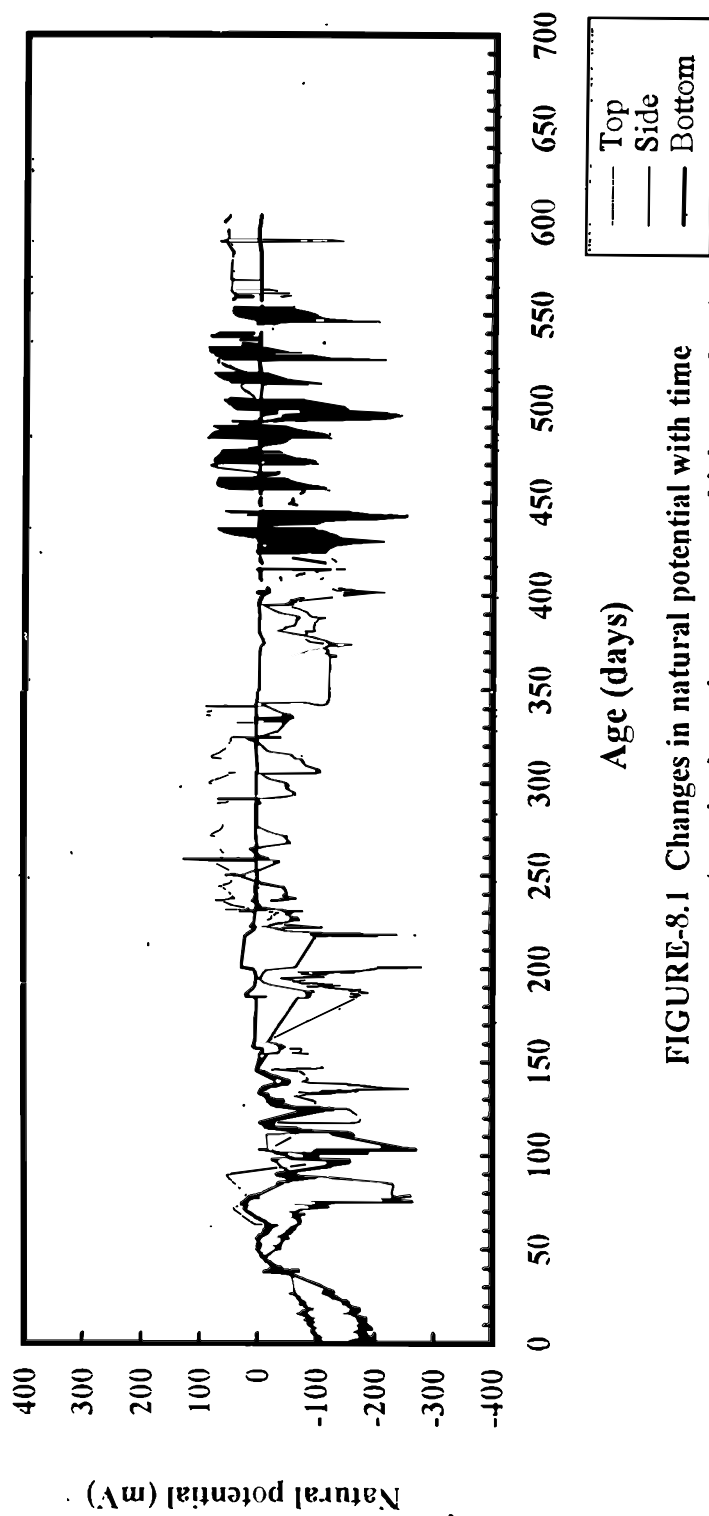
FIGURE-8.1 Changes in natural potential with time
(repaired specimens, cover thickness=2cm)

3) By means of non-destructive corrosion monitoring, above mentioned tendencies could be also observed as follows. Representative monitoring results on both repaired and unrepaired specimens with cover thickness of 2cm are shown in Figures 8.1, 8.2, 9.1, 9.2 10.1 and 10.2.

4) Natural potential readings were fluctuated between around -300mV and 100mV in both repaired and unrepaired specimens, however the differences between the two readings

could be clearly identified as follows: In repaired specimens, natural potential steadily increased with some fluctuations from the less noble values just after repairing to the noble values at around 600 days after repairing. On the other hand, unrepaired ones clearly showed a cyclic change of natural potential measurements (see Figures 8.1 and 8.2).

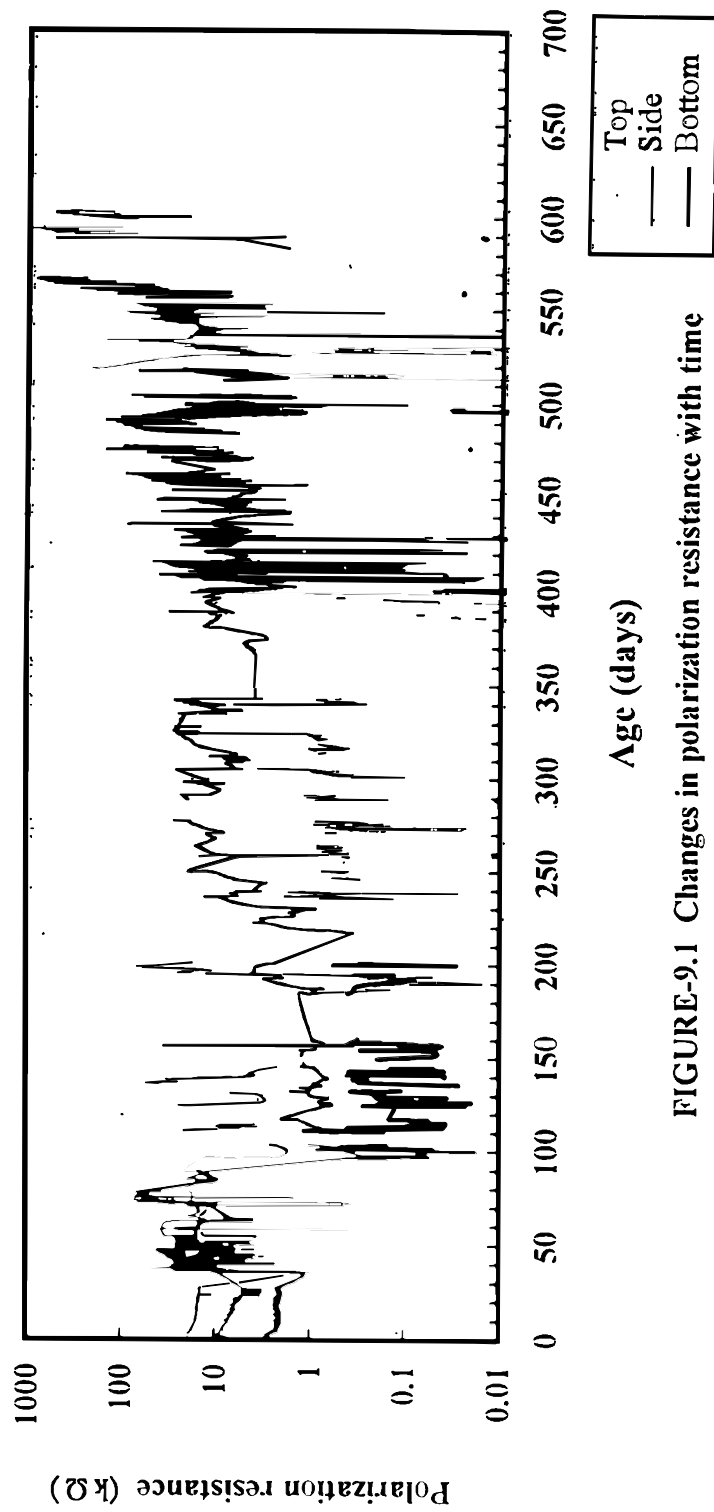
FIGURE-9.1 Changes in polarization resistance with time
(repaired specimens, cover thickness=2cm)

5) Polarization resistance readings fluctuated between around $0.01\text{k}\ \Omega$ and $1000\ \Omega$ in both repaired and unrepaired specimens, however the differences between the two readings could be clearly identified as follows: In repaired specimens, the readings clearly showed an increasing tendency with time. On the other hand, in unrepaired ones, the lower readings of around $0.1\text{k}\ \Omega$ have been continuously recorded at the early ages until an age of around 250 days. As a result of corrosion-accelerated curing, in all of the unrepaired specimens longitudinal cracks around 0.15mm in width appeared after approximately 200 days. The clear change in the readings of around 250 days after curing is thought to be due to these crackings (see Figures 9.1 and 9.2).

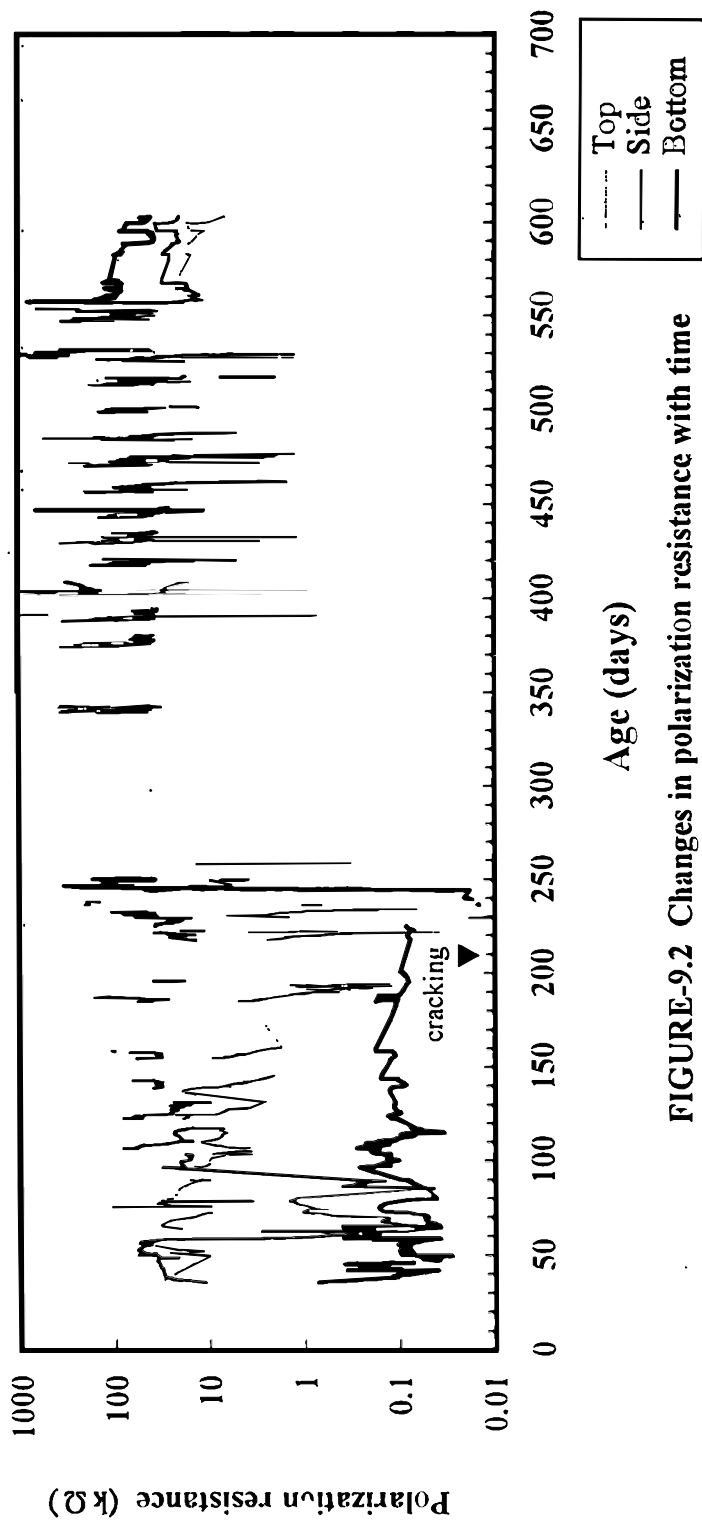
**FIGURE-9.2 Changes in polarization resistance with time
(unrepaired specimens, cover thickness=2cm)**

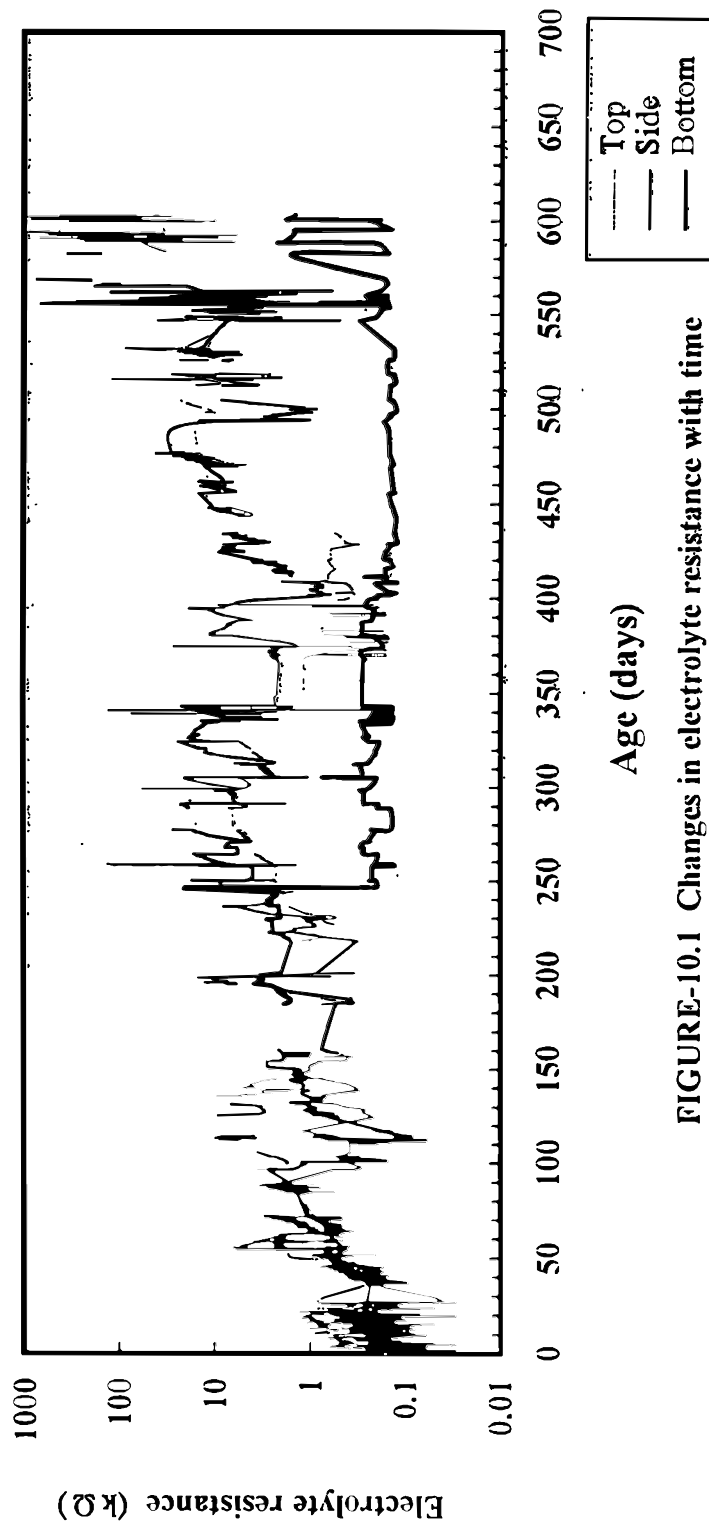
FIGURE-10.1 Changes in electrolyte resistance with time
(repaired specimens, cover thickness=2cm)

6) The electrolyte resistance readings fluctuated between around $0.01\text{k}\ \Omega$ $1000\ \Omega$ in both repaired and unrepaired specimens, however the differences between the two readings could be clearly identified as follows: In repaired specimens, the readings clearly showed an increasing tendency with time with a few exceptions. On the other hand, in unrepaired ones, some lower readings less than $0.1\text{k}\ \Omega$ were recorded at some time, such as just after the initial cracking at around 200 days, and at later ages of around 550 days (see Figures 10.1 and 10.2).
