# Evaluation of Migrating Corrosion Inhibitors Used in the Restoration and Repair of Reinforced Concrete Structures

MATTHEW S. DREW, JESSI JACKSON MEYER, AND JOSHUA HICKS,  
Cortec Corp., St. Paul, Minnesota

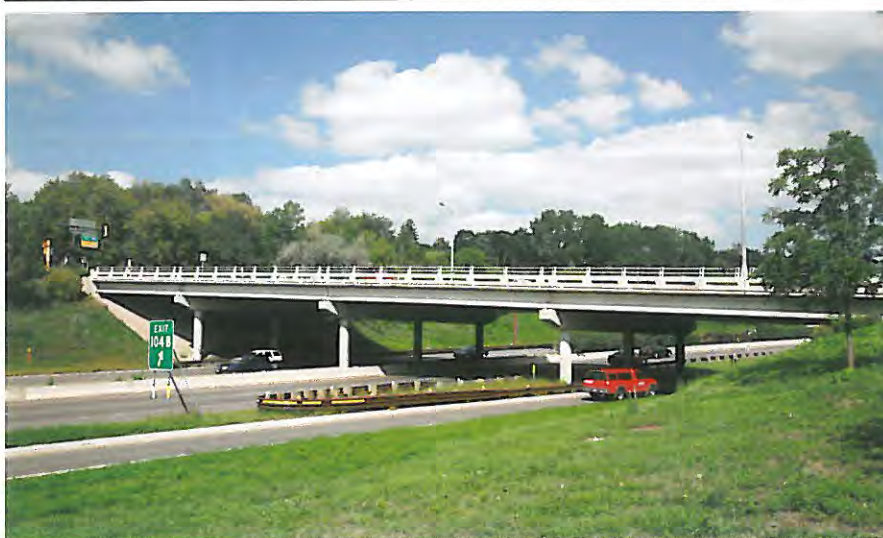
FIGURE 1

Constructed in the early 1960s, the Randolph Avenue Bridge in St. Paul, Minnesota, required extensive repairs from the results of chloride-induced corrosion of the reinforcing steel.

Constructed in 1963, the Randolph Avenue Bridge spans Interstate 35E in Saint Paul, Minnesota (Figure 1). Due to chloride-induced corrosion, embedded reinforcement deteriorated to the point of causing major cracking and spalling on the concrete bridge decks. In 1986, the top deck of the bridge was repaired in a project sponsored by the Minnesota Department of Transportation (DOT). Both sides of the deck were repaired using a low-slump, dense concrete overlay that incorporated a migrating corrosion inhibiting admixture in one side while the other was left untreated as the control. The treated westbound lanes have served as a real-world comparison of corrosion current reduction vs. the untreated “control” eastbound lanes (Figure 2).

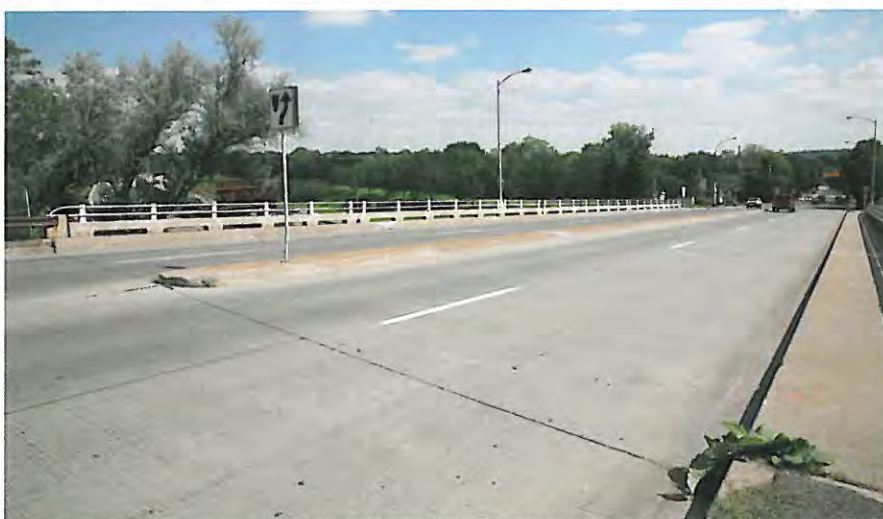
FIGURE 2

The westbound lanes of the Randolph Avenue Bridge were treated with a migrating corrosion inhibiting admixture and compared to the eastbound lanes that were refurbished with an untreated concrete overlay.
