# **MIP** A SUPPLEMENT TO **MATERIALS PERFORMANCE**

**Restoration of Reinforced Concrete  
Structures Using Migrating  
Corrosion Inhibitors**

**Corrosion Inhibitor Solutions for  
Cased Pipeline Crossings**

**Protective Systems Derived  
from Agricultural Byproducts**

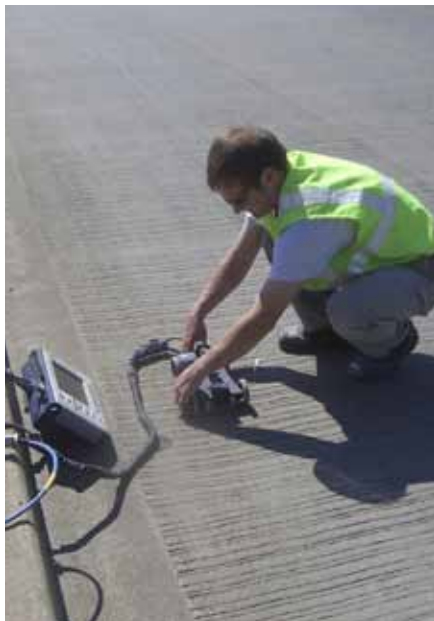
## About the Cover

Tim Suess of American Engineering and Testing uses ground-penetrating radar technology to locate steel rebar in the concrete deck of the Randolph Avenue Bridge located in St. Paul, Minnesota. Built in 1963, the bridge experienced severe cracking and spalling caused by chloride-induced corrosion of the reinforcing steel. The article beginning on p. 8 describes the use of migrating corrosion inhibitors to restore and repair the bridge, as well as how the technology worked for the rehabilitation of a parking garage located in Dayton, Ohio.

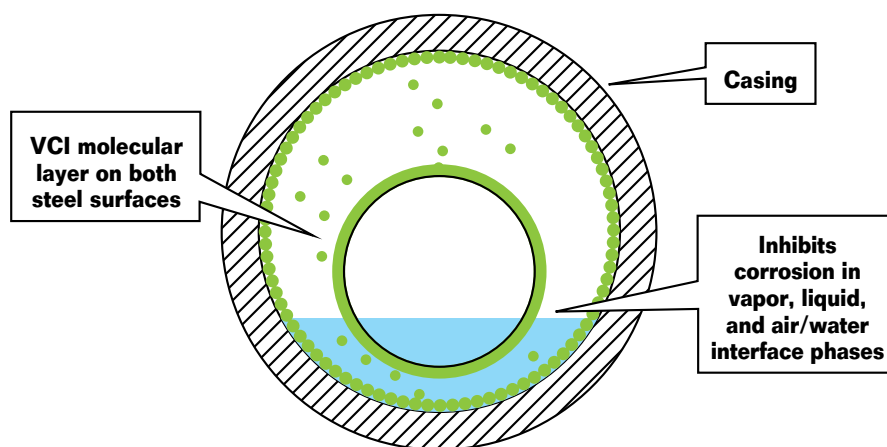
FIGURE 1

Multiphase corrosion control within casing annular space.

It is important to utilize VCIs that provide corrosion control in all three potential phases that may exist inside a cased crossing (Figure 1):

1. The liquid/solids phase where the metal surfaces are covered with water or soils that have migrated inside the casing.
2. The region along the interface of vapor and liquid/solids where accelerated corrosion may normally exist.
3. The vapor space exposed to atmospheric corrosion conditions.

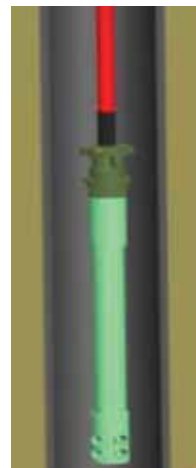
FIGURE 2

Custom ER probe for casings.

Measuring the corrosiveness of the environment inside cased crossings in real time is a valuable integrity management program component. Mature and reliable technology is available to assess the corrosiveness of the annular space in real time. This is accomplished through the use of custom-designed electrical resistance (ER) corrosion rate probes. Figure 2 shows an example of such a probe. The probe is designed to be lowered down to the carrier pipe surface and has a shield that prevents contact of the probe sensing element with the carrier pipe

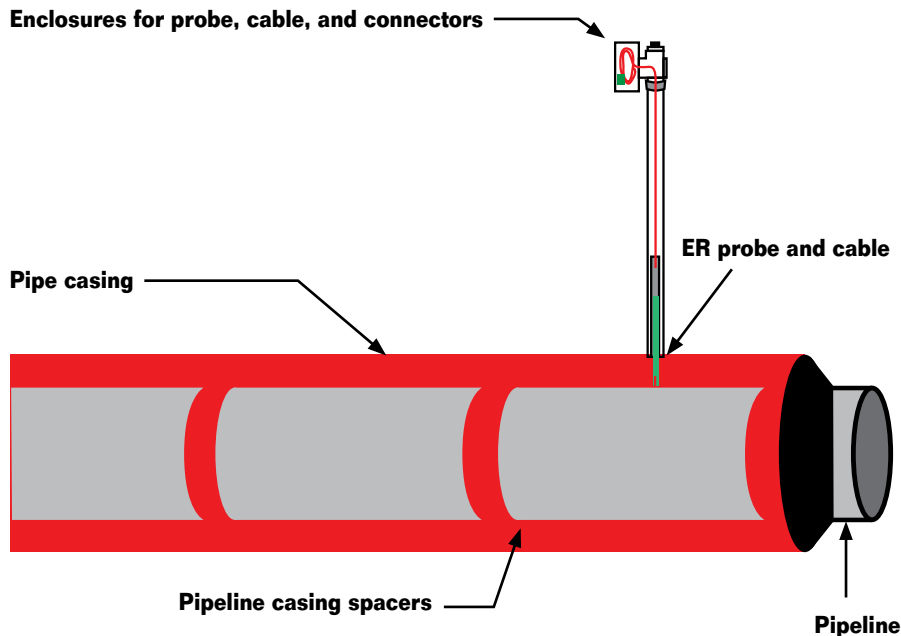
**FIGURE 3**

Typical ER probe installation.

Casing vent pipes normally located on each end of a cased crossing provide the only readily available access for installation of ER probes into the annular space (Figure 3). From a corrosion evaluation perspective, and per industry studies, the casing ends are found to normally experience the most ag-

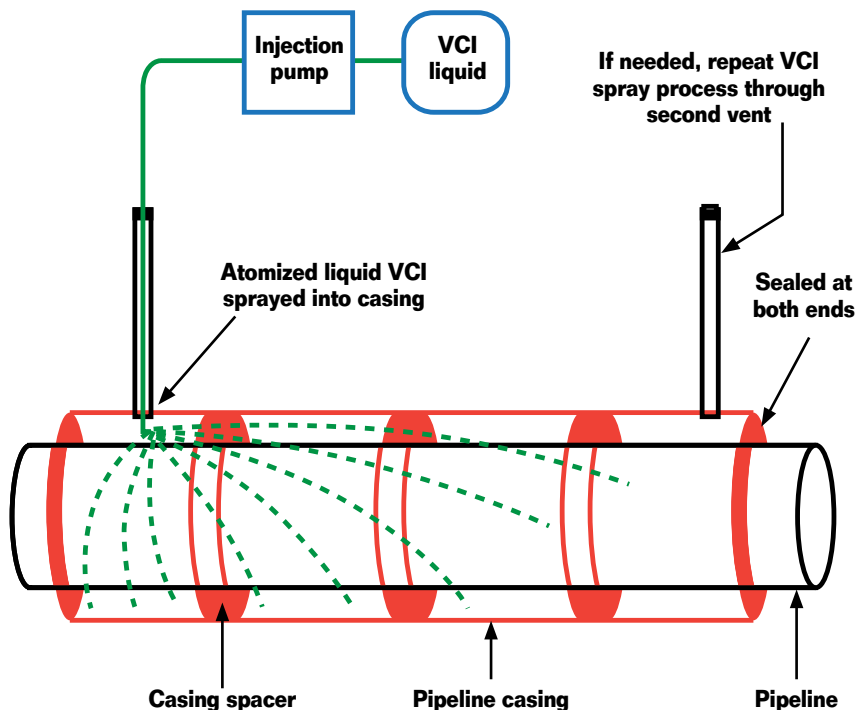
**FIGURE 4**

Application of atomized VCI into the annular space.

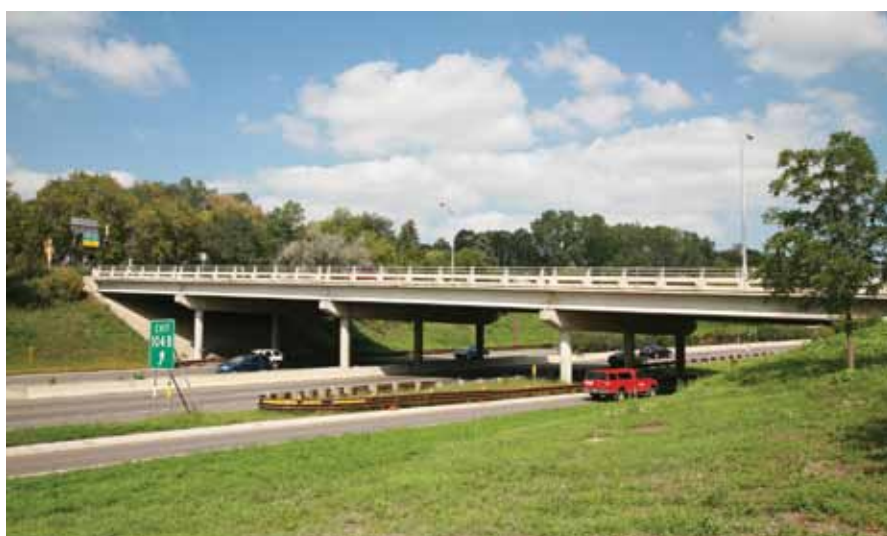
**FIGURE 1**

Constructed in the early 1960s, the Randolph Avenue Bridge in St. Paul, Minnesota, required extensive repairs from the results of chloride-induced corrosion of the reinforcing steel.

Constructed in 1963, the Randolph Avenue Bridge spans Interstate 35E in Saint Paul, Minnesota (Figure 1). Due to chloride-induced corrosion, embedded reinforcement deteriorated to the point of causing major cracking and spalling on the concrete bridge decks. In 1986, the top deck of the bridge was repaired in a project sponsored by the Minnesota Department of Transportation (DOT). Both sides of the deck were repaired using a low-slump, dense concrete overlay that incorporated a migrating corrosion inhibiting admixture in one side while the other was left untreated as the control. The treated westbound lanes have served as a real-world comparison of corrosion current reduction vs. the untreated “control” eastbound lanes (Figure 2).

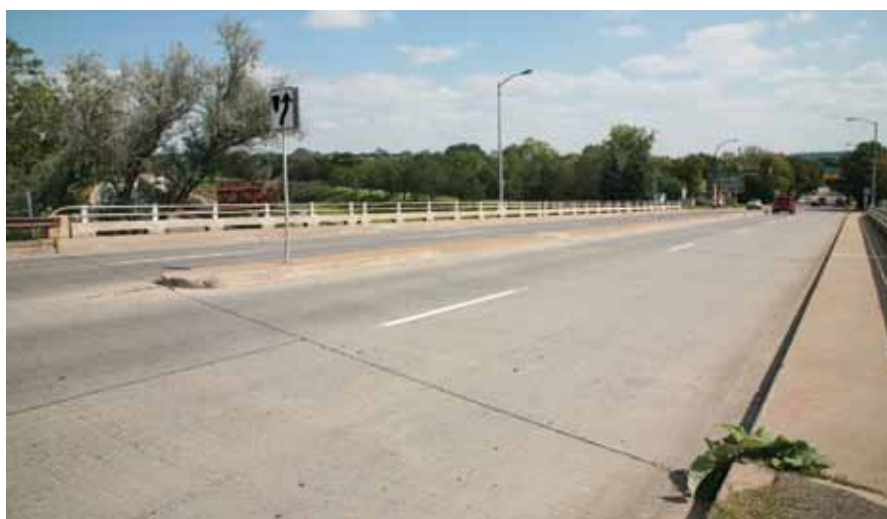
**FIGURE 2**

The westbound lanes of the Randolph Avenue Bridge were treated with a migrating corrosion inhibiting admixture and compared to the eastbound lanes that were refurbished with an untreated concrete overlay.

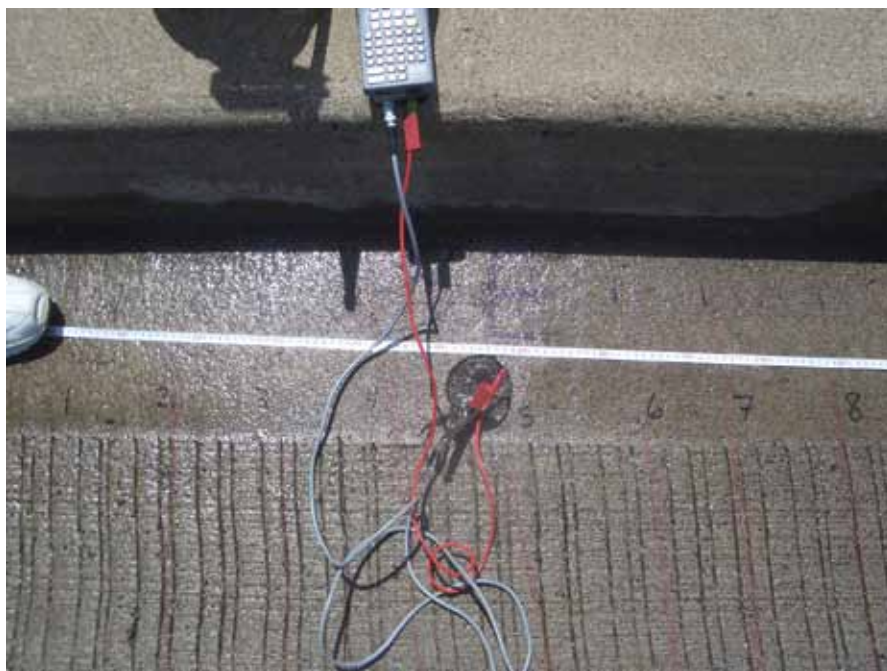
**FIGURE 3**

Linear Polarization Device 3 was used to help determine corrosion current, corrosion rate, and concrete resistivity on the concrete bridge decks.

potential readings were performed. Linear polarization readings using Linear Polarization Device 2 and a Galvapulse<sup>†</sup> (Linear Polarization Device 3) instrument (Figure 3) were also taken to determine corrosion current, corrosion rate, and concrete resistivity.

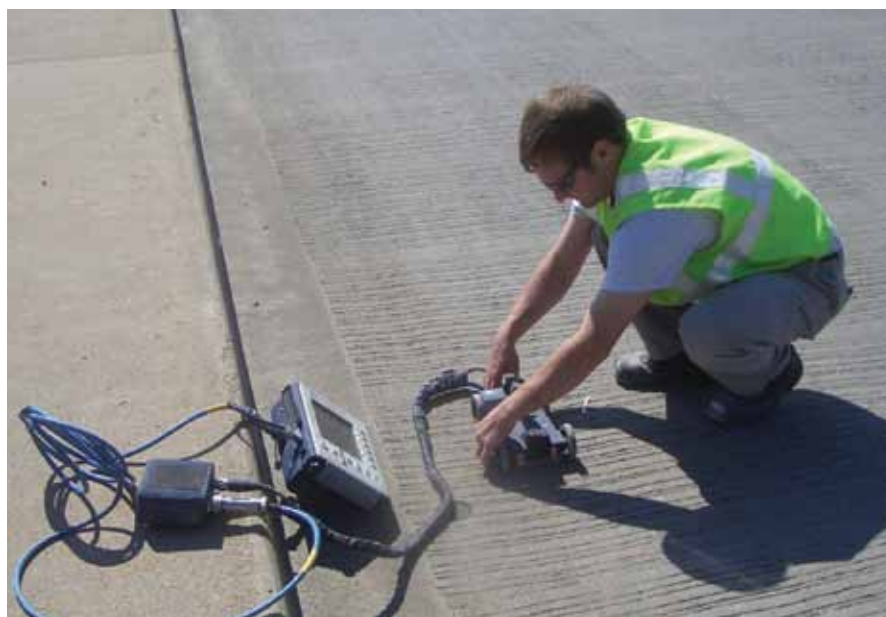
FIGURE 4

Ground-penetrating radar was used to locate reinforcing steel in the bridge.

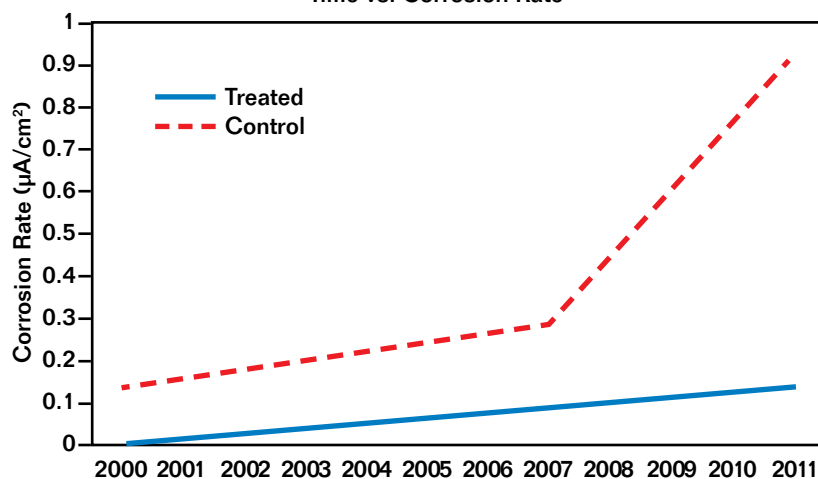
FIGURE 5

Time vs. Corrosion Rate

Average corrosion rates of the Randolph Avenue Bridge.

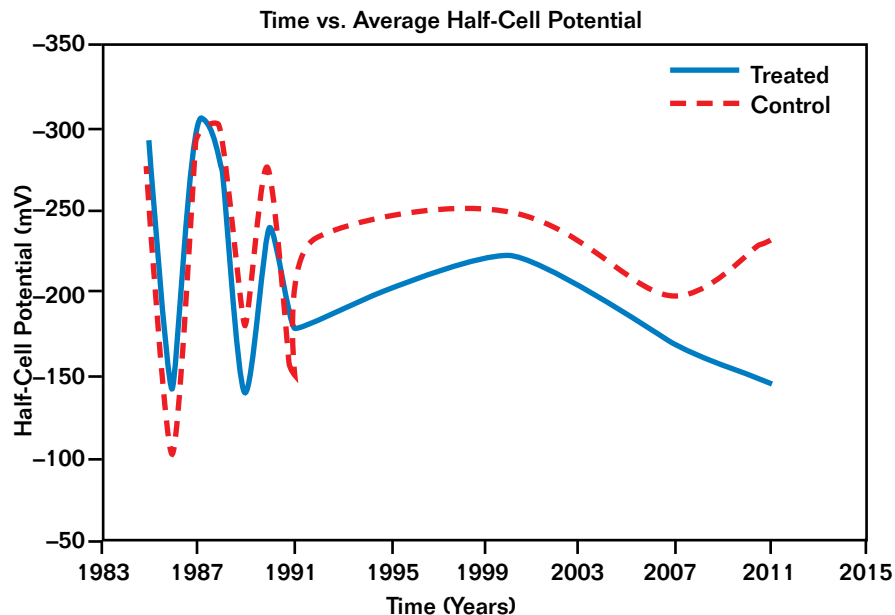
FIGURE 6

Average half-cell potentials of the Randolph Avenue Bridge.

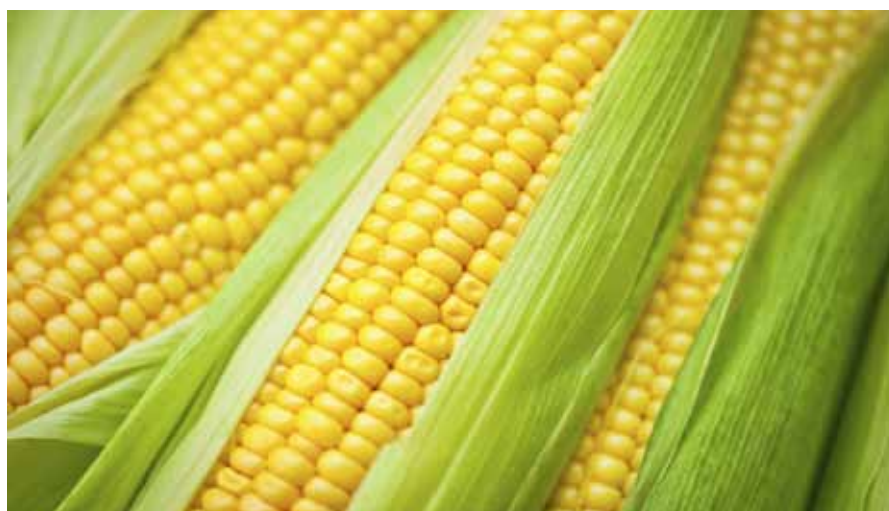
FIGURE 1

A variety of corn-derived byproducts were analyzed for use as corrosion inhibitors.

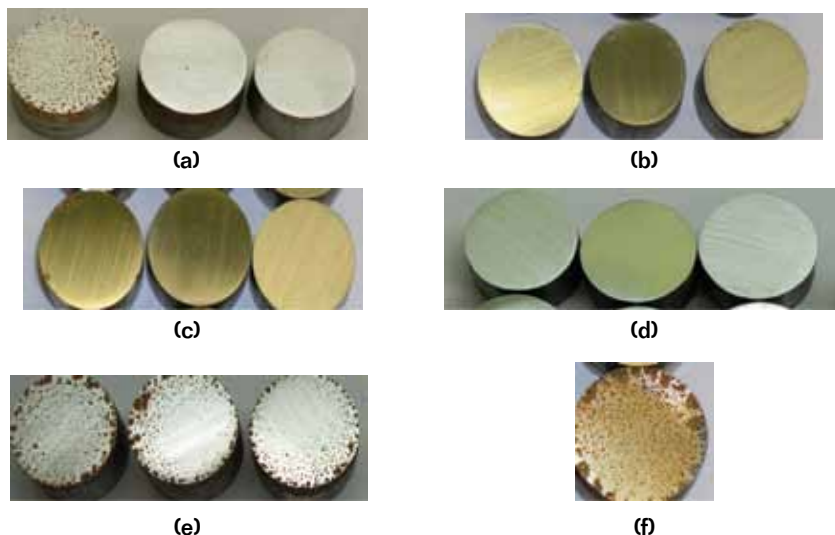
**FIGURE 2**

VIA test results of 5 g of sugar beet molasses: (a) as received, (b) raffinate distillate, (c) raffinate pot residue, (d) NH<sub>3</sub>-treated molasses, (e) NH<sub>3</sub> only, and (f) control.

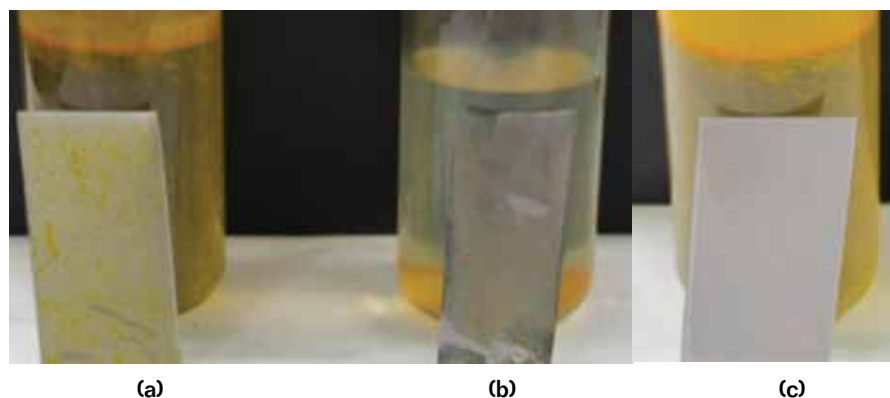
**FIGURE 3**

Steel coupons after removal from saltwater immersion test: (a) 0.5% DDGS extract, (b) control, and (c) cleaned coupon from (a).

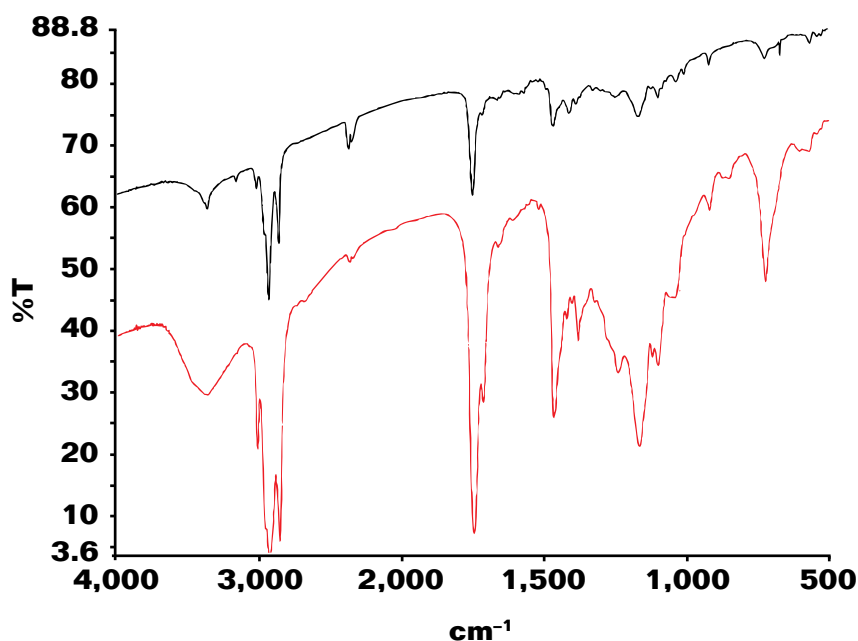
FIGURE 4

FTIR spectrum of solvent extract (red) and aqueous extract (black).
