CUTTING OUT CORROSION

REMEDIAL WORK IS GIVING THE SEVERN BRIDGE SUSPENSION CABLES A NEW LEASE OF LIFE

BY KATHERINE SMALE

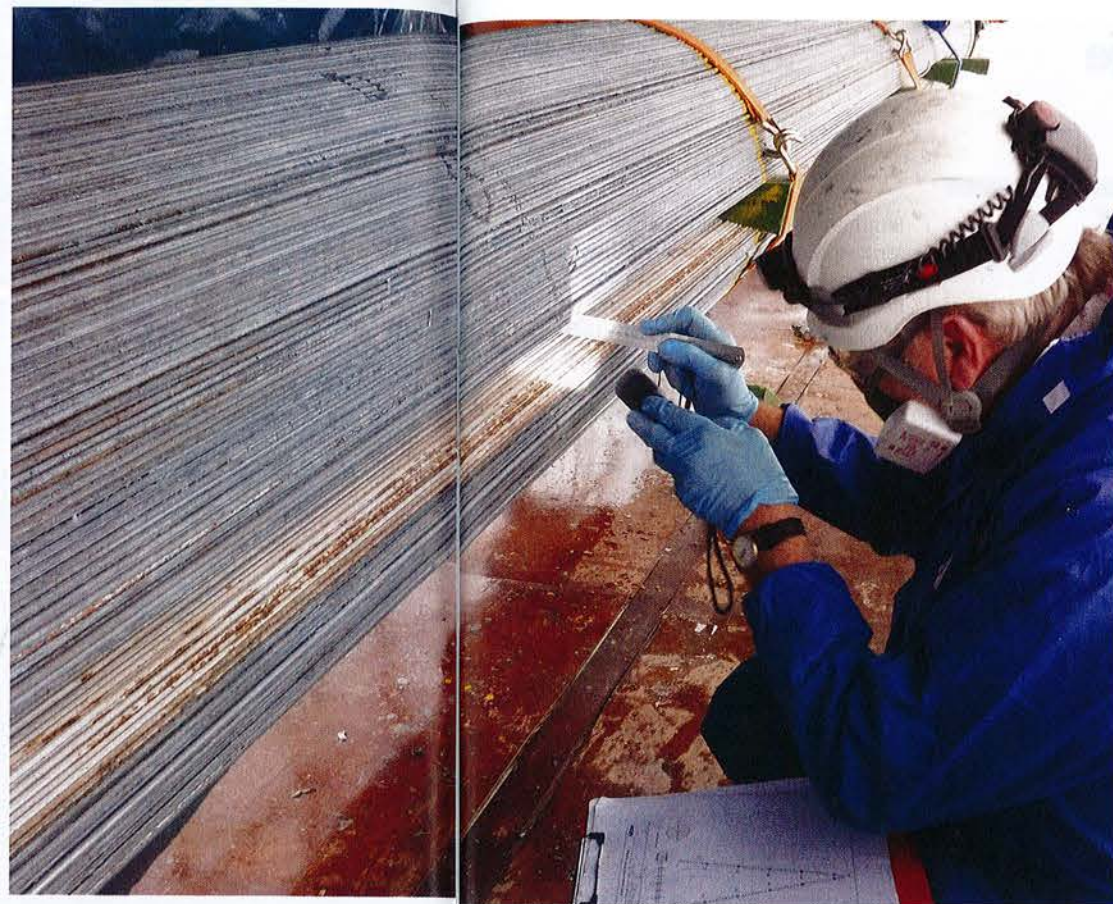
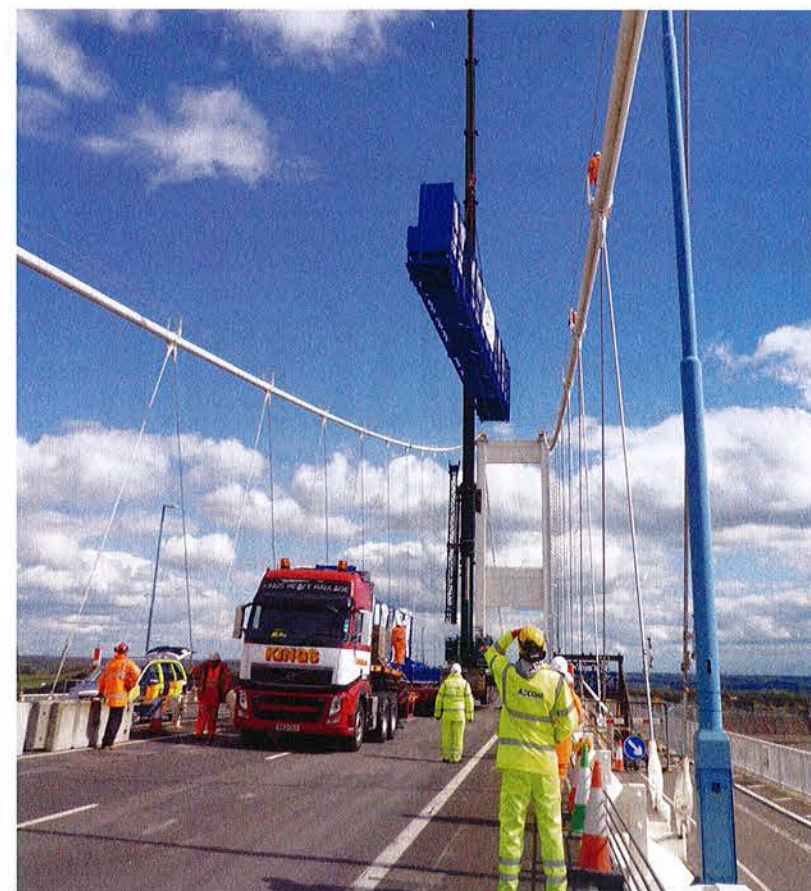
Left: Stripped cables are inspected for corrosion and breaks
Right: The high level inspection scaffolding is lifted into place

The inspections themselves were akin to open heart surgery. Each of the cables was first stripped of its white protective polyethylene sheath, the original red lead paint was then removed to expose the 8,322 individual 5mm diameter parallel high-tensile steel strands which make up the overall main cable.

Inspecting the cables higher up was also a challenge. Each area has had to be inspected from a 30m long, high level scaffolding system which was hoisted up to wrap around the cable.
