## **Galvanic Liquid Applied Coating for the Protection of Concrete Reinforcement**

**Andrea Hansen  
Alla Furman  
Marlin Hansen  
Angel Green  
Jessi Meyer**

**Cortec Corporation  
4119 White Bear Parkway  
White Bear Lake, MN 55110  
ahansen@cortecvci.com**

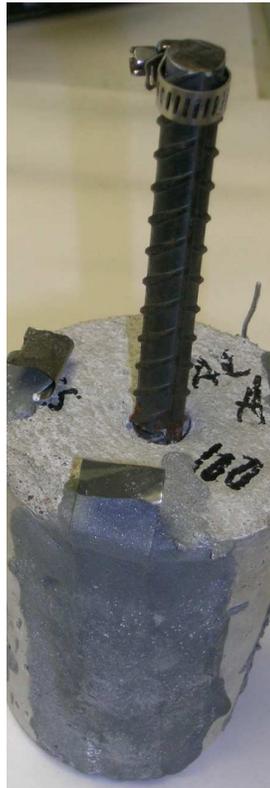
FIGURE 1 – Lollipop Set-up

3. Galvanic coating was applied onto 'lollipop' shaped samples with one embedded rebar. To accelerate the test, some of the samples were placed in a 'Salt Spray' cabinet set according to ASTM B 117<sup>4</sup> at 95°F with a constant salt fog produced from a 5% NaCl solution and some of the samples were immersed in a 3.5% NaCl solution. Electrochemical potential, current flow and 'instant off' were evaluated.

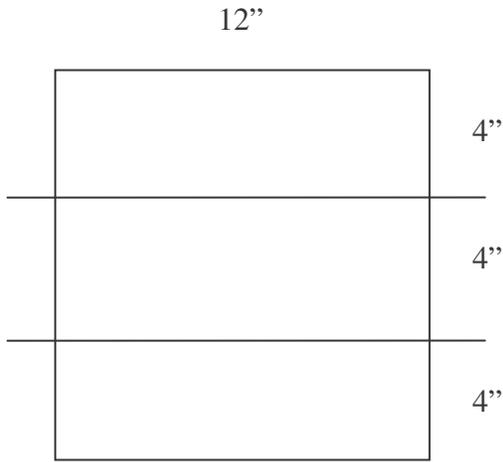
Bars have 2" cover on top and bottom  
FIGURE 2 - Slab Set-up

4. Galvanic coating was applied on a concrete block with two embedded rebars at 28mil wet

film thickness. To accelerate the test, the coated and control blocks were placed in humidity cabinet set at 105°F and with a 100% Relative Humidity. Blocks were monitored for the level of electrochemical potential for 1700 hours.

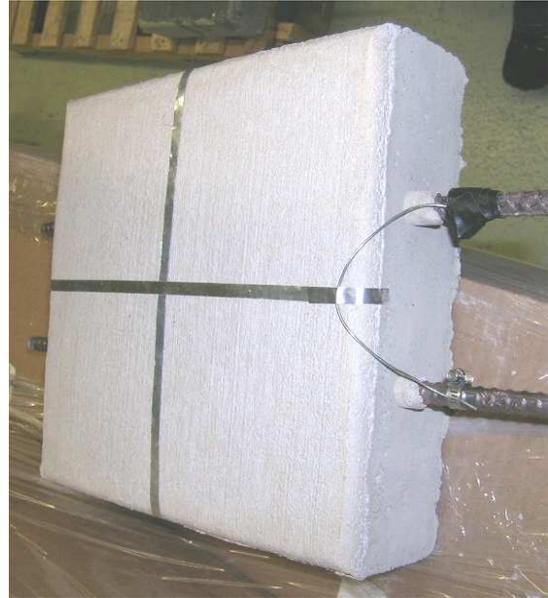
FIGURE 3 - Connection Set-up

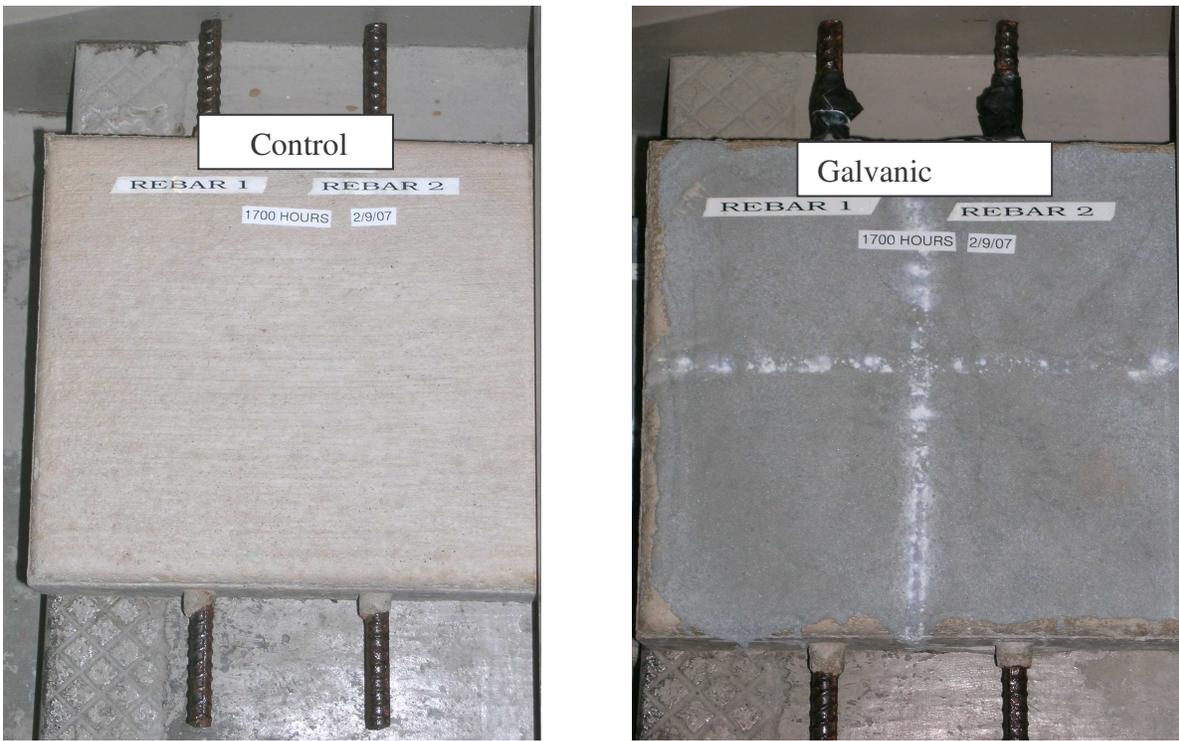
Figure 4 - Concrete Slabs After 1700 Hours in Humidity Chamber

Table four presents the results from the galvanic coating applied on concrete slabs and electrically connected with rebars. Figure four shows the concrete slabs and figure five is a graphically interpretation of the data. The data shows that a cathodic potential was provided for the rebar and was maintained during the testing time, which agrees with the testing done in table three.

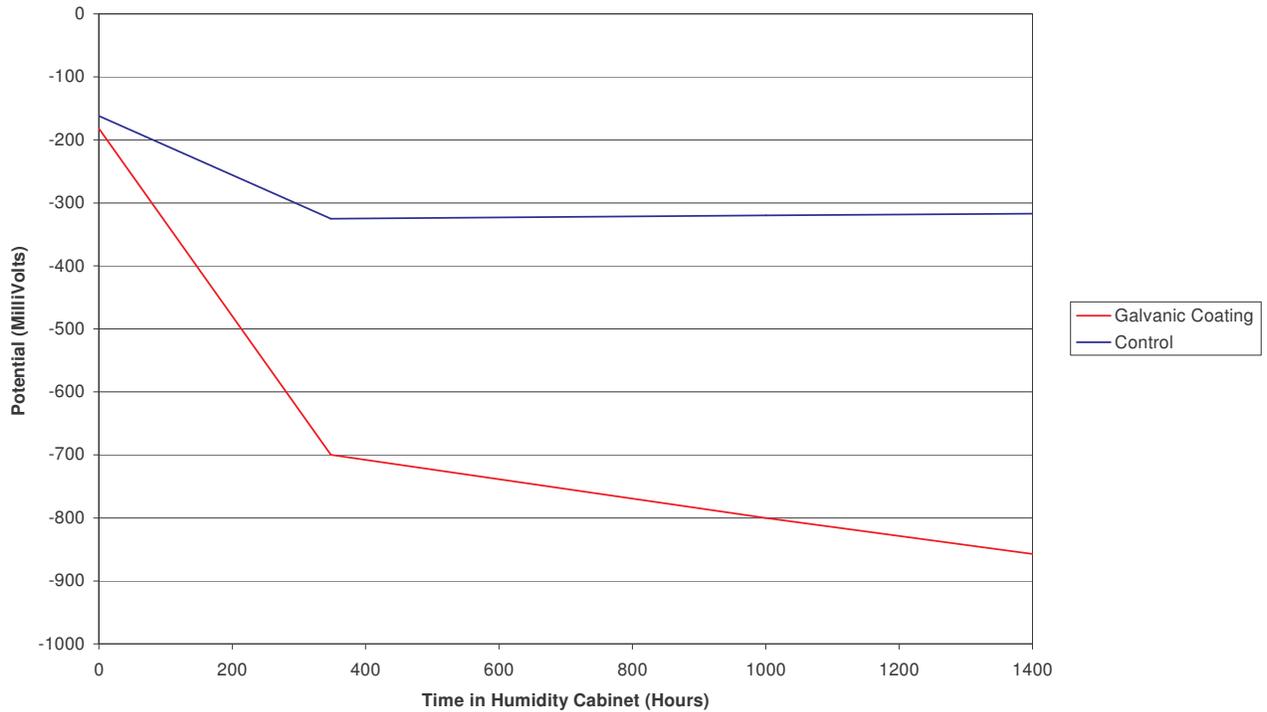
Potential of Connected Galvanic Coating vs Time

Figure 5 - Half-Cell Potentials of Embedded Rebars in Concrete Slabs

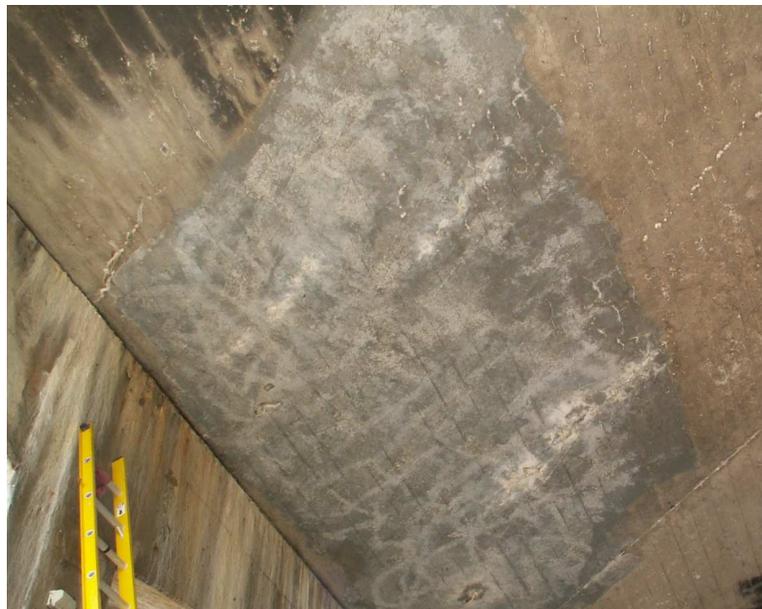
Figure 5 - View of Galvanic Coating under deck in 2007

This project has resulted in a professional looking application of the galvanic coating. The outdoor weathering to date indicates that the galvanic coating will have a white oxide form on the surface with time. But it has not had any peeling or sagging. In spite of the damp saline concrete conditions, the coating remains completely intact as it was applied. This suggests that a ten year life could be expected.

After 4 years, the half cell potentials of the coating remain lower than the half cell potentials of the rebar. The lower potential of the coating, versus the rebars, shows that the coating is acting as an anode for the rebars and when it is connected to the rebars, the coating is sacrificed as it oxidizes before the rebars. Although the coating is connected to the whole bridge deck rebar grid, the protection has been enough to stop ring anode effect corrosion around the two patches.

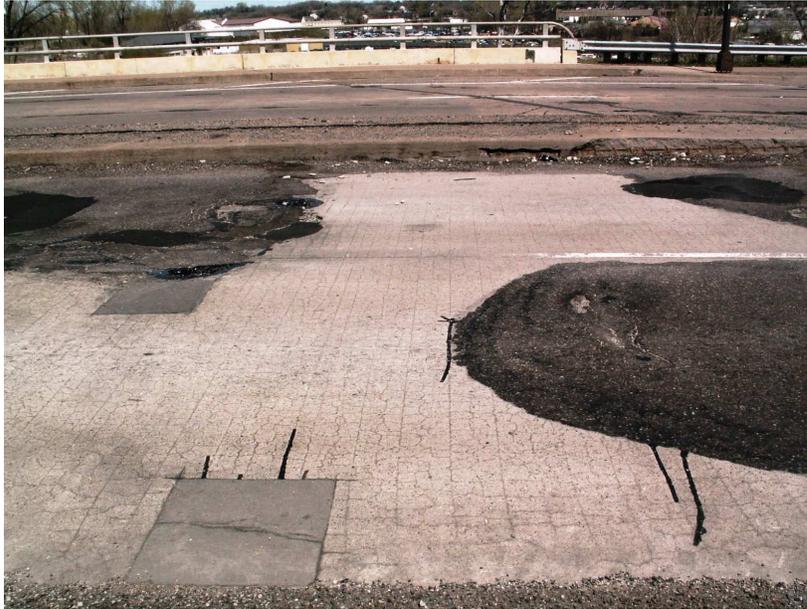
Figure 6 - View of Bridge Deck in 2007

The patches were averaging a life span of about 3 years in between repairs before the galvanic coating was applied because of the high chloride environment. After four years, there were no visual signs of ring anode affect or spalling of the patches.

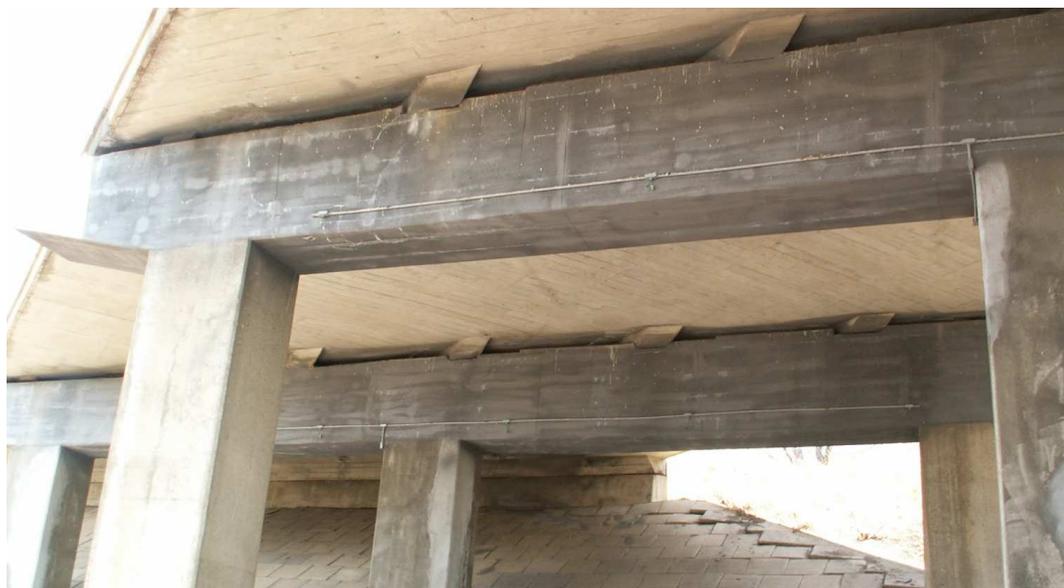
Figure 7 - Bridge piers with Galvanic Coating 4/2007

This project has resulted in a very professional looking application of the galvanic coating. The outdoor weathering to date indicates that the galvanic coating will have white oxide form on the surface with time. It has not had any peeling or sagging. See photos at the end of this report.

After winter deicing cycles, and as the concrete loses its alkalinity, it would be expected that the corrosion current would increase. Recent galvapulse measurements of the rebars in the bridge showed a range of 1.7-3.7 $\mu\text{A}/\text{cm}^2$  (average of 2.7 $\mu\text{A}/\text{cm}^2$ ) on the side protected by the galvanic liquid coating versus a range on the control side of 3.5-19.6 $\mu\text{A}/\text{cm}^2$  (average of 8.3 $\mu\text{A}/\text{cm}^2$ .)

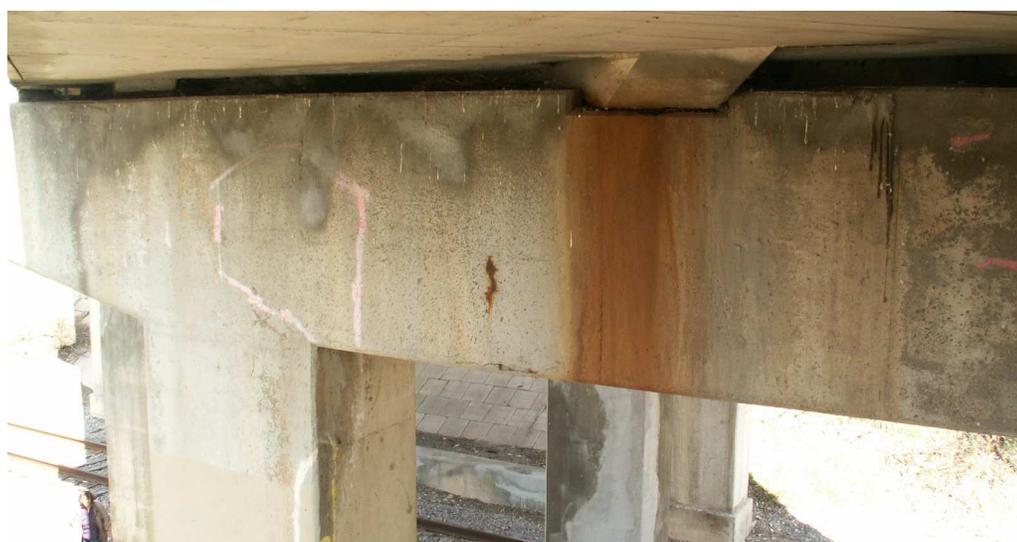
Figure 8 - Bridge piers without Galvanic Coating 4/2007
