**Protection of Offshore Platform Caisson Legs with a Vapor
Corrosion Inhibitor- A Case Study**

Talal A. Rahman Al-Sayed
Ahmed Fathi Eid
Mahdi Mohamed Al-Marzooqi

Abu Dhabi Marine Operating Company
(ADMA-OPCO)
United Arab Emirates

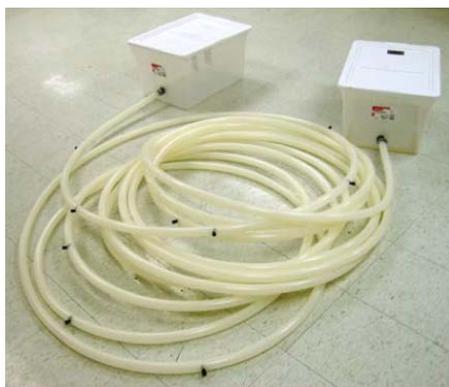
Figure 1: Testing apparatus for verifying VCI diffusion with no air movement

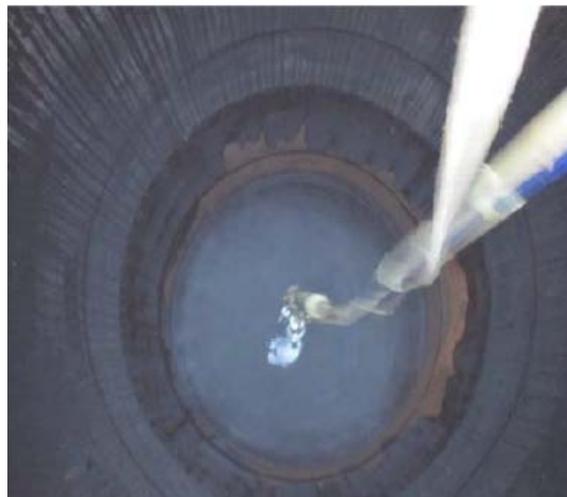
The original intention was to apply Inhibitor A using a three lance spray system. However, prior to adoption of this system, the Painting Section conducted a trial using their pipe coating system hung in the center of the leg. The pipe coater (Figure 1) was hung using a single sheave pulley attached to the scaffolding. The trial was successful and this application methodology was adopted. The application was carried out in one run starting from the bottom section going up. The pipe coater was raised slowly as it applied a pre-calculated quantity of product to ensure the entire uncoated surface was well covered. It took approximately 15 minutes to apply all the materials.

Figure 2: Application of Inhibitor A using a pipe coater

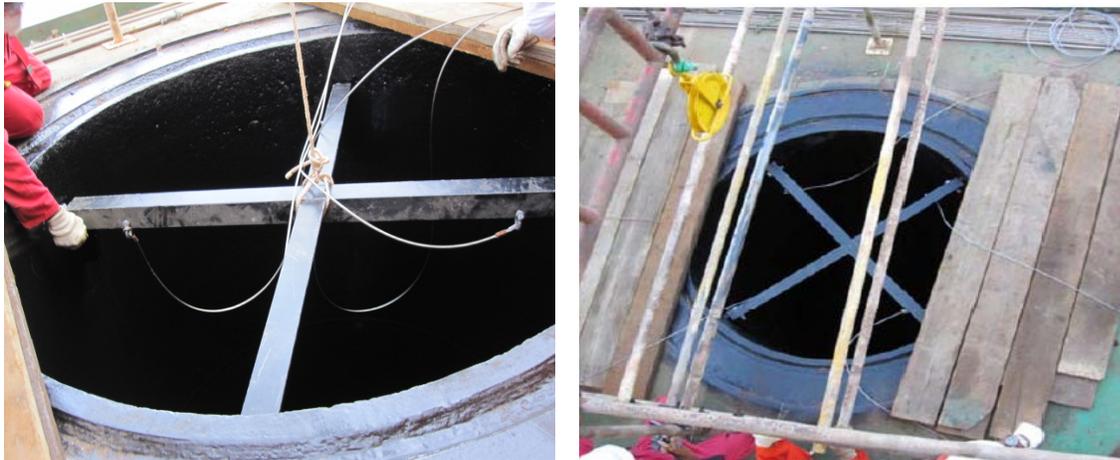
Cross-angle bars were fabricated and bolted to the welded pad eyes inside the caisson legs (Figure 2). Inhibitor B pouches were attached through their button holes to a 6mm Stainless steel wire rope, which was then lowered down the leg. Three sets of pouches on wire were suspended. The first set of pouches accidentally detached when the buttonholes failed to hold the pouches. The other two sets were suspended successfully.

Figure 3: Steel frame setup for suspending Inhibitor B pouches.

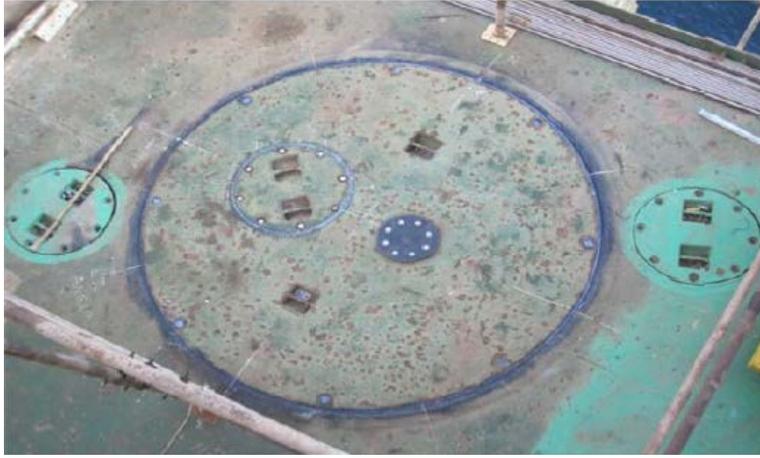
The caisson leg was then covered with a 15 mm steel plate (Figure 4) with an opening for carbon steel weight loss corrosion coupons attached to a small plate cover using a wire rope. Corrosion coupons were introduced to monitor and evaluate the effectiveness of the protection system.

Figure 5: Caisson Leg Sealed Cover

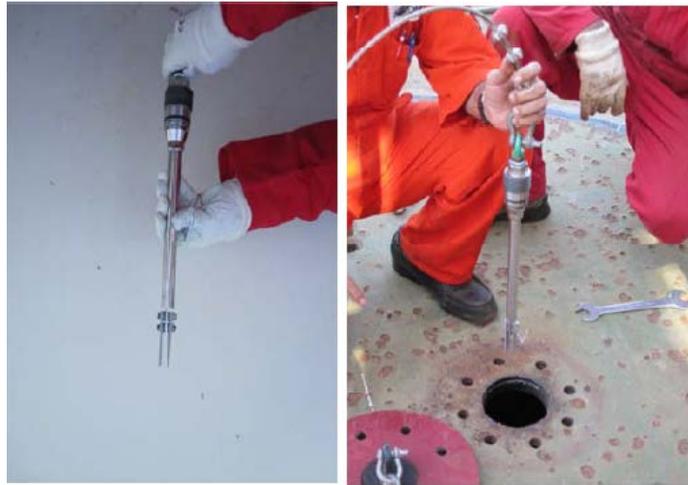
The corrosion coupons were retrieved and evaluated at different intervals (Table 1). The first such evaluation was in October 2011, one year after the pilot, when corrosion rate of 0.29 mils per year (mpy) was recorded. In January of 2012, the coupons were again evaluated as per ASTM G4-01⁶ and found to have corroded at a rate of 0.11 mpy.

Figure 6: Weight Loss Corrosion Coupons

Since there was no control against which these results can be benchmarked, similar corrosion coupons were introduced in December 2010 in two control caisson legs that had not been emptied. Being full of water, one coupon was immersed in the treated water while another was installed in the overhead above the water line.

By September 2012, corrosion rate for the pilot leg was 0.45 mpy while the control leg corroded at an average of 12.90 mpy above the water line and 0.97 mpy under the water line.

In March 2013, the corrosion rate for the pilot leg increased to 3.18 mpy while the control leg corroded at an average of 16.50 mpy above the water line and 1.17 mpy under the water line.
