Laboratory Test to Evaluate the Vapor-Inhibiting Ability of VpCI309A for Temporary Protection of Ferrous Surfaces

CORTEC Corporation

Behzad Bavarian and Lisa Reiner
California State University, Northridge, USA 91330

November 2018

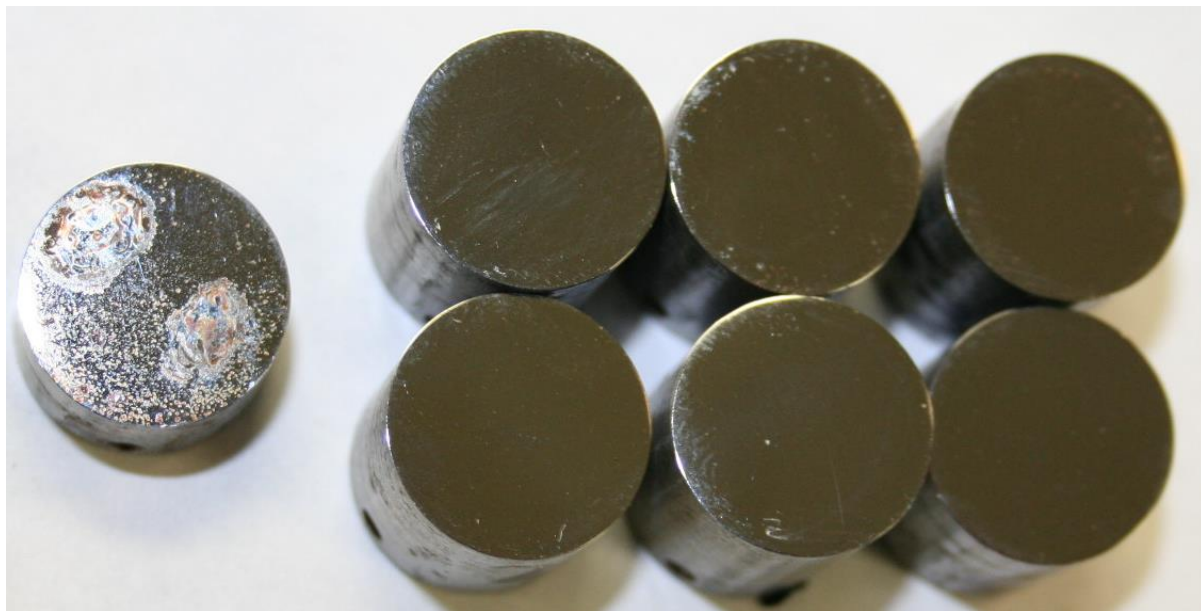
Typical visual patterns for rating VIA test results

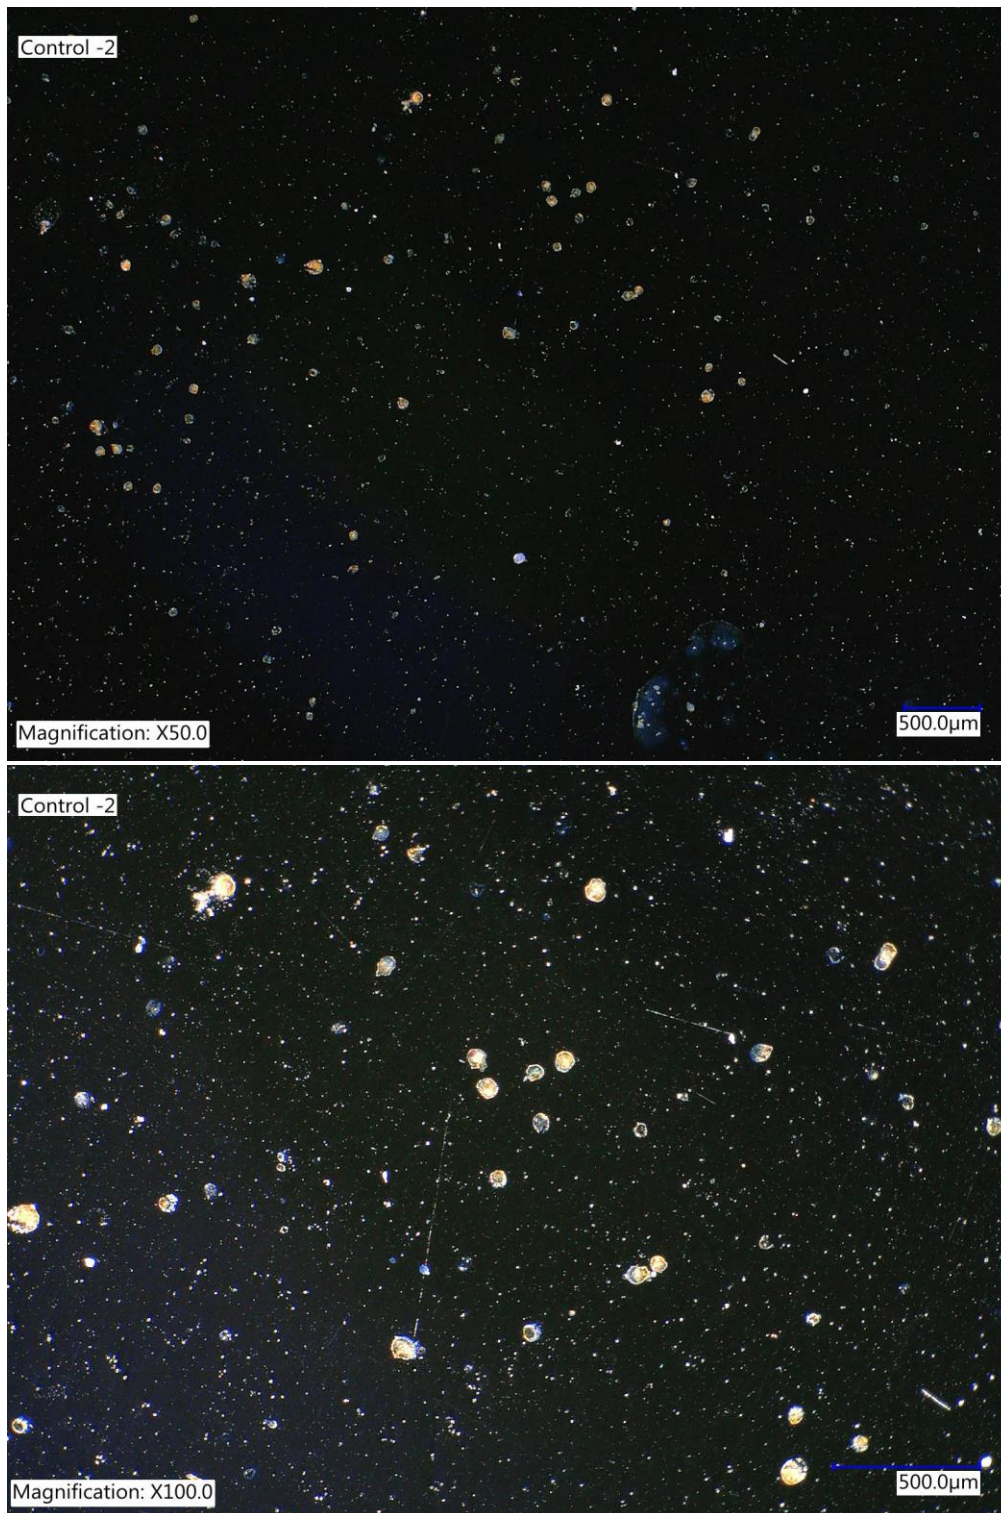
Control#2, grade 0

Fig. 3: Optical micrographs of the Control sample#2 in TM0208 VIA test.

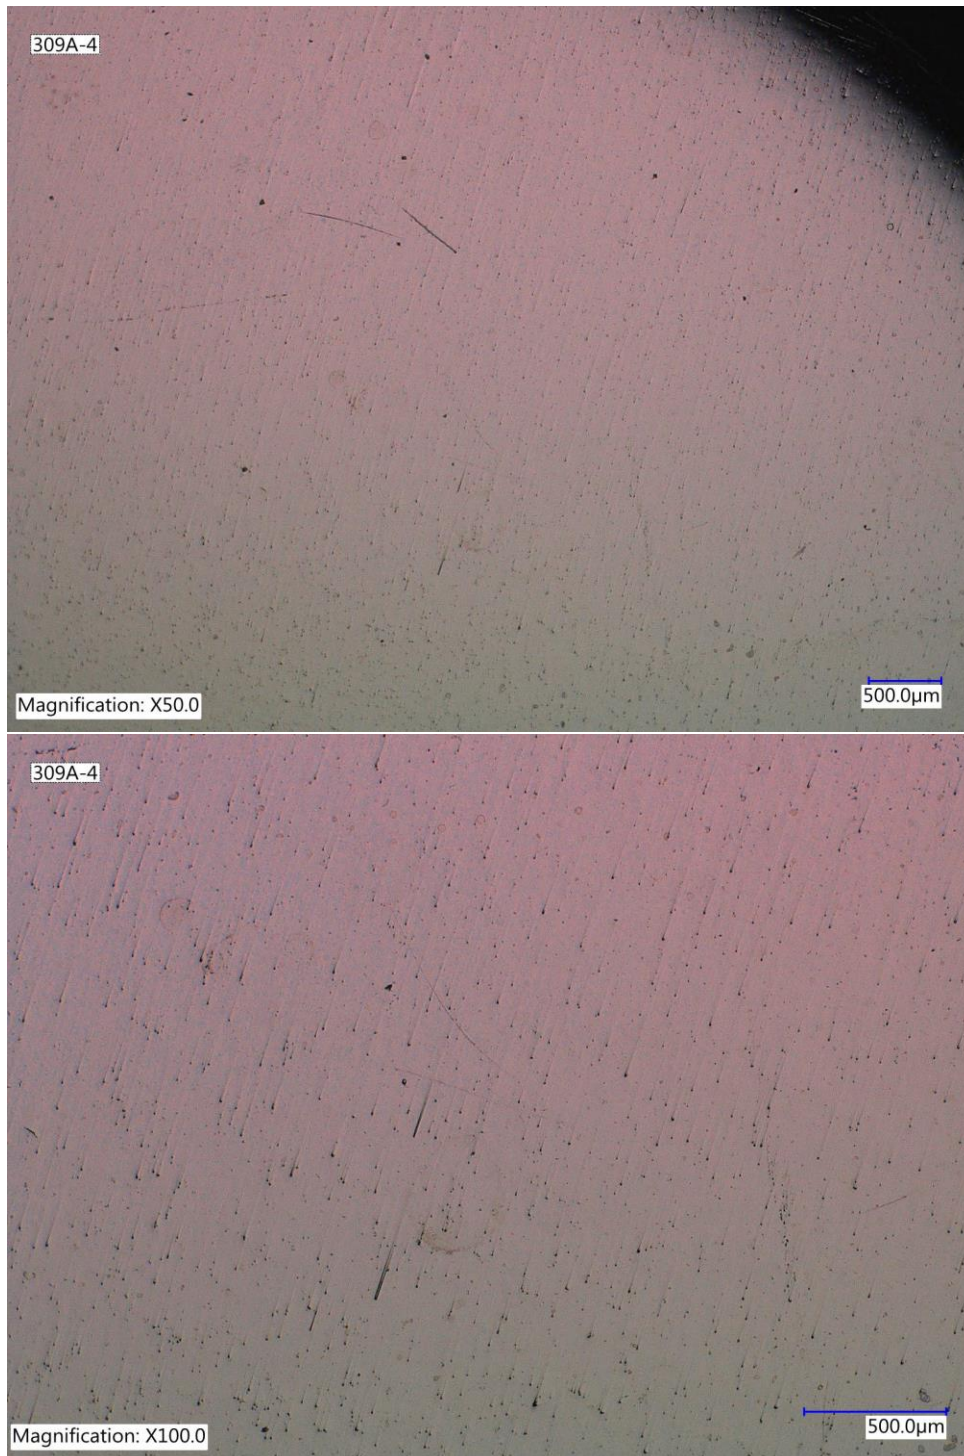
Fig. 8: Optical micrographs of the sample #4 exposed VpCI 309A in TM0208 VIA test, Grade 3.
