## Evaluating VpCI-325 and Castrol Oil for Protection of Taurus Gun Barrels

**Purpose:** Compare the corrosion protection of VpCI-325 and Castrol Safe Coat oil on gun barrels

Project #: 07-166-1825

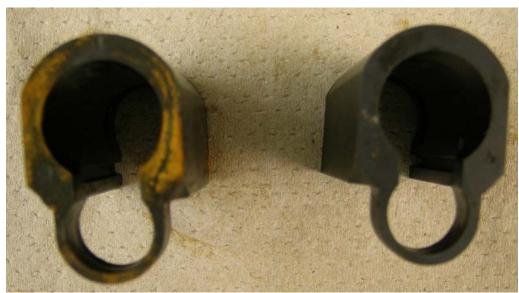
After 96 hours in ASTM B 117 Salt Spray. Castrol on left, VpCI-325 on right.

When moved to salt spray, corrosion occurred much faster, and results were more dramatic. The piece dipped in Castrol oil started to corrode after 48 hours, and had corroded significantly after 96 hours. After 96 hours, the first small spots of corrosion were also present on the piece dipped in VpCI-325. At that point, both pieces were pulled from testing.
