## **Evaluating Rust Preventatives for Customer**

**Project** #: 12-187-1825.bis

**Date:** September 10, 2012

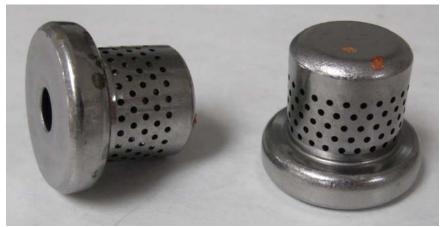
Parts Treated with BioCorr

The results of this test are comparable to the previous test for customer. Cleaner RP-10 only provided corrosion protection about twice as long as not using a rust preventative. BioCorr significantly extended the life of the part by protecting over 20 times as long as the control sample. The photographs after 48 hours in the chamber reinforce the results that BioCorr is the better rust preventative.

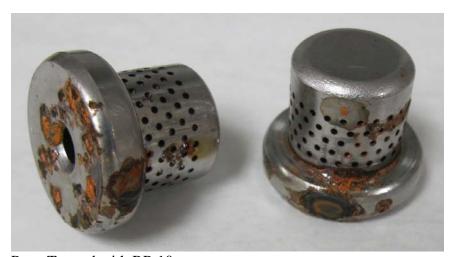
Parts Treated with RP-10
