Comparing VpCI Packaging Films for Customer

Project #: 13-039-1125.bis

Date: May 14, 2013

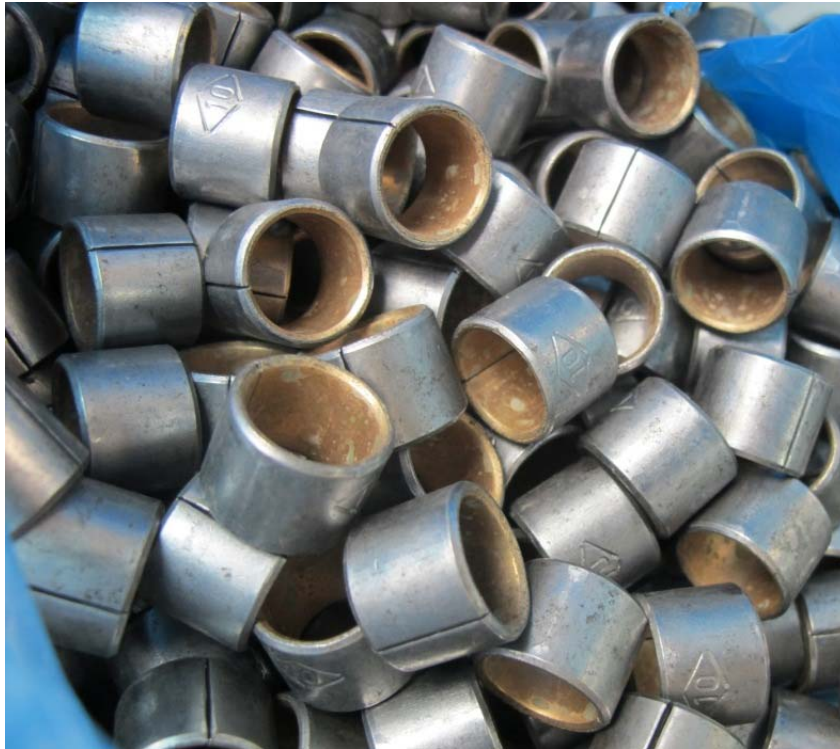
Figure 1: Bushings found to be corroded upon receipt. These parts were not tested.

- 1) Two bags of bushings were visually inspected prior to testing.
 - a. One of the bags contained parts that were almost all tarnished on the inside (copper) portion of the bushing. These parts were not tested.

Interpretations: Two bags of bi-metal bushings were sent from customer. One bag contained hundreds of bushings that were tarnished (on the copper side) and, in some cases, corroded on both sides. The remaining bushings were dirty and/or oily. The bushings dipped in DryCoat and packed in Armor VCI film were not successfully protected, as every one corroded during 336 hours of ASTM D-1748 testing. Conversely, cleaning with VpCI-416 removed this contamination and provided increased corrosion protection. The addition of BioPad increased the protection even further.

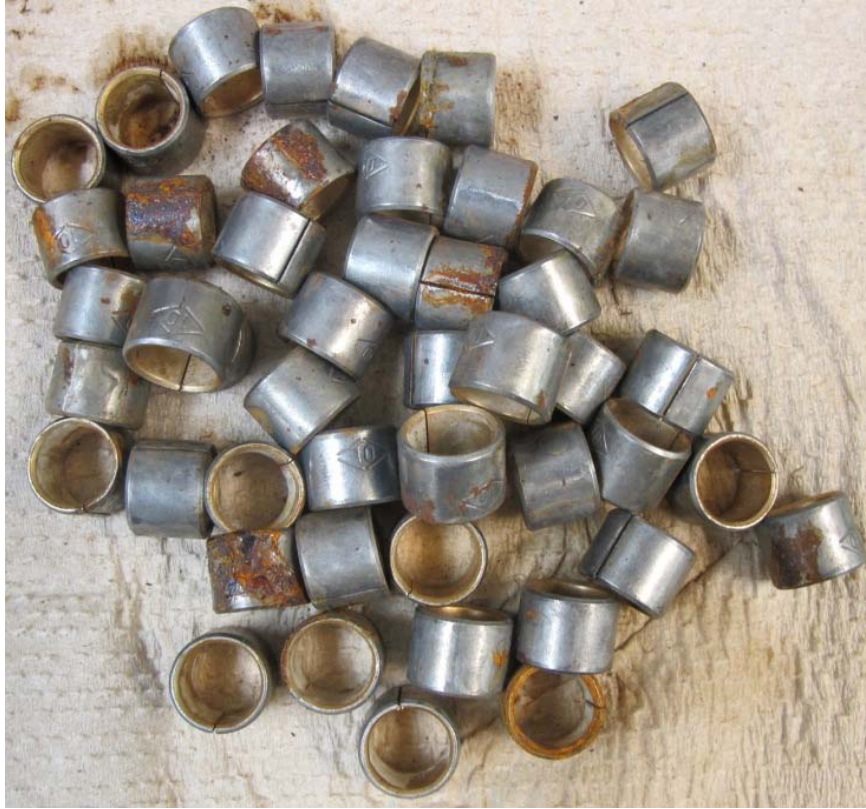
Figure 2: Dry Coat/Armor VCI treated parts, after 336 hours of testing.

- 2) After inspection, parts were broken into three groups of fifty bushings, and treated as follows:
 - a. Dipped in Dry Coat Rust Preventative (used as received), allowed to air dry, and then packed in Armor VCI bag, which was closed via heat seal.

Protection System	Parts Corroded after 336 Hours
Dry Coat/Armor VCI Film	50/50
VpCI-416/VpCI-126	12/50
VpCI-416/VpCI-126/BioPad	5/50

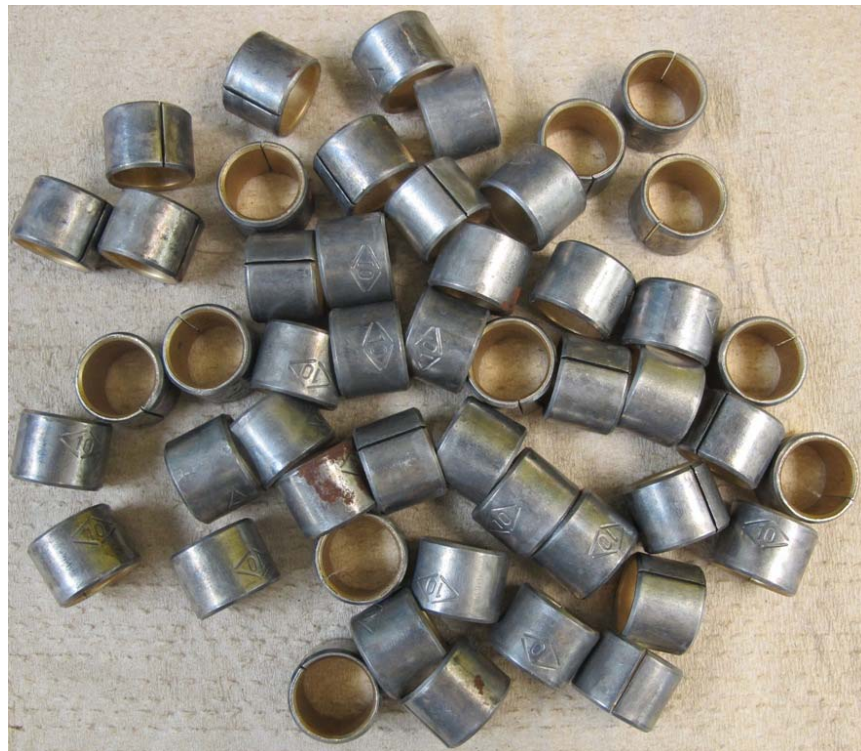
Figure 3: VpCI-416/126 treated parts, after 336 hours of testing.

- b. Immersed for 5 minutes in 10% (by volume) VpCI-416 solution, allowed to air dry, and then packed in VpCI-126 Blue Film, which was closed via heat seal.

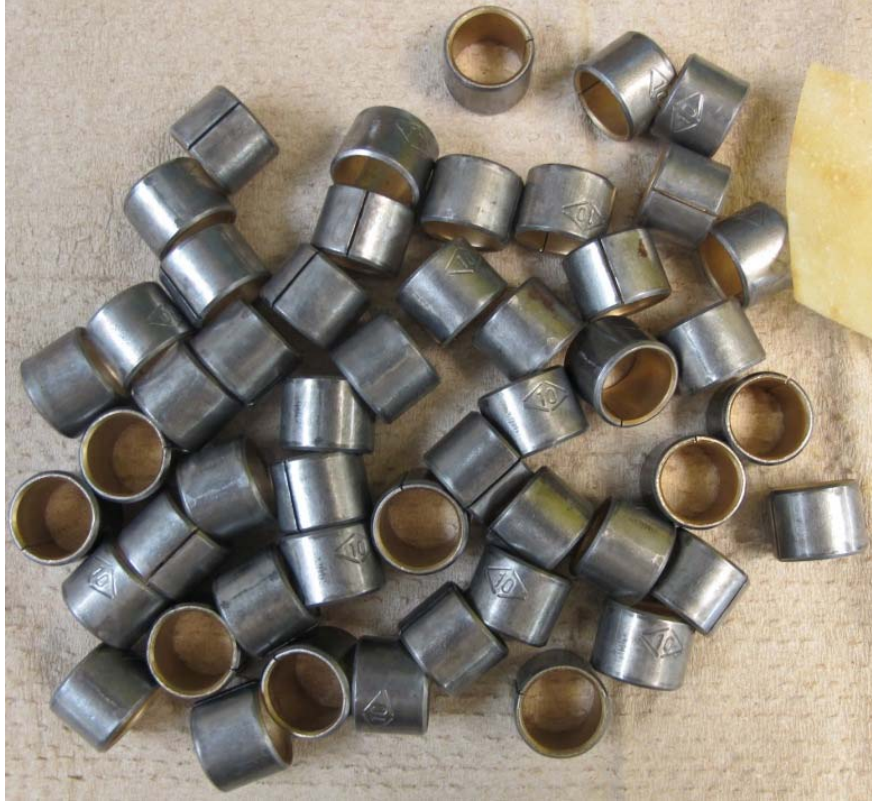
Figure 4: VpCI-416/126/BioPad treated parts, after 336 hours of testing.

- c. Immersed for 5 minutes in 10% (by volume) VpCI-416 solution, allowed to air dry, and then packed in VpCI-126 Blue Film, which was closed via heat seal.

- i. A small (~2") square of BioPad was also added to this bag.
- 3) After packing, each bag was allowed to sit overnight in ambient laboratory conditions.
