Protection of Steel Part Prior to Powder Coating

Project #: 13-236-1625.bis

Date: December 6, 2013

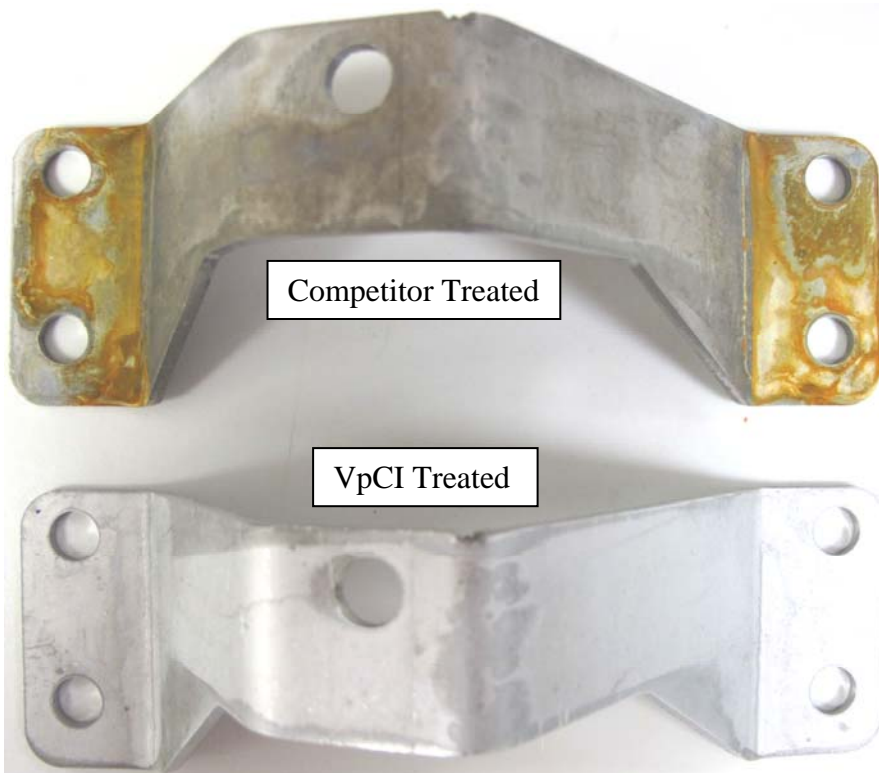
Photos:

Interpretations: Cortec treatment maintained the color and finish of the parts while the SecureKote 200 product caused flash rust and streaking on the part. The streaking may have no negative affect on the powder coat, but the flash rust will likely affect adhesion of the coating in this area. Please see the photo below to see the difference. Note that any change in the finish of the parts occurred during the rust removal process and not from the VpCI-418 LM and VpCI-440.

Product	Visual Change in the Part
Methanol	No visual change
VpCI-418 LM	No visual change
VpCI-440	No visual change
Zirtech 100M	No visual change
SecureKote 200	Flash rust on any flat section and darkening/streaking elsewhere
