Brake Pad Housings

Project #: 15-109-1125.bis

Background:

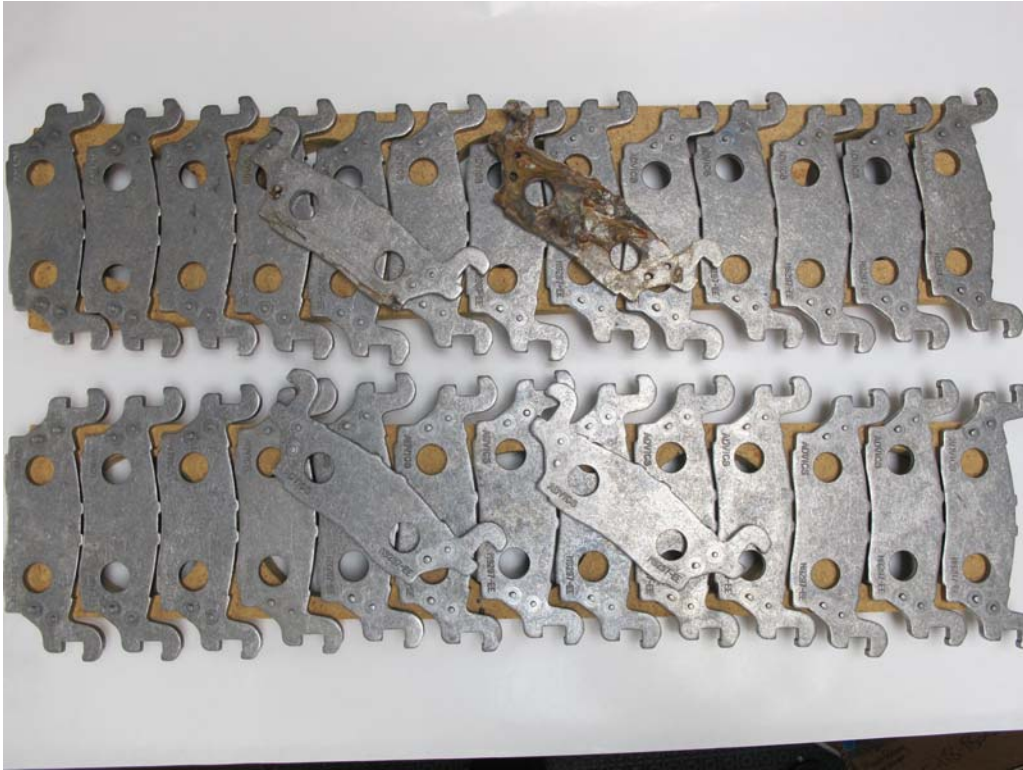
Picture 1: An overview of all parts from both bags after 360 hours in the humidity chamber. The top row is from the Armor-protected bag while the bottom row is from the Cortec-protected bag.

The Cortec-protected parts clearly show a lower level of corrosion than the Armor-protected parts. The Armor-protected parts primarily corroded on the bottom of the bag where the polyethylene was in direct contact with the metal surface. This type of corrosion was not seen in the Cortec system because VpCI-126 has contact-phase protection to discourage this type of corrosion.

The test was ceased because it appeared the water of the VpCI-126 bag was discolored in a way indicating corrosion. In fact, upon further examination of the parts from both bags the Cortec-protected parts possessed no corrosion.

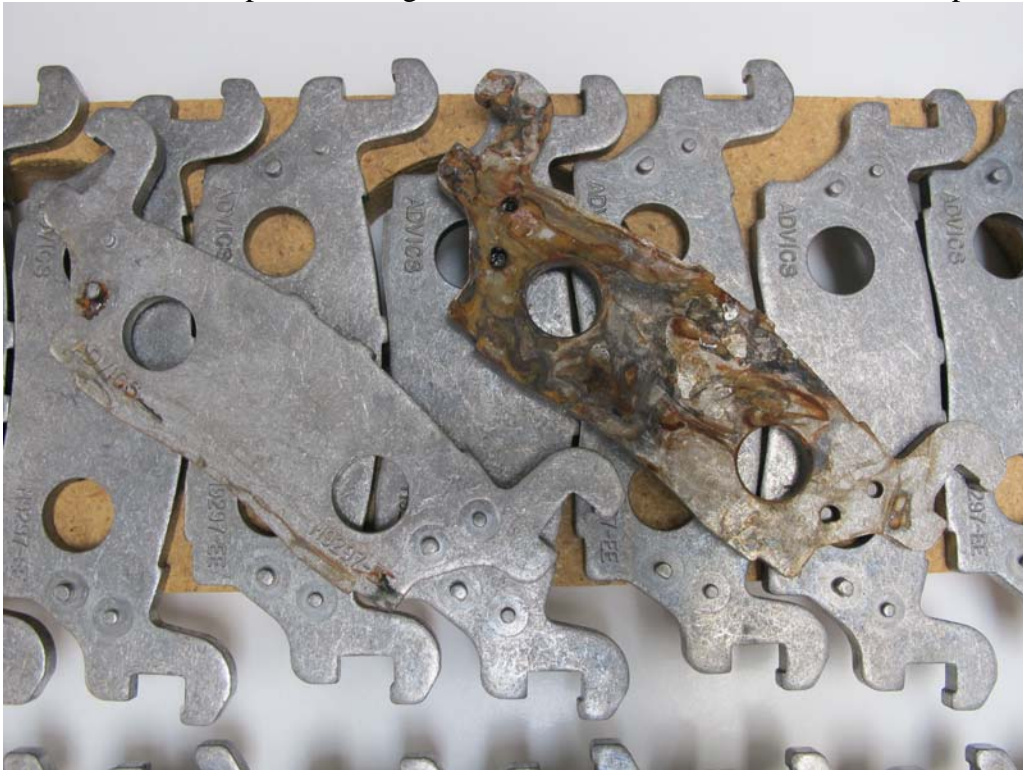
Picture 2: A closer image of the Armor-protected parts after 360 hours in the chamber. These were the parts in the bottom of the bag.
