Evaluating Corrosion Prevention Systems

Project #: 16-049-1125.bis

Background:

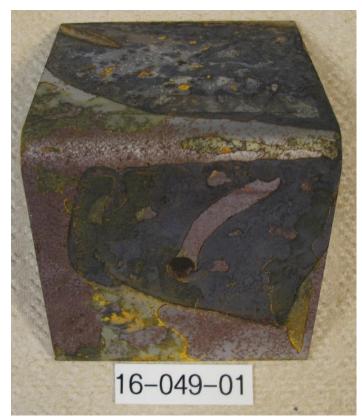
Figure 1: Part #1, after 522 hours in ASTM D-1735 testing.

After 522 hours of accelerated corrosion testing, the effectiveness of VpCI-126 was readily apparent. Whereas a cleaned part packed in non-VCI polyethylene corroded in less than 24 hours, a cleaned part packed with only VpCI-126 showed no corrosion at the end of testing. This shows an improvement of >2100%. All other systems utilizing VpCI-126 showed excellent results as well.

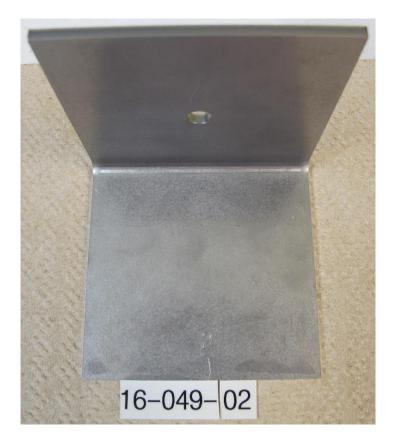
Figure 2: Part #2, after 522 hours in ASTM D-1735 testing.

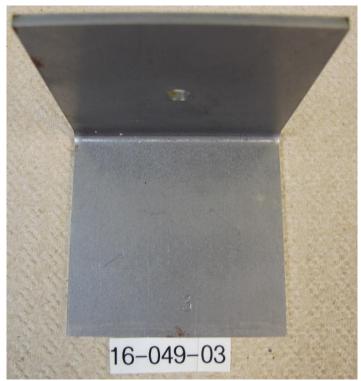
Figure 3: Part #3, after 522 hours in ASTM D-1735 testing.

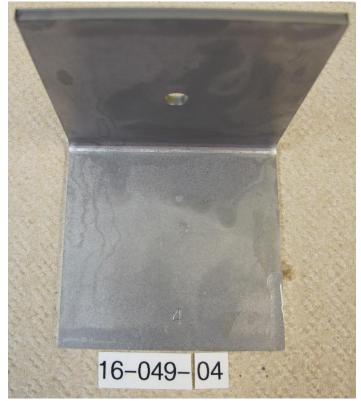
Figure 4: Part 4, after 522 hours in ASTM D-1735 testing.

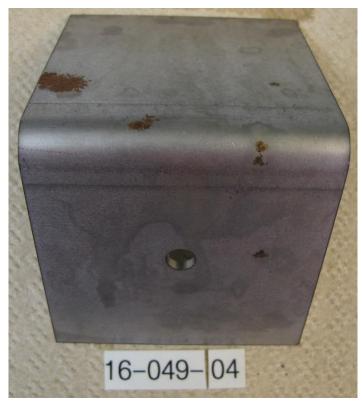
Figure 5: Part 4 (opposite side), after 522 hours in ASTM D-1735 testing.

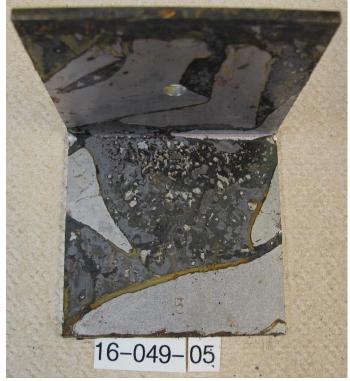
Figure 6: Part 5, after 522 hours in ASTM D-1735 testing.

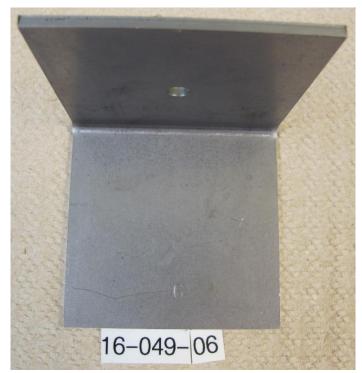
Figure 7: Part 6, after 522 hours in ASTM D-1735 testing.

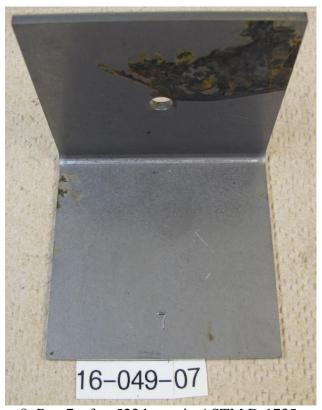
Figure 8: Part 7, after 522 hours in ASTM D-1735 testing.

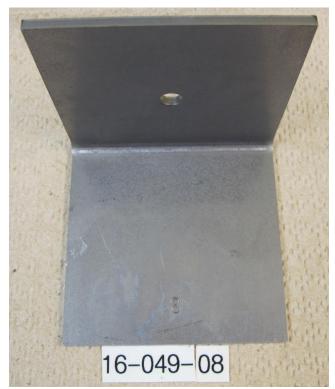
Figure 9: Part 8, after 522 hours in ASTM D-1735 testing.

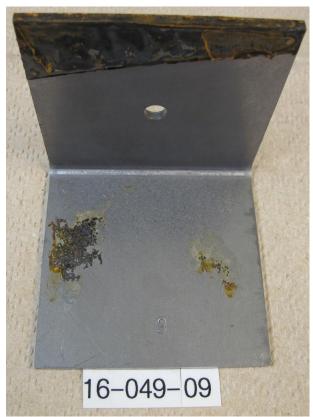
Figure 10: Part 9, after 522 hours in ASTM D-1735 testing.

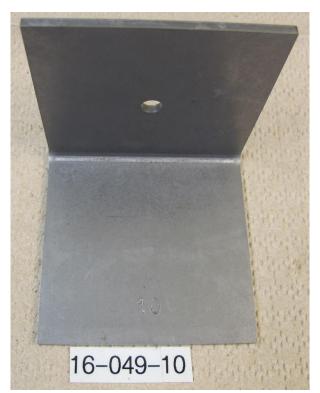
Figure 11: Part 10, after 522 hours in ASTM D-1735 testing.

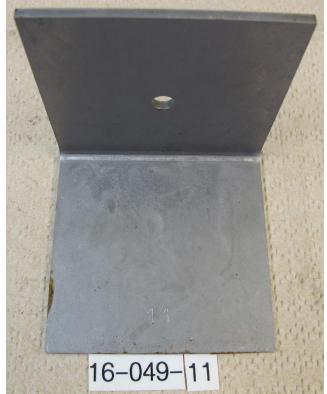
Figure 12: Part 11, after 522 hours in ASTM D-1735 testing.

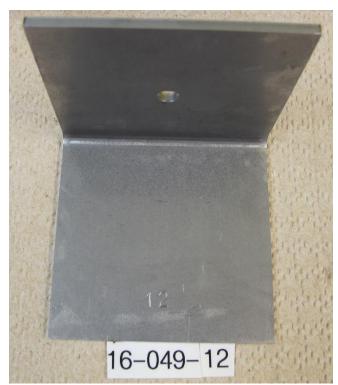
Figure 13: Part 12, after 522 hours in ASTM D-1735 testing.

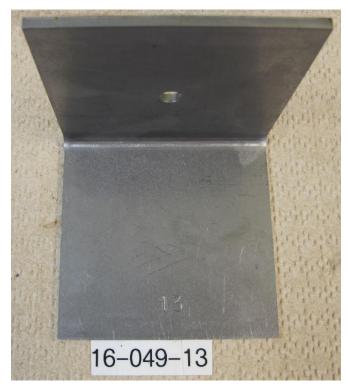
Figure 14: Part 13, after 522 hours in ASTM D-1735 testing.

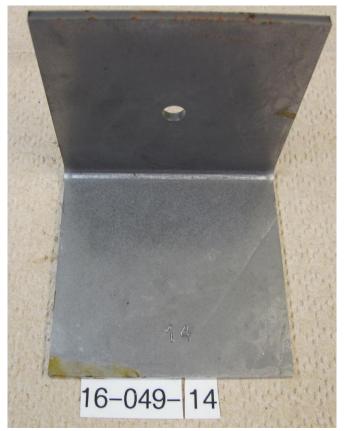
Figure 15: Part 14, after 522 hours in ASTM D-1735 testing.

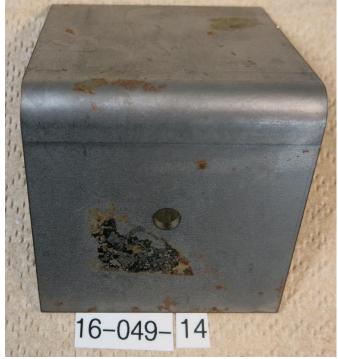
Figure 16: Part 14 (opposite side), after 522 hours of ASTM D-1735 testing.
