Comparing Chemetall Protexo 1125 to VpCI-325 on Connecting Rods

Project #: 16-226-1825.bis

The customer is a world leader in the design, manufacture, and supply of metal-formed components and assemblies for powertrain applications. The customer manufactures connecting rods, and utilizes Chemetall Protexo 1125 as a rust preventive liquid. The efficacy of this product will be evaluated and compared to VpCI-325.

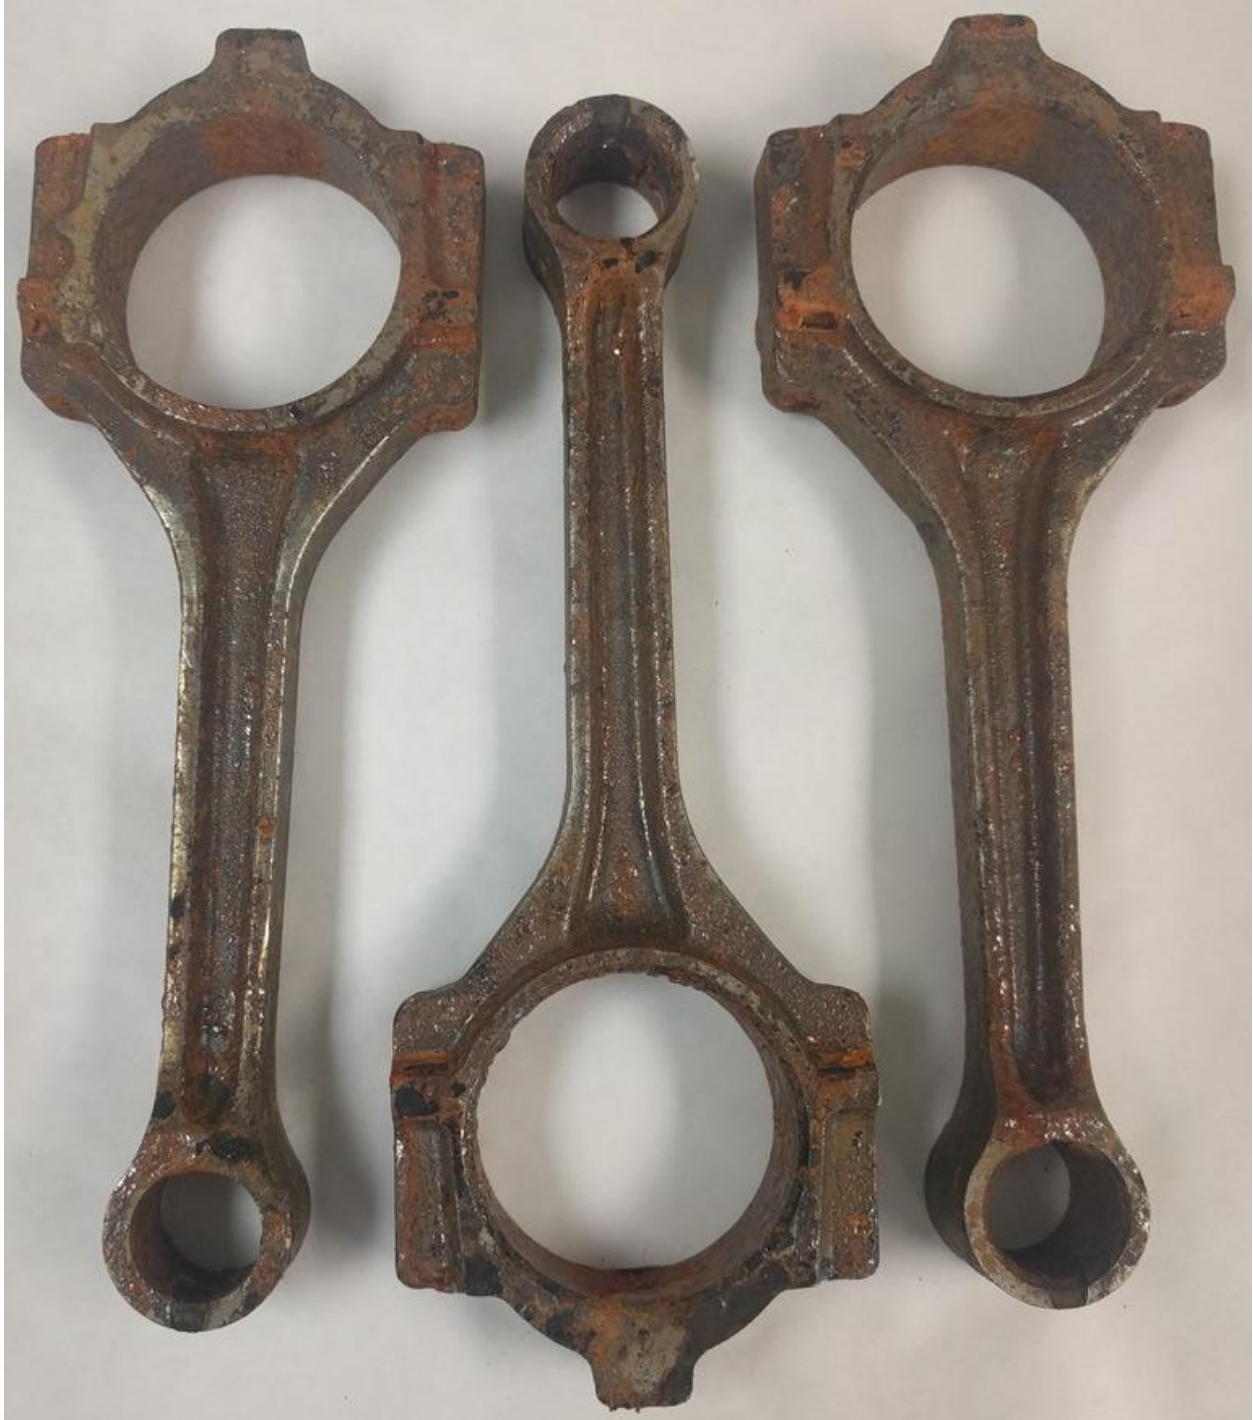
Photo 1: Control connecting rods, after 744 hours in accelerated corrosion testing.

Treatment	Time to Failure (Hours)
None (Control)	72*
Chemetall Protexo 1125	336
VpCI-325	720*

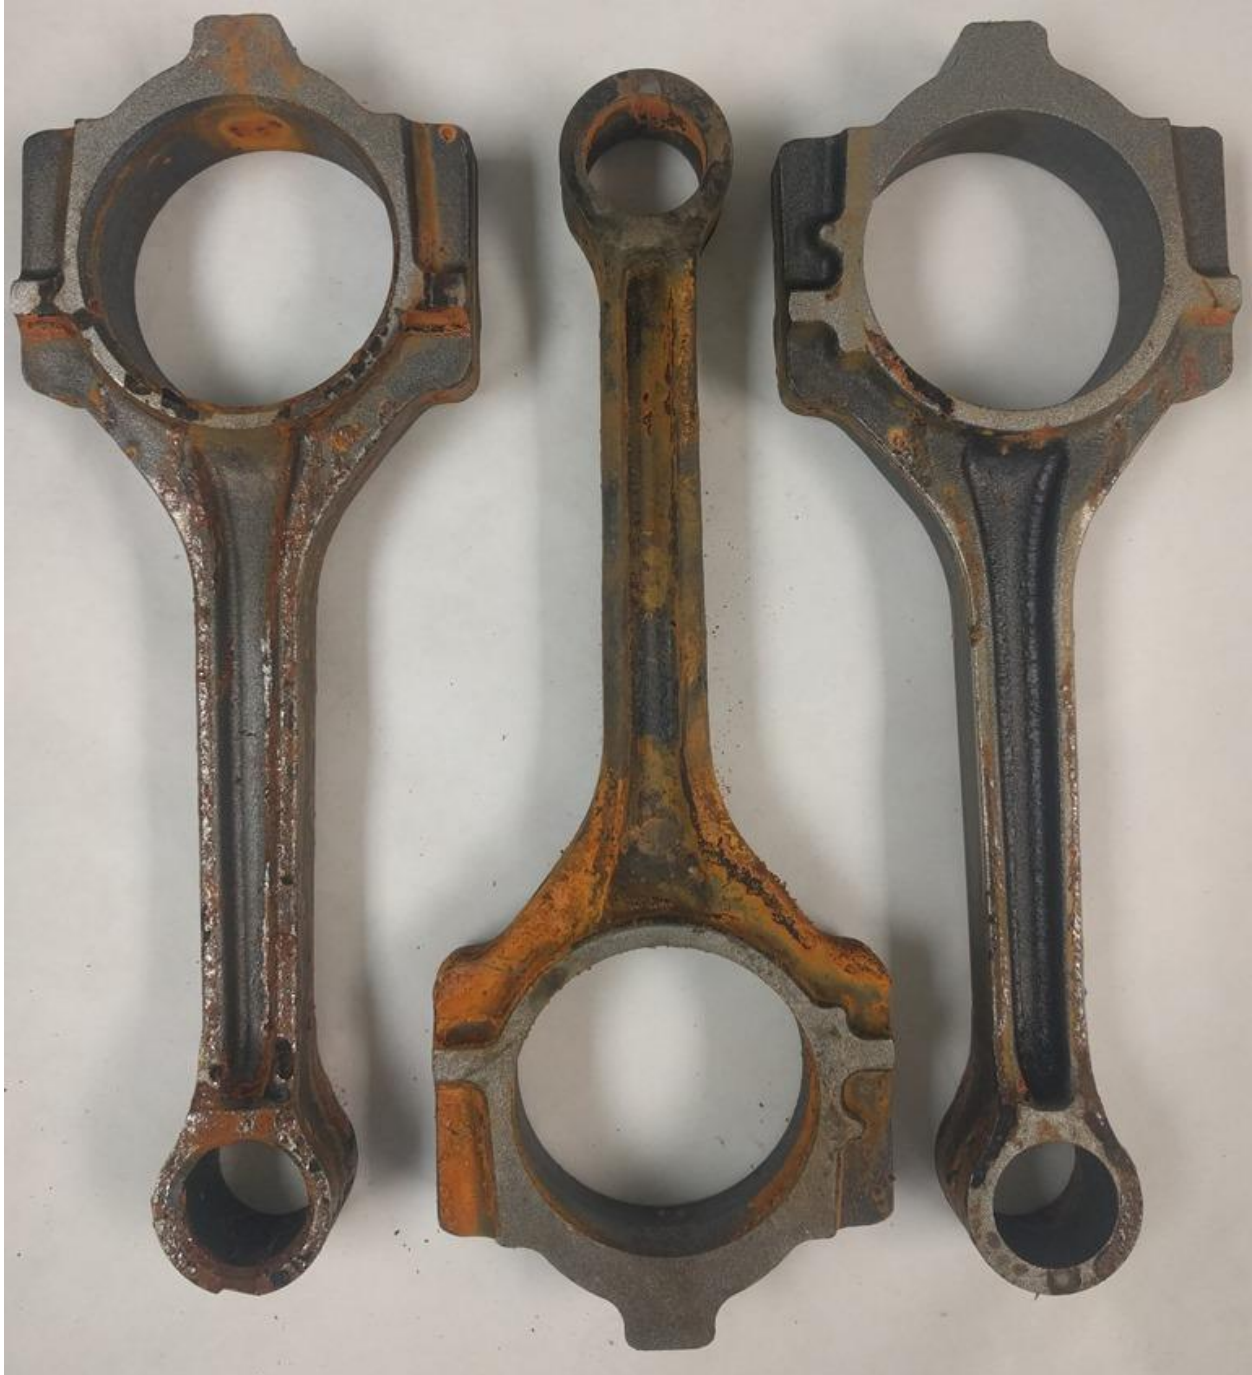
Photo 2: Protexo 1125 treated connecting rods, after 744 hours in accelerated corrosion testing.

After 744 hours of accelerated corrosion testing, VpCI-325 provided superior rust protection, compared to Chemetall Protexo 1125. The initial onset of corrosion for connecting rods protected with Protexo 1125 was 336 hours. Conversely, VpCI-325 lasted more than twice as long before the initial onset of corrosion.

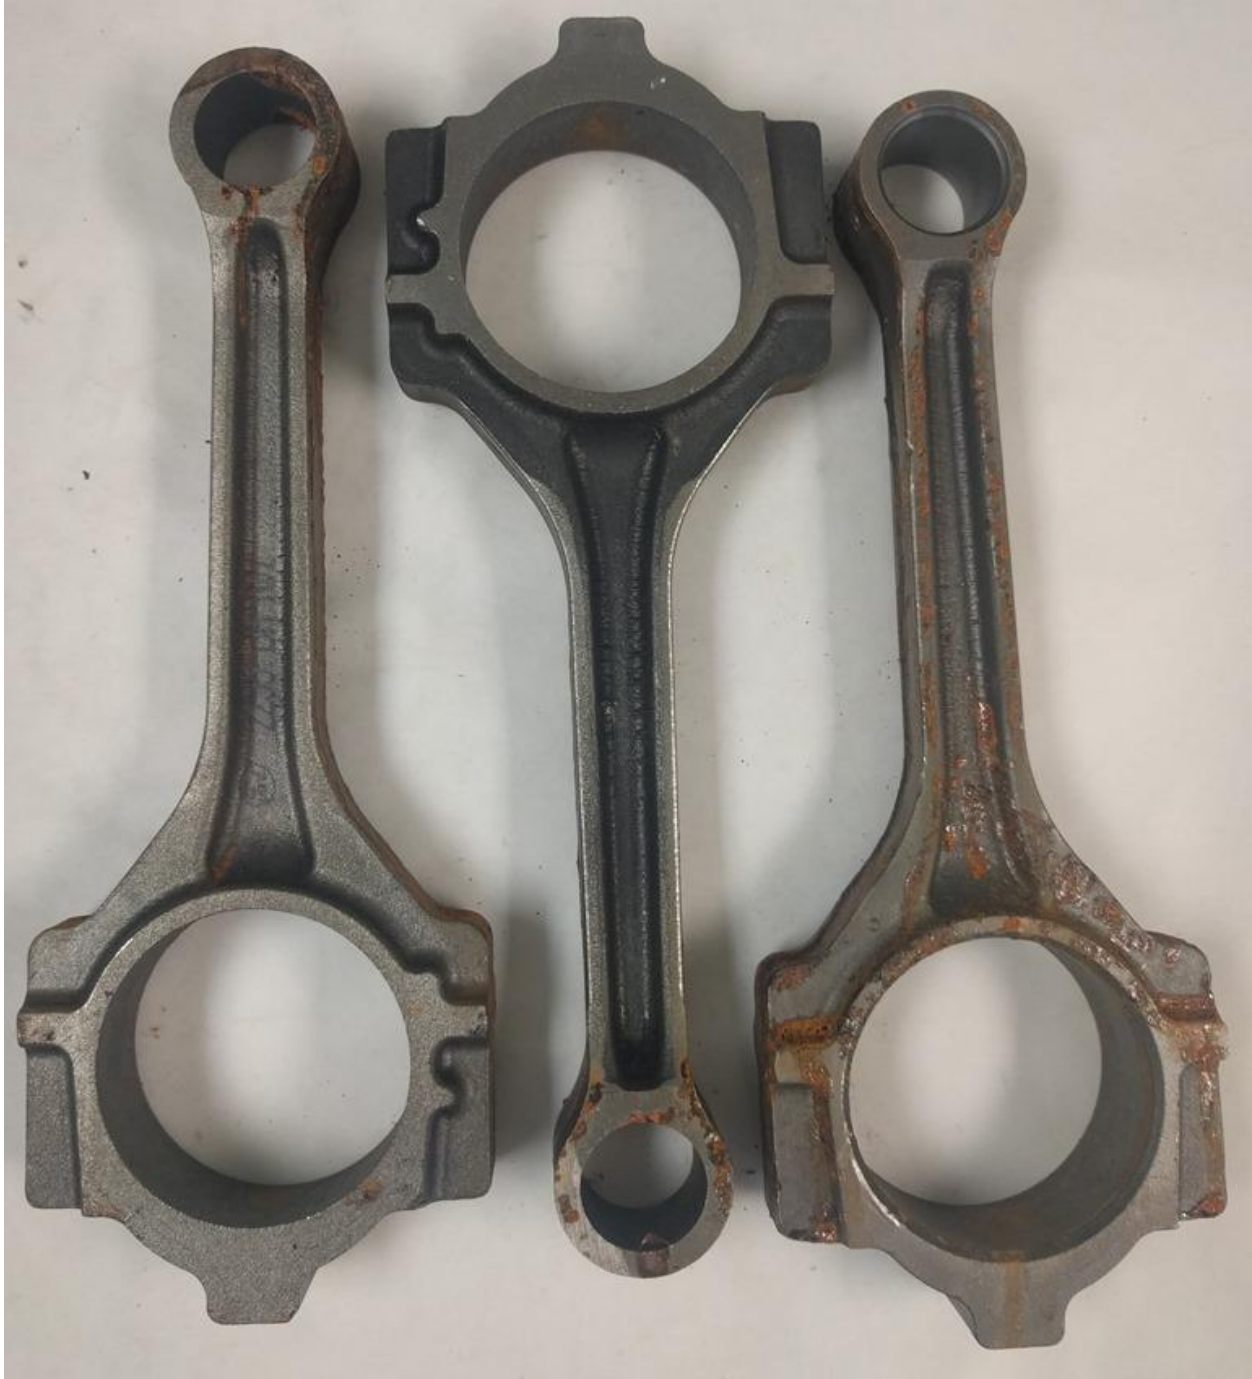
Photo 3: VpCI-325 treated connecting rods, after 744 hours in accelerated corrosion testing.
