VCI Film Comparison for Our Customer

Project #: 19-110-1125.bis

Our customer manufactures springs and small automotive components. After manufacturing and processing, automotive parts are placed in VCI bags to prevent corrosion during storage and transport. Cortec Laboratories was asked to test the effectiveness of their current VCI bags and desiccant against Cortec's VpCI-126 bags and DesiCorr.

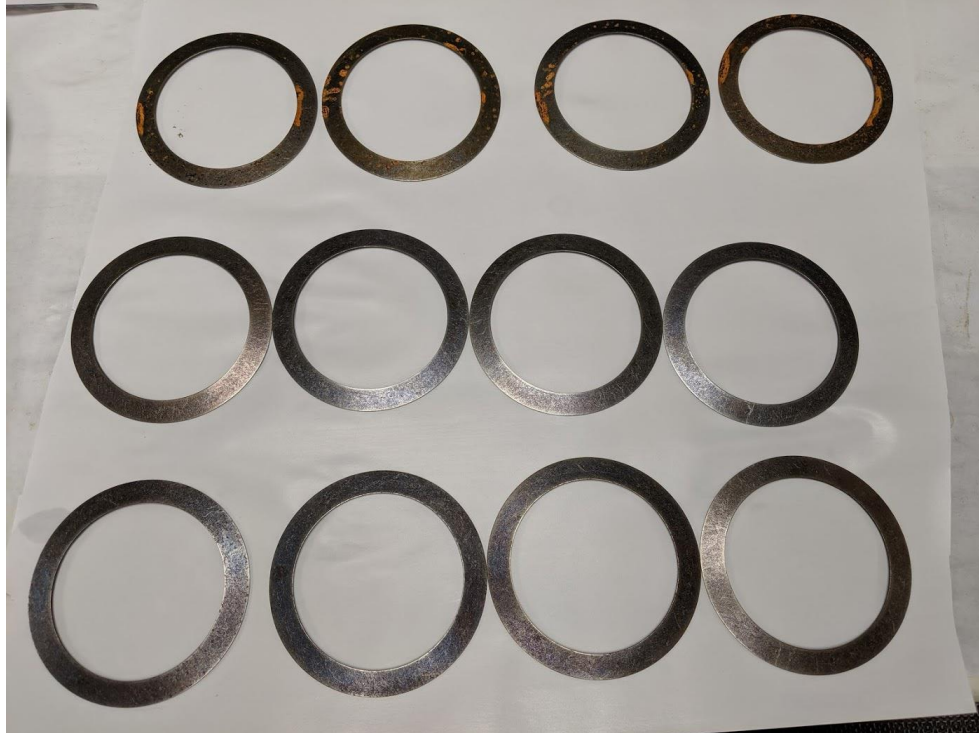
Figure 1: All rings after 120 hours of testing. The top row of rings is the control group. Middle row, VpCI-126 and DesiCorr protected. Bottom row, yellow VCI film and silica desiccant protected.

- All rings in the control group showed varying levels of corrosion on all surfaces.
- Rings protected by VpCI-126 and DesiCorr did not show any corrosion after 120 hours of testing.
- Rings protected by the yellow VCI film and silica desiccant showed very minor signs of corrosion along the top surface after 120 hours.

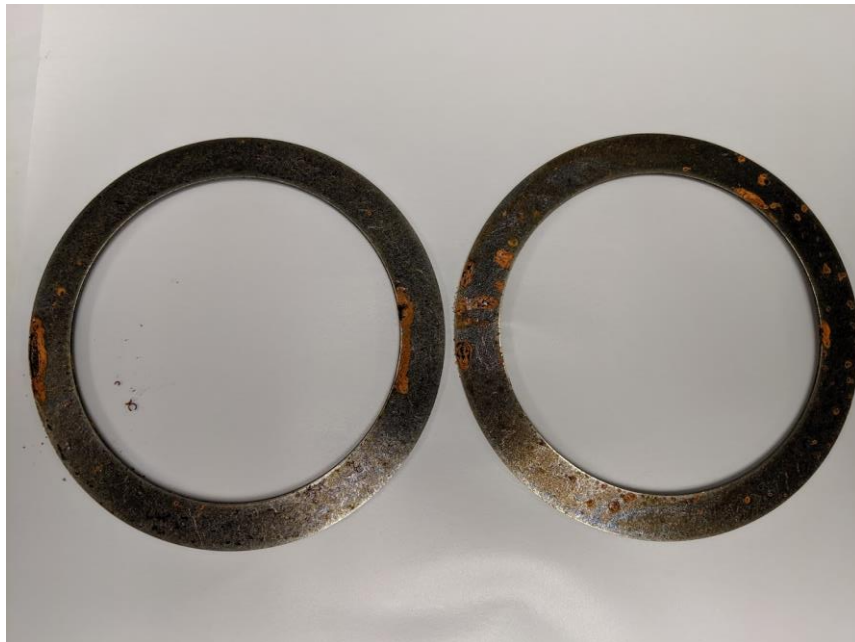
Figure 2: Rings from control group at 120 hours. Obvious signs of corrosion along the top surface, with small dark spots of corrosion seen as well.

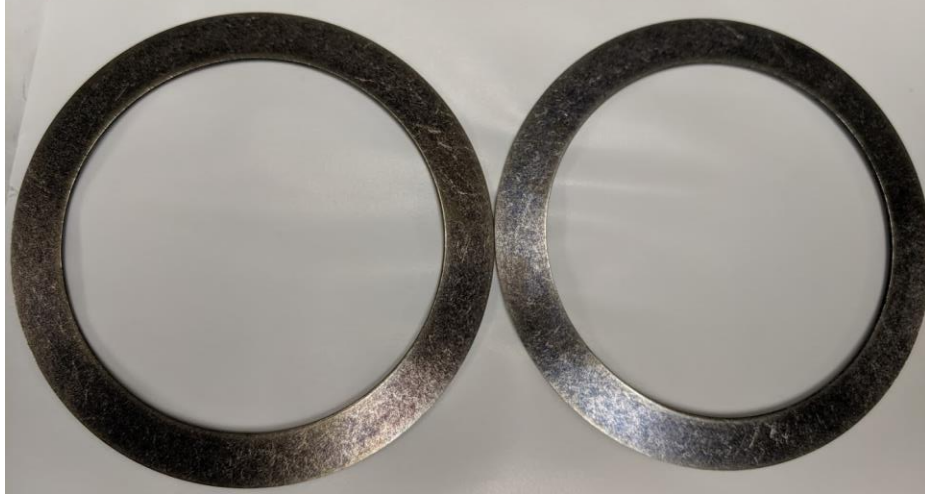
Figure 3: Close up of parts protected by VpCI-126 and DesiCorr. No signs of corrosion.

A loosely wrapped bag of VpCI-126 and a 1/6th Unit DesiCorr showed excellent corrosion resistance in ASTM D-1735 conditions at 120 hours. No signs of corrosion were seen on the surfaces of any rings tested with VpCI-126 and Desicorr.

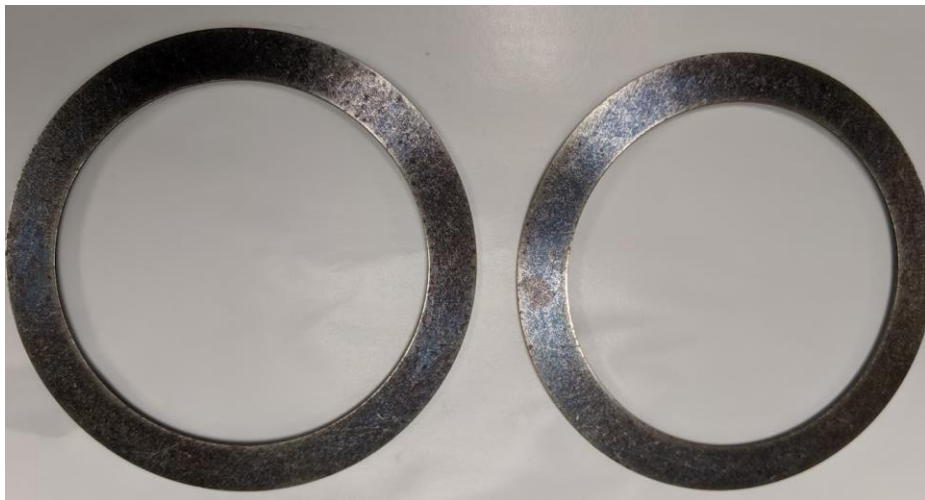
Figure 4: Close up of parts protected by yellow VCI film and silica desiccant. Small dark spots of corrosion starting can be seen along the top surfaces.

Rings protected by yellow VCI film and silica desiccant appeared in adequate condition at 120 hours of testing in ASTM D-1735. Closer inspection of rings from this group showed small signs of corrosion starting on the top surface of the rings.

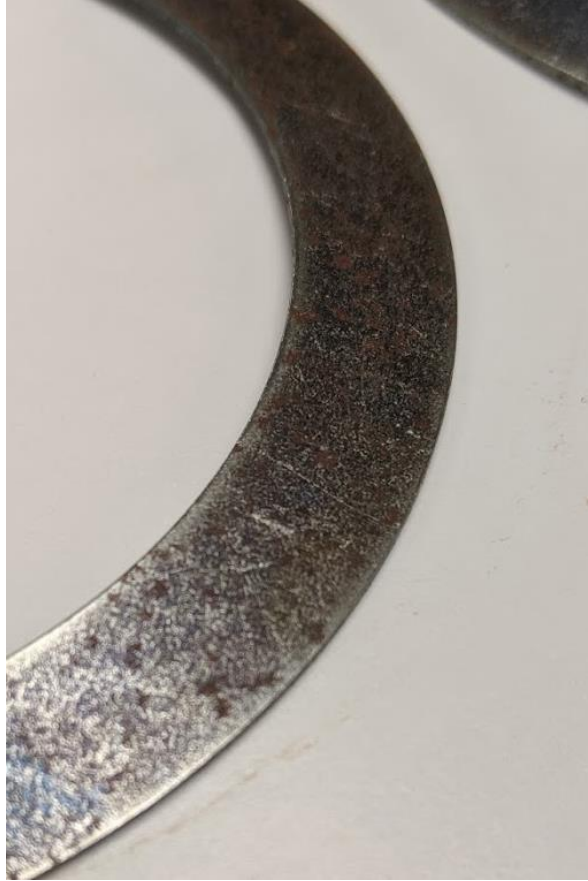
Figure 5: Close-up of a ring protected by yellow VCI film and silica desiccant. Small dark spots of corrosion can be observed on the surface.
