Packaging Evaluation for Our Customer

Project #: 20-022-1125.bis

Background:

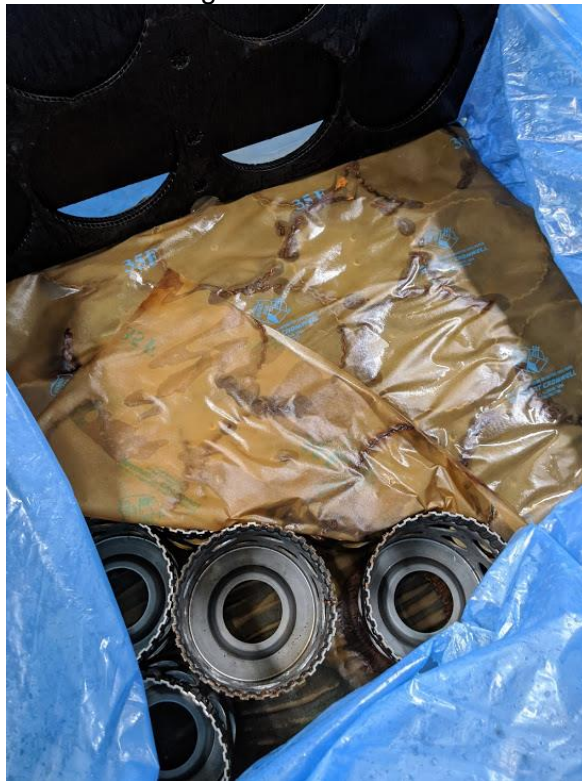
Figure 1: Parts protected by competitor VCI film. Heavy water ingress caused corrosion on the parts.

Parts protected by VpCI-126 film did not show any corrosion during the duration of the test. Parts protected by the competitor film showed corrosion after 96 hours in the large humidity chamber. Pictures of the parts at 96 hours of testing can be seen below.

Water ingress occurred in the crate protected by competitor VCI film. No obvious signs of ingress were observed, e.g. holes, tears, openings. The parts protected by VpCI-126 did not show similar water ingress, nor did any parts show corrosion after 96 hours of testing.

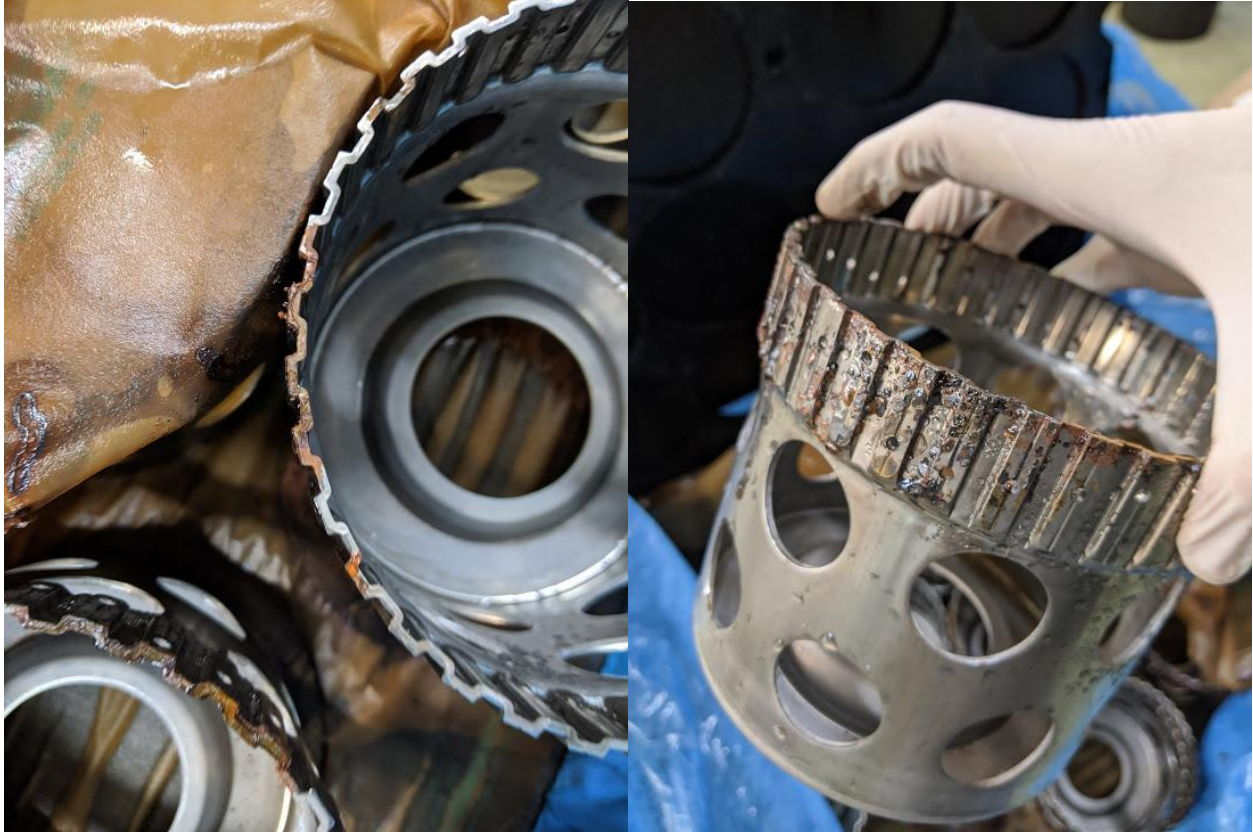
Figures 2 & 3: Close up view of corrosion on parts protected by competitor film.

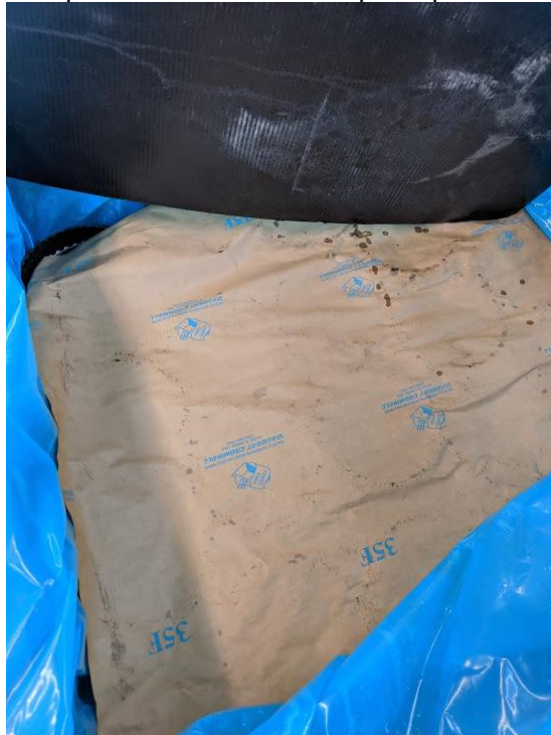
Figure 4: Top layer of paper, parts protected by VpCI-126 film. No significant water ingress occurred.

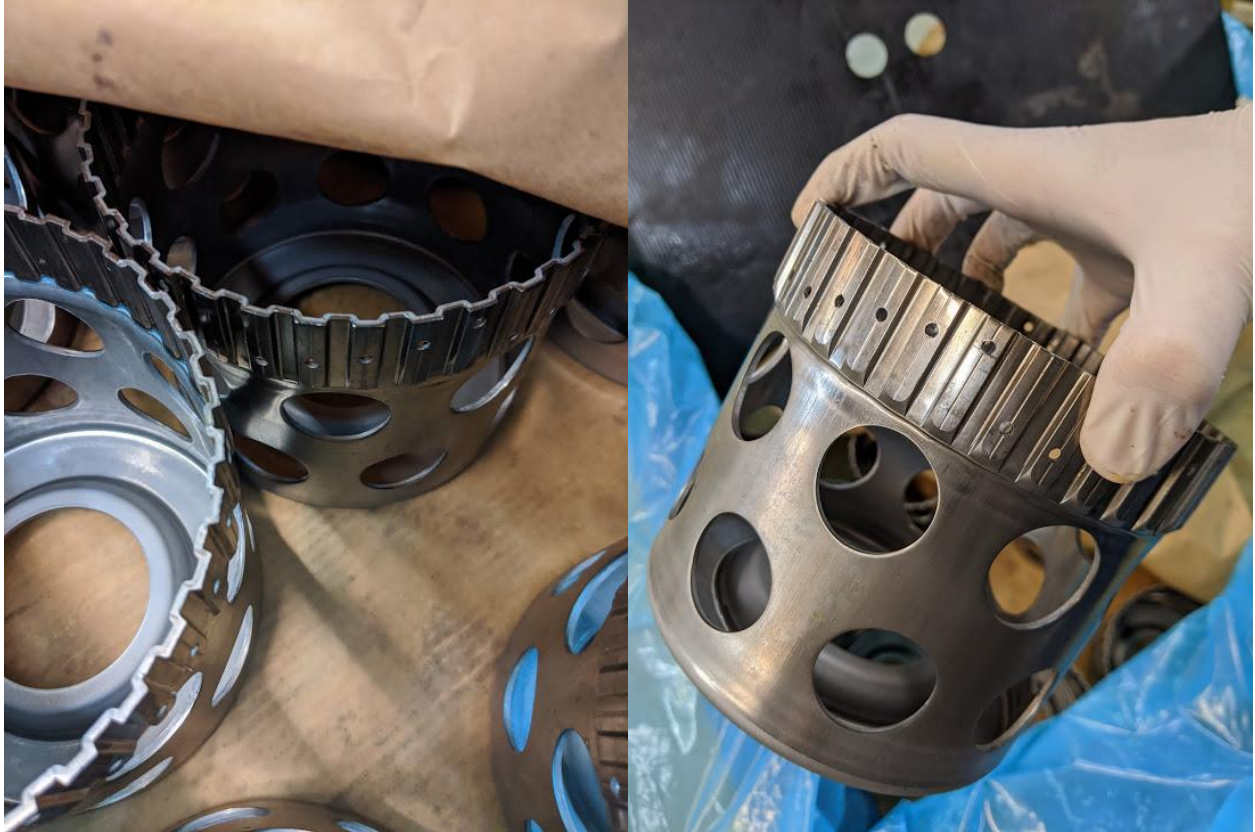
Figures 5 & 6: Parts protected by VpCI-126 film. No visible corrosion was seen on the parts.
