# Achieving sustainability

*Preventing tragic events of collapsing structures by utilizing migratory corrosion inhibitor technology*

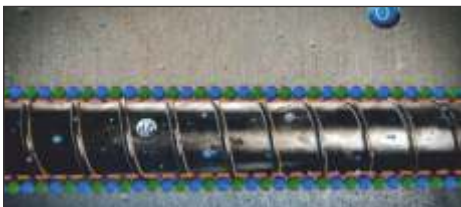
Migrating corrosion inhibitors form a protective layer on the surface of embedded steel reinforcement.

MCIs are based on amine technology. They are classified as mixed inhibitors, meaning they affect both anodic and cathodic portions of a corrosion cell. MCI® is applied in many forms including as a concrete admixture or a topical treatment. It moves as a liquid through the concrete matrix via capillary action and migrates in a vapor phase throughout the concrete pore structure. When MCI® comes in contact with embedded metals, it has an ionic attraction to it and forms a protective molecular layer.

This film prevents corrosive

elements from further reacting with the reinforcement and also reduces existing corrosion rates, greatly extending concrete service life.
