Lomost: engineering heritage in the heart of Croatia

The oldest reinforced concrete bridge in Croatia showed serious signs of deterioration and needed extensive repairs. Among the solutions was a corrosion-inhibiting admixture to protect the steel reinforcement in the concrete.

Lomost Bridge in the Ogulin City is the oldest reinforced concrete bridge in Croatia. It was constructed by the Austrian Company Eduard Ast & Co from Vienna. The bridge structure is the patented single-span Hennebique system. In the ribbed span assembly with 10m free span, smooth reinforcement with 25 and 27mm diameters was built-in. The longitudinal reinforcement was built-in following the rules of covering the moment diagram with cross reinforcement made from narrow steel sheets. Lower body elements of abutments were constructed as gravity concrete elements with no reinforcement.

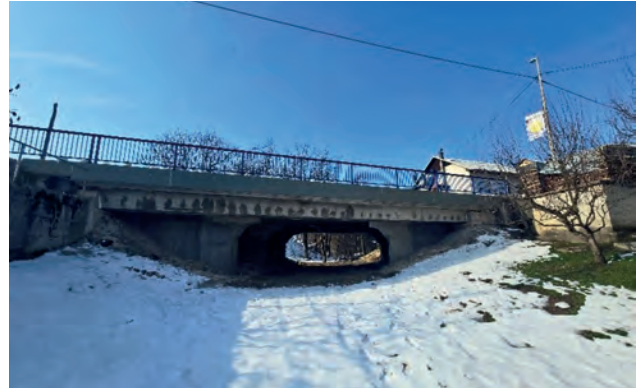
Above: Temporary support of the Lomost Bridge edge girders from October 2021 until full bridge repair works started.

20 tons per vehicle was allowed to travel on the bridge, which, after inspection and assessment of the condition, was further limited to 3.5 tons per vehicle and a maximum vehicle speed of 10km/h with the obligation to support the edge girders.

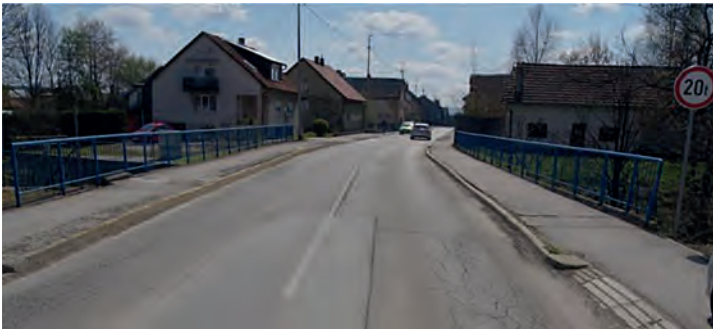
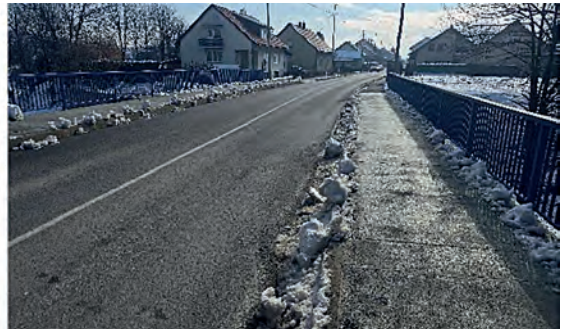
Below: (left and right): Lomost Bridge – pavement level old (left) and after reconstruction (right).

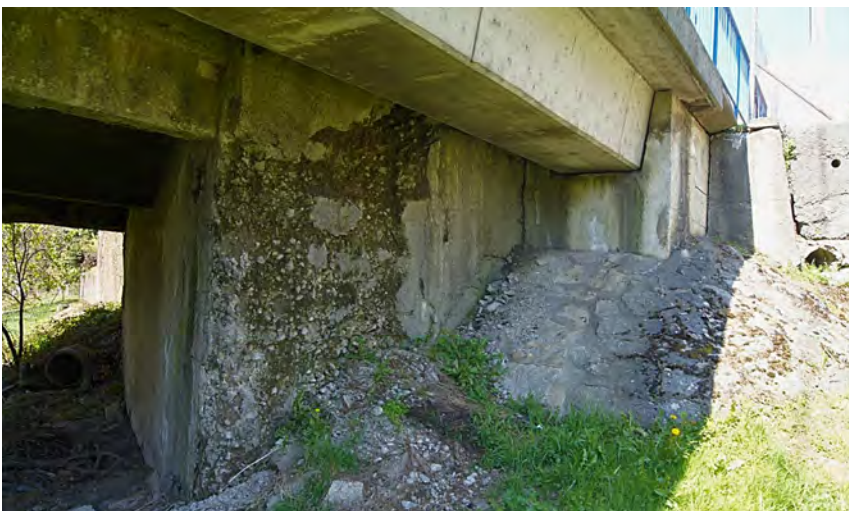
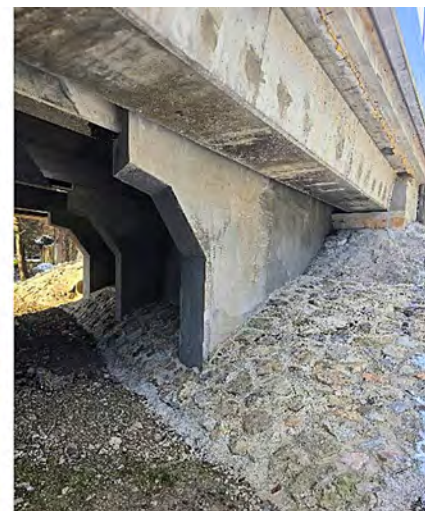
Bottom: (left and right): Abutment A1, before reconstruction (left) and after (right).

The restoration of the bridge included hydro-demolition works of concrete and reinforced concrete surfaces of the structural elements of the bridge with the application of a liquid migrating inhibitor directly to the prepared structural elements surfaces and mixing it into repair mortar R4 (BS EN 1504-3⁽¹⁾), and the reconstruction of the bridge included the construction of a concrete relief plate with mixed-in liquid migrating corrosion inhibitors (MCI); the construction of supporting cantilever protrusions for longitudinal supports and reinforcement of ribs with carbon-fibre-reinforced polymer (CFRP) lamellas and carbon sheets.

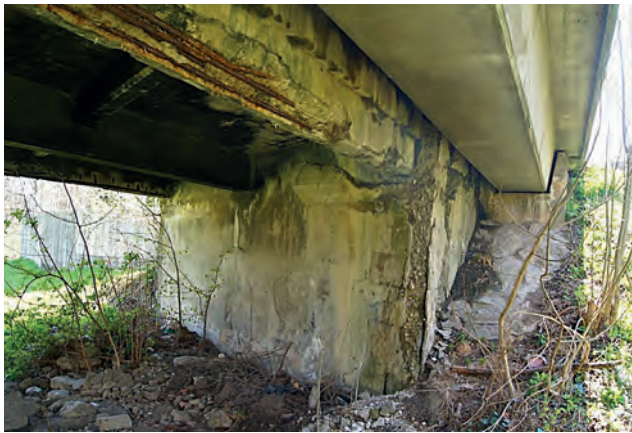
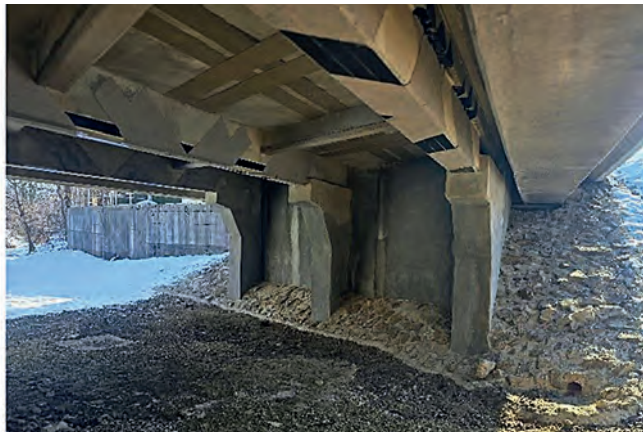
Above: Abutment A2, before reconstruction (left) and after (right).

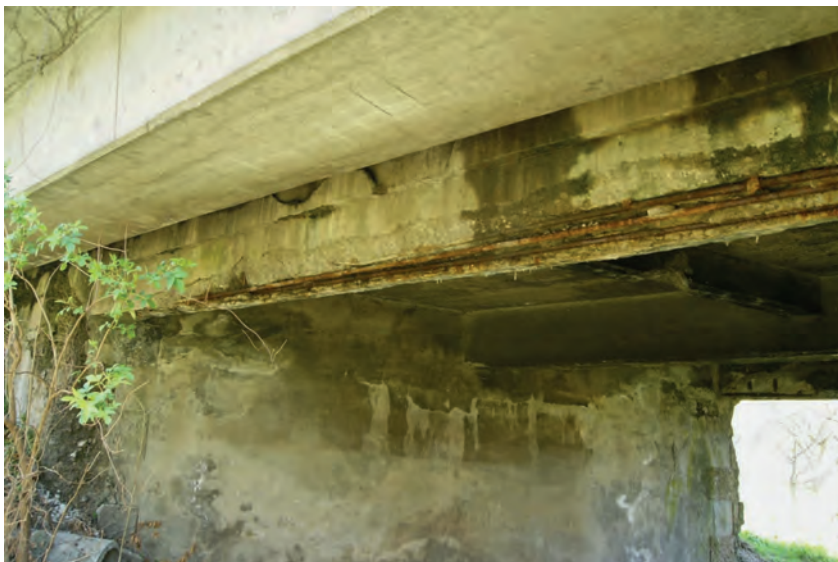
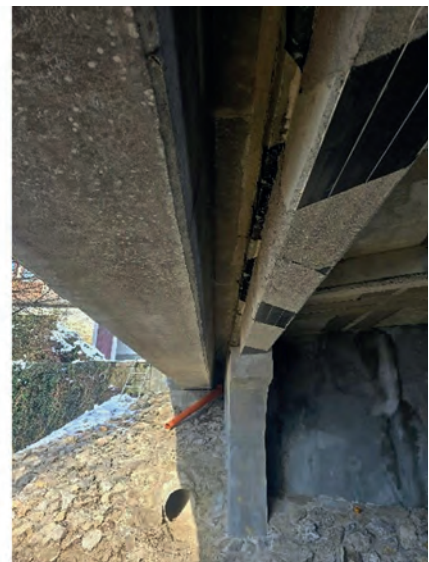
all structural elements of the main historic bridge. The structure was riddled with cracks, visible traces of seepage and, in winter, freezing of chloride-contaminated water from the pavement level. Also, large areas showed signs of deteriorating and spalling from the basic concrete material. Due to seepage at the junction of the main bridge and the edges to the pedestrian bridges, the exposed surfaces of the reinforced concrete superstructure have been significantly damaged with visible and wide-band corroded longitudinal reinforcement, which was on large sections completely outside the concrete cross-section (no function), while simultaneously the transverse reinforcement on exposed parts has been completely severed.

Due to significant damage to the longitudinal rib's

edges, the deformations of the superstructure increased under heavy vehicles traffic. Due to separate deformations of the different systems of the main bridge and the side pedestrian paths, the contact joint additionally opened, which increased the penetration of water from the roadway level towards the edge structural elements of the main bridge.

Below: Edge longitudinal girder – level of damage (left) and after (right).

The use of MCI, a chemical substance based on the technology of organic amine alcohols and amine carboxylicates, ensured reduced metal corrosion without reducing the concentration of the corrosive substance that caused corrosion. After the analyses were carried out, the project defined the direct application of the inhibitor on vertical surfaces and undersurfaces of the slab and girders in a higher concentration and density (3.68l/m²) to ensure the achievement of the goals.
