Preservation of historical structures

The repair of two historically important sites in Croatia has been carried out with differing construction chemical solutions.

Ana Juraga and Ivana Liposcak, Cortec, Zagreb, Croatia

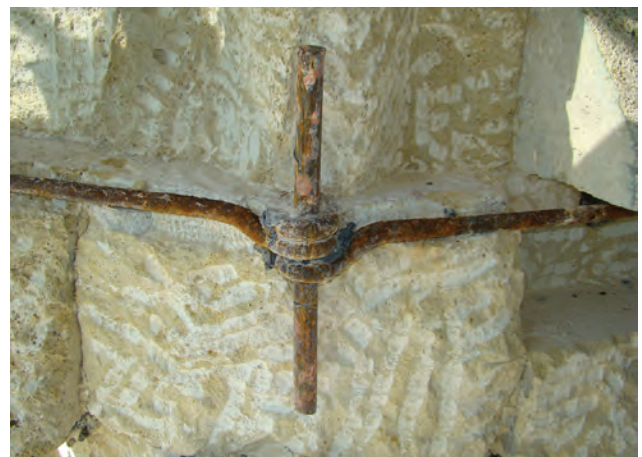
During reconstruction work on the south tower in 2012, damaged steel joints were found surrounding the tower

100mm below the surface at approximately every 3m. Most of the joints were only partially exposed in order to replace the surface layer of stone on the belltower, while the back of the joints remained embedded in stone and lime mortar. The joints were covered with a layer of rust and, in drainage areas, corroded all the way through the cross-section.

Zagreb Cathedral – damaged steel joints on south tower.

It was suggested to use a minimal range of intrusion to keep the mechanical resistance and stability of the tower structure at their existing levels, while keeping costs at a minimum. Cortec's CorrVerter MCI Rust Primer was recommended for corrosion protection. The rust primer is a water-based product that quickly converts rust into a protective layer and is capable of penetrating into corroded surfaces. It contains a chemical chelating agent that modifies surface rust into a hydrophobic passive layer.

A metal brush was used to remove loose rust from the joints. Then, two layers of the rust primer coating were applied directly onto the metal. A brush was used for

application on smaller metal joint surfaces, while spray application was used for larger areas. The first coat was applied at a thickness of 100 microns (4 mils). A second coat was applied at a thickness of 75 microns (3 mils). During application, the coating temperature was 13°C (55°F). The joints were then reinforced with steel fishplates that were welded onto the joints and also protected with CorrVerter. The final step was to replace the stones around the joints. With the help of a skilled team and good project management, the entire project was completed successfully with minimal cost and intrusion, as specified. The coating penetrated into the metal and stopped further advancement of the corrosion process.

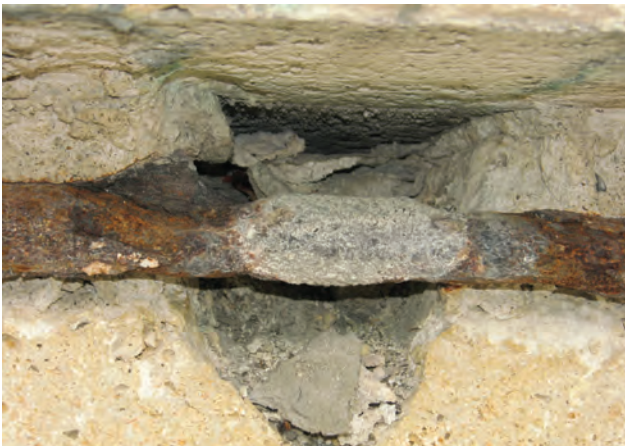
Zagreb Cathedral – damaged steel joints on south tower.

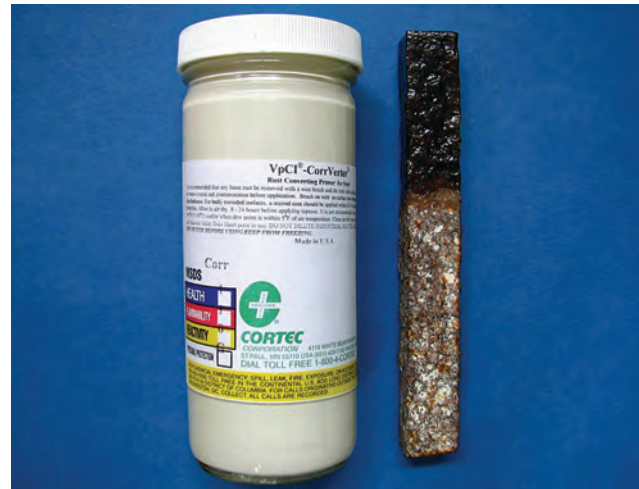
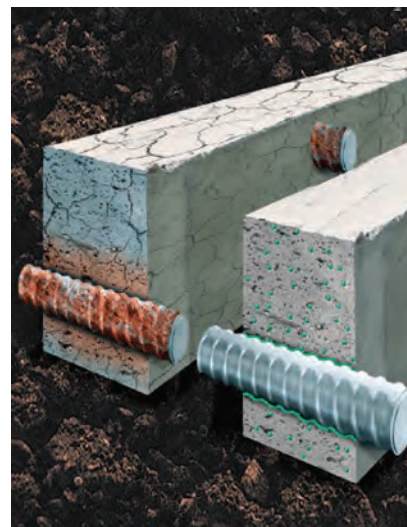
The tower walls have a square floor plan and rest on foundations made of broken stone. These walls are exposed to damaging atmospheric influences and the binding material between the bricks has washed away, leading to brick deterioration. Renovation work on ‘tower three’ includes strengthening of the foundations, restoration of collapsed parts and injection of cracks.

The project involves the use of corrosion inhibitors to prolong the life of the structure. Cortec’s corrosion inhibitor MCI-2005 is added into concrete being used to reinforce the foundation. This amine-carboxylate-based

corrosion inhibitor admixture to protect embedded metallic reinforcement from corrosion in order to extend the lifetime of the walls. MCI-2005 is a water-based, organic corrosion-inhibiting admixture with set-retarding effects. When incorporated into concrete,
