MICRO-CORROSION INHIBITING COATINGS POWERED BY NANO VPCI®

CASE HISTORY SPOTLIGHT

Case History #197: Solving Corrosion Problems for Combat Readiness

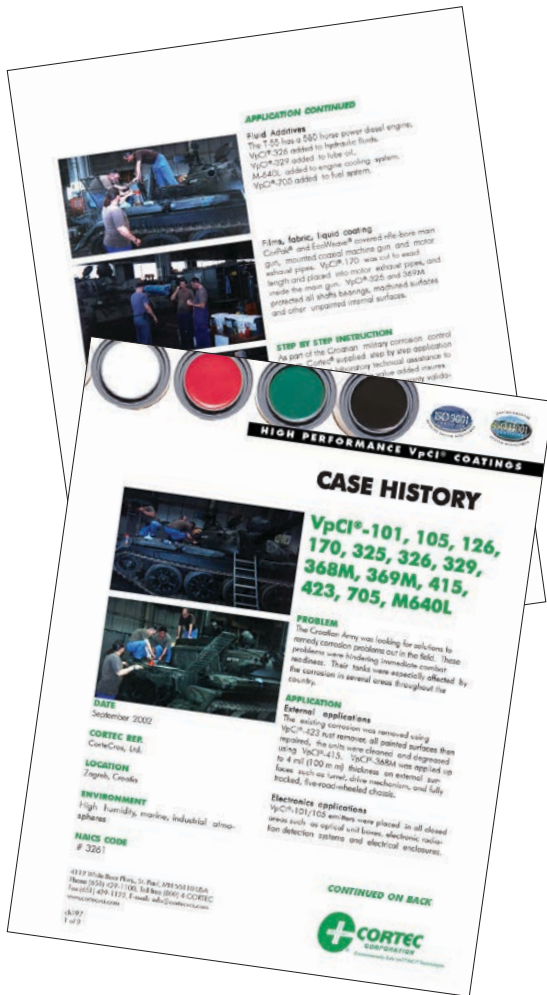
An army in southeastern Europe was having trouble maintaining combat readiness because of corrosion problems—especially on tanks—in several regions of the country. With the guidance and technical support of Cortec® to ensure proper application and warranty validation, the army applied the following remedy.

The application team removed rust using VpCI®-423, repaired all painted surfaces, and cleaned the tank using VpCI®-415. They applied VpCI®-368 M to outer surfaces such as the turret, drive mechanism, and chassis. VpCI®-101 Devices and VpCI®-105 Emitters were placed in electronic, electrical, and optical unit enclosures. The 580-horsepower diesel engine was protected by adding a variety of Cortec® additives to hydraulic fluids, lube oil, the engine cooling system, and the fuel system. Protective VpCI® film and fabric such as Cor-Pak® and EcoWeave® were used to cover the mounted coaxial machine gun, the main gun, and motor exhaust pipes, with strips of VpCI®-170 inserted into the last two. VpCI®-325 and VpCI®-369 M were applied to shafts bearings and various machined and unpainted surfaces.
