CORTEC
CORPORATION

MIGRATORY CORROSION INHIBITOR (MCI®) PRODUCTS FOR CONCRETE

Case History #314: Parking Garage Restoration

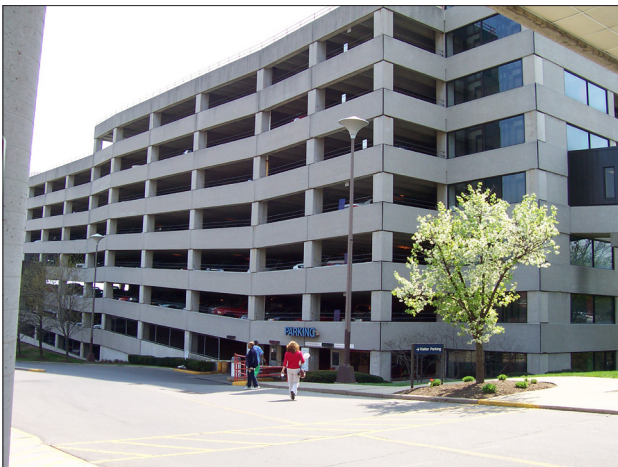
A medical center parking garage in Ohio had corrosion problems in its top precast slab, requiring partial to full repair. MCI®-2005 NS was added to new parts of the slab to mitigate corrosion of existing steel and protect against the ring anode effect. Areas with heavy reinforcing mats were treated with MCI®-2020 surface applied corrosion inhibitor. These Cortec® products provided a superior method of restoration and corrosion prevention that was efficient, cost-effective, and easy to apply.
