CASE HISTORY SPOTLIGHT

Case History #380: Power Plant Inventory Preservation

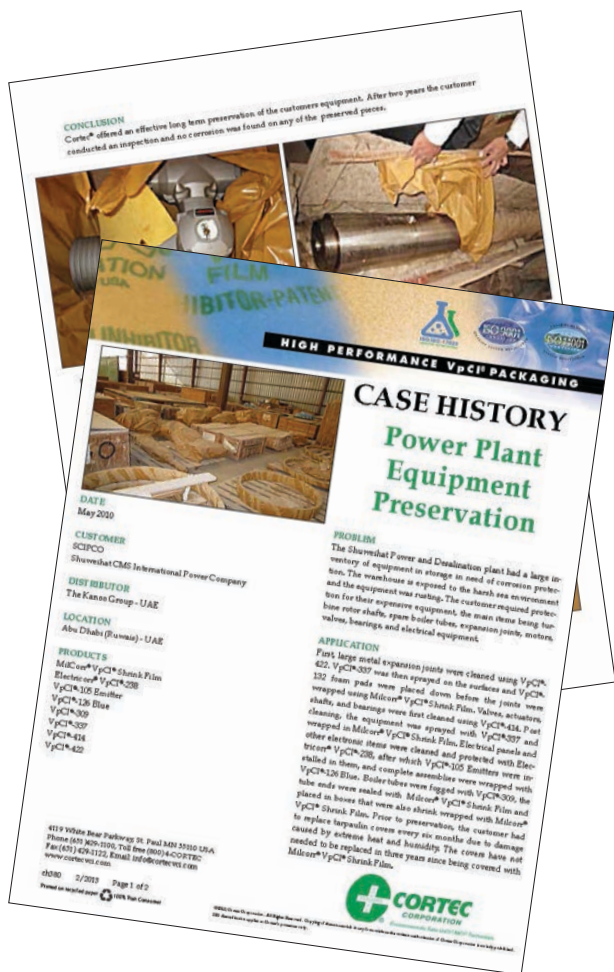
The warehouse at a power and desalination plant in the Middle East had a large inventory of equipment, some of which was rusting due to exposure to a harsh sea environment. Inventory included costly items such as turbine rotor shafts, spare boiler tubes, expansion joints, motors, valves, bearings, and electricals.

First, rust on the expansion joints was removed using VpCI®-422. These large parts were then protected with VpCI®-337, VpCI®-132 Foam pads, and MilCorr® VpCI® Shrink Film. Valves, actuators, shafts, and bearings were cleaned with VpCI®-414 and preserved with VpCI®-337 inside MilCorr® VpCI® Shrink Film. Electricals and electronics were cleaned and protected with Electric® VpCI®-238, equipped with VpCI®-105 Emitters, and wrapped inside VpCI®-126 Film. Boiler tubes were fogged with VpCI®-309, ends sealed with MilCorr® VpCI® Shrink Film, and the tubes placed in boxes that were further shrink-wrapped with MilCorr® VpCI® Shrink Film.

At the two-year inspection, no corrosion was found on the preserved pieces. In addition, whereas the client used to have to replace tarpaulin covers every six months because of damage from high temperatures and humidity, they did not need to replace any covers for at least three years after starting to use MilCorr® VpCI® Shrink Film.
