CASE HISTORY SPOTLIGHT

Cortec® Case History #449: Medieval Cathedral Restoration

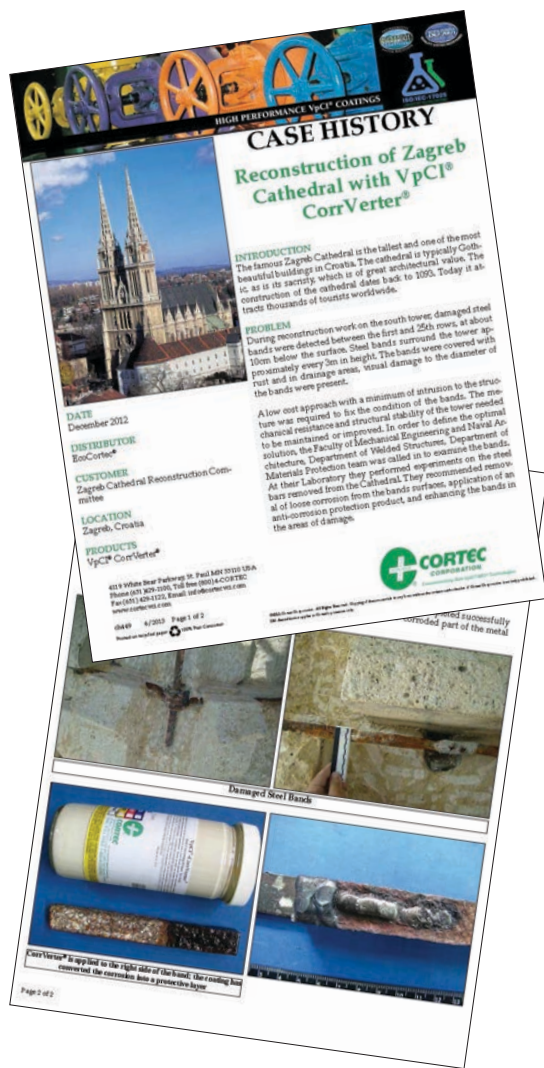
The sacred and architectural significance of the medieval Zagreb Cathedral make it a major tourist attraction in Croatia. When reconstructing the south tower several years ago, workers discovered a number of rows of rusty steel bands that surrounded the tower. The bands were spaced 3 meters apart, about 10 centimeters below the surface. Visual damage was present at drainage areas.

The problem was taken to the Faculty of Mechanical Engineering and Naval Architecture, Department of Welded Structures, Department of Materials Protection team. After examining the rusted bands and performing experiments at their laboratory, they recommended removing loose rust, applying CorrVerte[®], and reinforcing the bands in damaged areas.

Two coats of CorrVerte[®] were applied to the rusty bands, which were then reinforced with steel fishplates also protected with CorrVerte[®]. The stones were then replaced around the bands. The corrosion solution met the project requirements of low cost and minimal intrusion and was deemed successful.
