CASE HISTORY SPOTLIGHT

Case History #529: Rusty Spiral Staircase Preservation

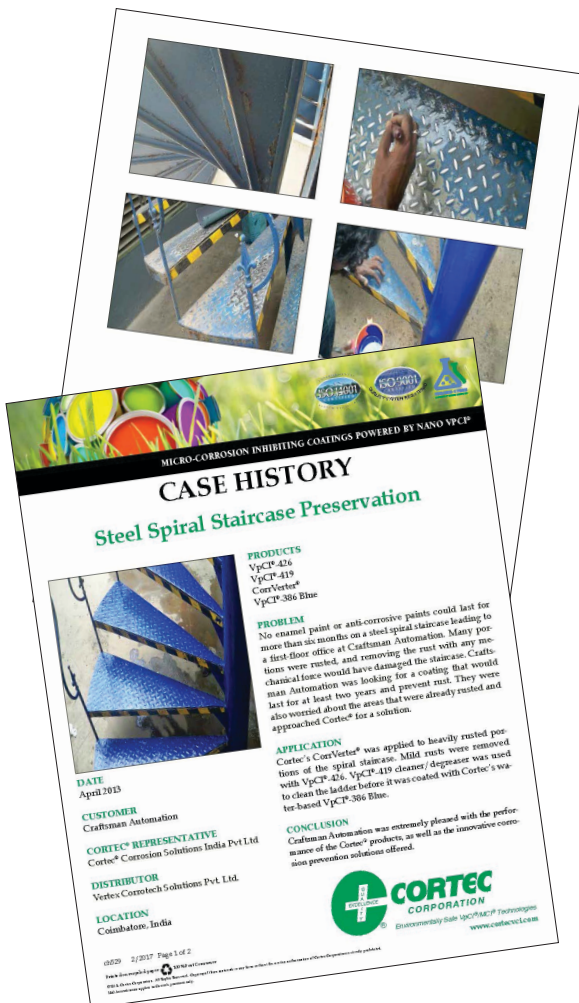
A manufacturing firm in Coimbatore, India, could not get any enamel or anti-corrosion paints to last more than six months on a steel spiral staircase leading to an office. Although many surfaces were already rusted, rust removal by mechanical force would have damaged the staircase. The manufacturer approached Cortec® for a corrosion solution and a protective coating that would last at least two years.

The remedy involved passivating heavily rusted surfaces with CorrVerter® and removing light rust with VpCI®-426. VpCI®-419 was used to clean the staircase before applying water-based VpCI®-386 Blue as a topcoat. The customer was very pleased with the products' performance and Cortec's innovative solution.
